# ROAD SAFETY AUDIT

Dresser Hill Road  
Town of Dudley  
June 2015

Prepared For:  
MassDOT

Prepared By:  
Chappell Engineering Associates  
201 Boston Post Road West

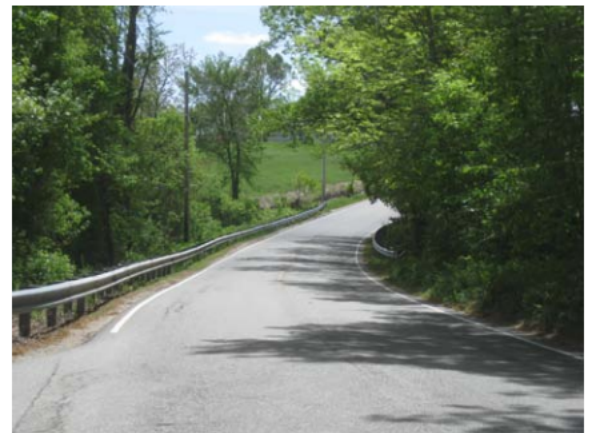
Between the Charlton Town Line and Koebeke Road, and Leo Ave and the Connecticut State Line, Route 31 contains a series of horizontal and vertical curves. These curves obscure sight lines between motorists on the roadway and vehicles entering or exiting driveways or side streets. Vertical downgrades may also contribute to travel speeds on downgrades.

***The horizontal and vertical geometry restrict sight distance and may result in excessive travel speeds***

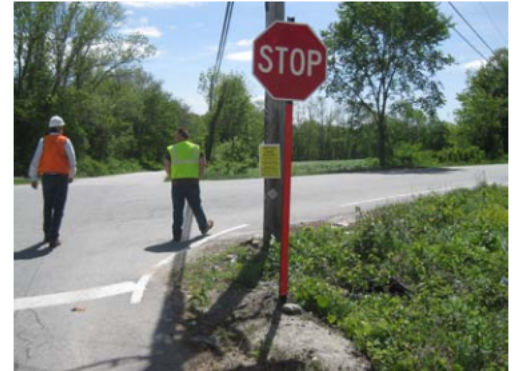
Stop signs are located at the intersecting streets to Route 31, with no advance warning of the intersection and the paint was non-reflective and faded, making them harder to see at night. The stop signs also lack proper marking as one or two way stops and can be mistaken for four way stops, having the potential to cause serious crashes if drivers expect all vehicles to stop at the intersection. These signs should be replaced with current highly reflectorized signage. Team members also noted lacking signage including advanced curve warnings, chevron markings, animal crossings, and dangerous roadway condition warnings.

***The stop signs also lack proper marking as two way stops***

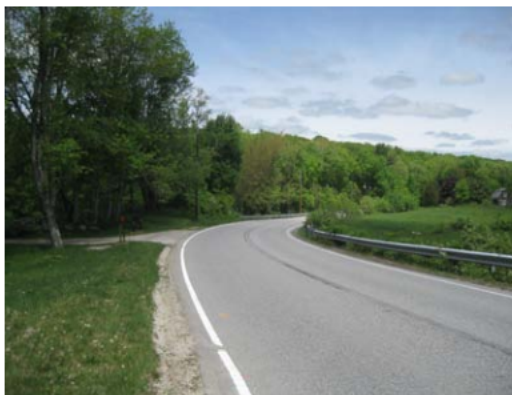
***A lack of delineation was observed throughout the corridor as seen in this photo where the double yellow center line has worn away.***

A lack of delineation was observed throughout the corridor. Delineation devices such as retro reflective pavement markings, recessed pavement markers, roadway edge reflectors, and guardrail reflectors are not provided or are in need of upgrading. The lack of delineation makes it difficult for drivers to locate the edge of the roadway, and makes it difficult for motorists to navigate the winding roadway, especially at night and during inclement weather. The lack of delineation likely contributes to the single vehicle departure crashes.

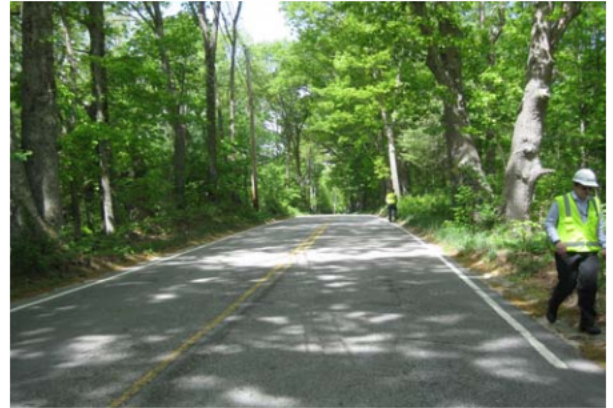
RSA participants observed that there are no bicycle and pedestrian facilities on the corridor. Dudley residents have made Town Representatives aware of safety concerns for cyclists and pedestrians on Route 31, particularly given the high vehicle travel speeds along the corridor and the history of speed related crashes where drivers lost control of the vehicle. Although no pedestrian and only one bicycle crash was reported in the crash data, the concern of missing pedestrian and bicycle accommodations was still raised during the RSA. Route 31 can be considered a regional connector for bicycle travel between Dudley and Charlton, as it connects the two town centers as well as functioning as a recreational route.

***RSA participants observed that there are no bicycle and pedestrian facilities on the corridor.***

- h. Consider providing a paved shoulder to provide motorists with a recovery zone in case they depart the roadway. Mark the shoulder with a solid white edge line (SWEL) to guide motorists along the roadway and to help keep vehicles away from the guardrails. Consider using a 30-degree shoulder slope, or *Safety Edge*, as outlined by the Federal Highway Administration (FHWA) to reduce the occurrence of tire scrubbing, which can cause motorists to lose control of their vehicles. According to the FHWA, the *Safety Edge* may reduce the occurrence of crashes on two-lane highways by 6%.

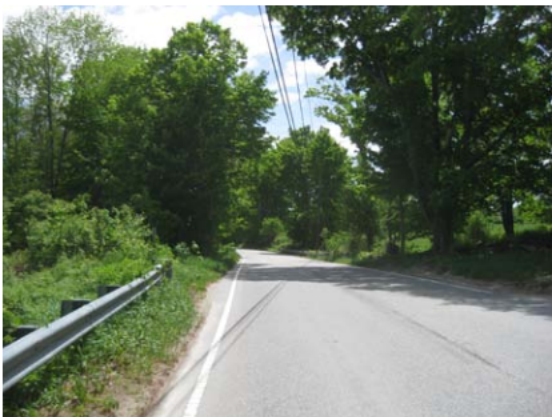
***Dense vegetation restricts sight distance at various points throughout the corridor.***

The visibility along Route 31 is very limited, both to curves and to intersections ahead of the driver. This is mostly caused by dense vegetation along the side of the roadway. Dense forest is most prevalent on the northern segment of the road between the Charlton Town Line and the Koebke Road intersection, as well as on the southern segment beginning at the Leo Ave intersection and ending at the Connecticut State Line. In these areas, trees grow very close to the edge of the roadway, blocking the sightline of drivers as they approach the many dangerous curves in the roadway. The drivers have little to no advanced sight of what lies around the corner until they are in a place where it is too late for the situation to be mitigated.

- i. Clear the edge of the roadway as much as possible of vegetation, trees, and utility poles to increase sight distance, limit the hazard of fixed object crashes and to give motorists additional recovery room.

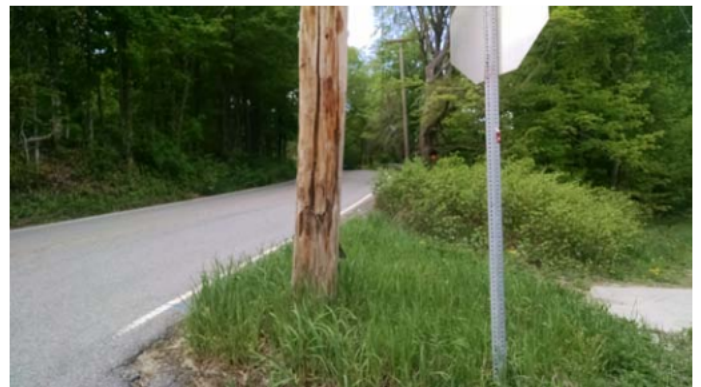
To the right, Healy Road drivers are forced to look through utility poles, trees, and shrubbery in order to see the roadway ahead. It is difficult to see through these factors, effectively blinding the driver to oncoming traffic. To the left, the Healy Road driver has better visibility, though low lying branches and foliage overhanging the road intrudes into the sightline.

A utility pole blocks the right hand sight line from being viewable. The pole is mildly fragmented, possibly from being struck, though there was no report of such an accident in the data.

***To the right, drivers are forced to look through a utility pole, trees, and shrubbery in order to see the roadway ahead***

- c. Consider movement/replacement of the utility pole currently located to the north of the intersection.
- d. Consider removal of vegetation around the intersection as well as pushing back of the tree line both in the immediate surroundings and the surrounding horizontal curves on Route 31. This will aid in both snow removal and sightline increase.
- e. Place advisory speed signage if applicable based upon a study.

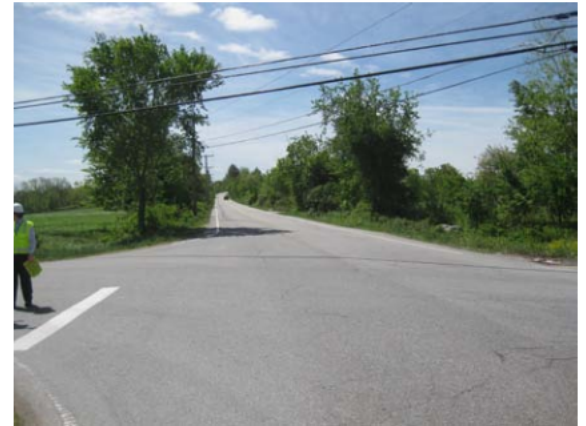
The western side has more trees and vines blocking drivers, making this side of the intersection less visible to mainline traffic from the south until the side street driver has entered the intersection. A stone wall and telephone pole on the northwest corner block the view towards the curve north of the intersection on Route 31.

***At the intersection, trees are present as they border the fields surround the intersection on the southern and northwestern corners.***

- c. Consider removal of trees and vegetation surrounding the intersection. Care should be taken to avoid removing all vegetation as this could cause problems with snowdrift from the fields. If done properly, the intersection will be more visible and snow removal will be easier with more roadside space. See **Figure 5**.

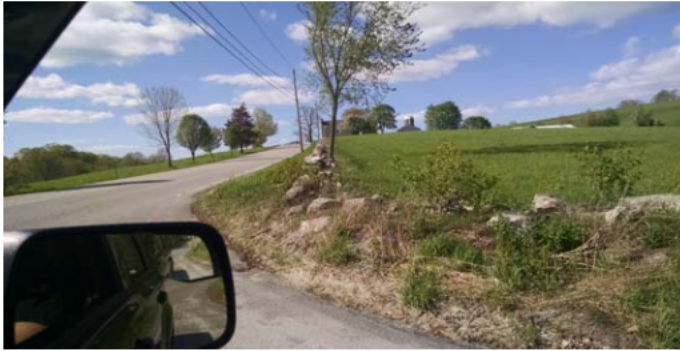
***There is a hill to the north, off which Route 31 approaches the intersection at a downgrade.***

Route 31 intersects Dresser Hill Road #2 and NW Schoolhouse Road on a steep southerly downgrade. Dresser Hill Road #2 and NW Schoolhouse crest at Route 31. The upgrade of the intersecting roadways makes cars difficult to see from Route 31, leaving potential for dangerous crashes when drivers are unable to see each other and vehicles must travel up an incline from a stopped position when entering Route 31.

- a. Consider implementation of warning signage on Route 31, Dresser Hill Road #2 and NW Schoolhouse. Route 31 signage should include dangerous intersection warnings. Dresser Hill Road #2/NW Schoolhouse Road should include route marker assemblies. Current signage should be replaced with retroreflective signage. New signage should be considered for energy efficient lighting options to highlight to drivers that they are approaching a dangerous intersection. This is particularly relevant to stop and warning signs.
- b. Consider removal of trees and vegetation surrounding the intersection.
- c. Consider altering roadway and intersection geometry to create a more level intersection and to reduce the steep upgrading of intersecting roadways.
