Jericho-Brandon Study Area Town of Dudley, Massachusetts

Jericho-Brandon Infrastructure Planning Project

Prepared For: Town of Dudley 71 West Main Street Dudley, Massachusetts

June 2021

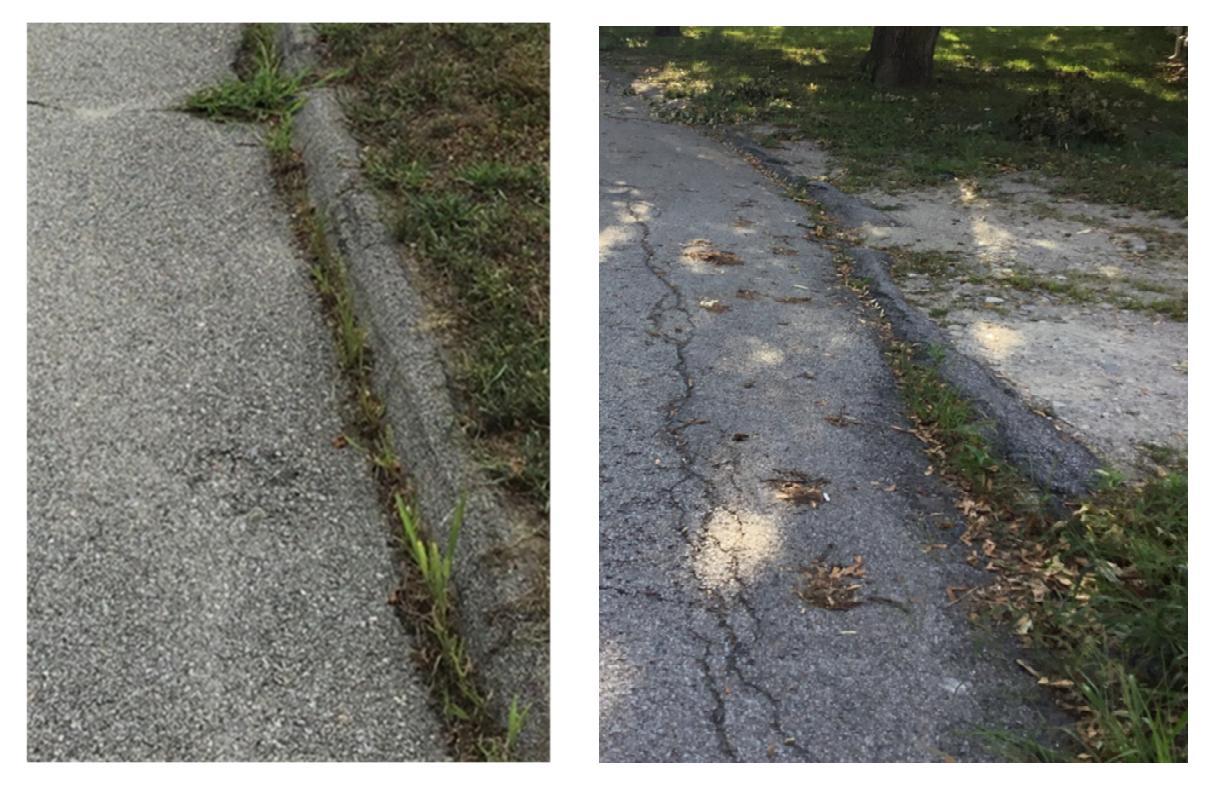
Photo 3: Good Curb

Photo 4: Fair Curb

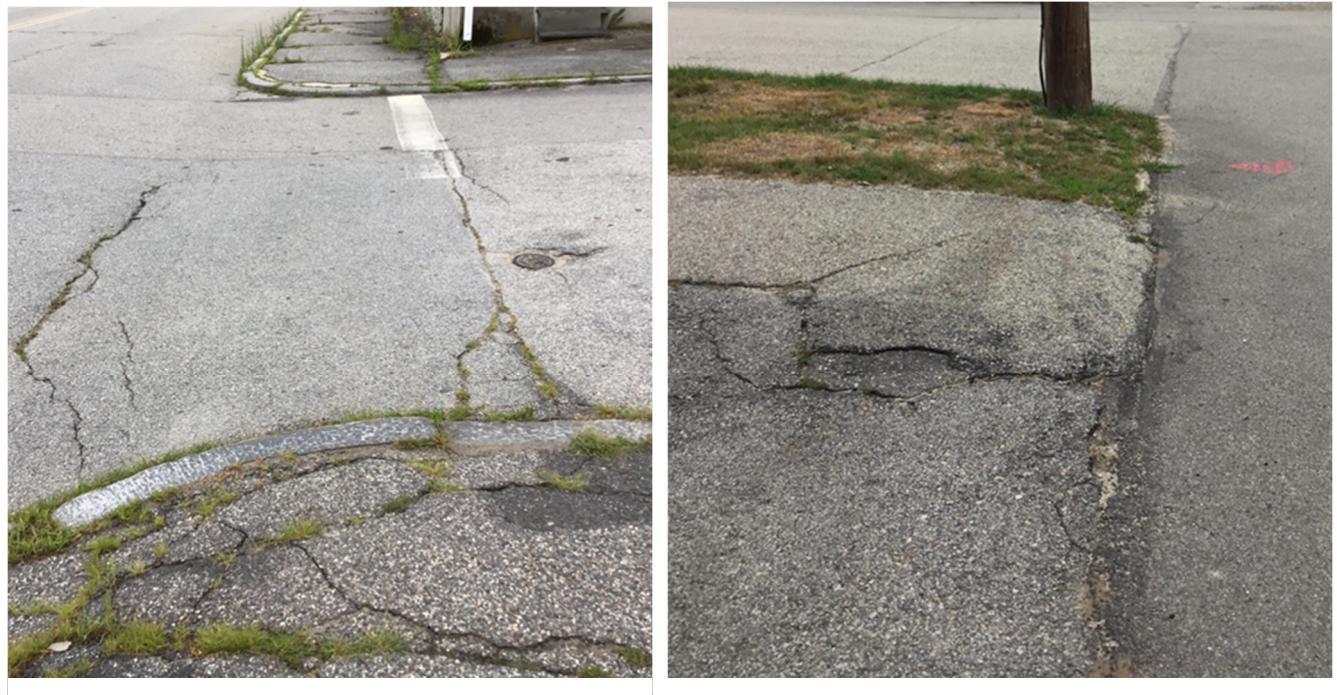
As indicated in Table 3.5, 8.7% of the ramps are in excellent condition and meet accessibility requirements. 37.0% of the ramps are in good condition, being passable for some disabled, elderly, and those with strollers but not compliant with accessibility requirements. The remaining 54.4% of the ramps, those designated as being in fair or poor condition, are unusable for the disabled, elderly, and those with strollers. Photo 8 represents an area that does not have a ramp and Photo 9 is a ramp that does not meet accessibility requirements.

Photo 9: No Ramp

Photo 8: Non-Compliant Ramp

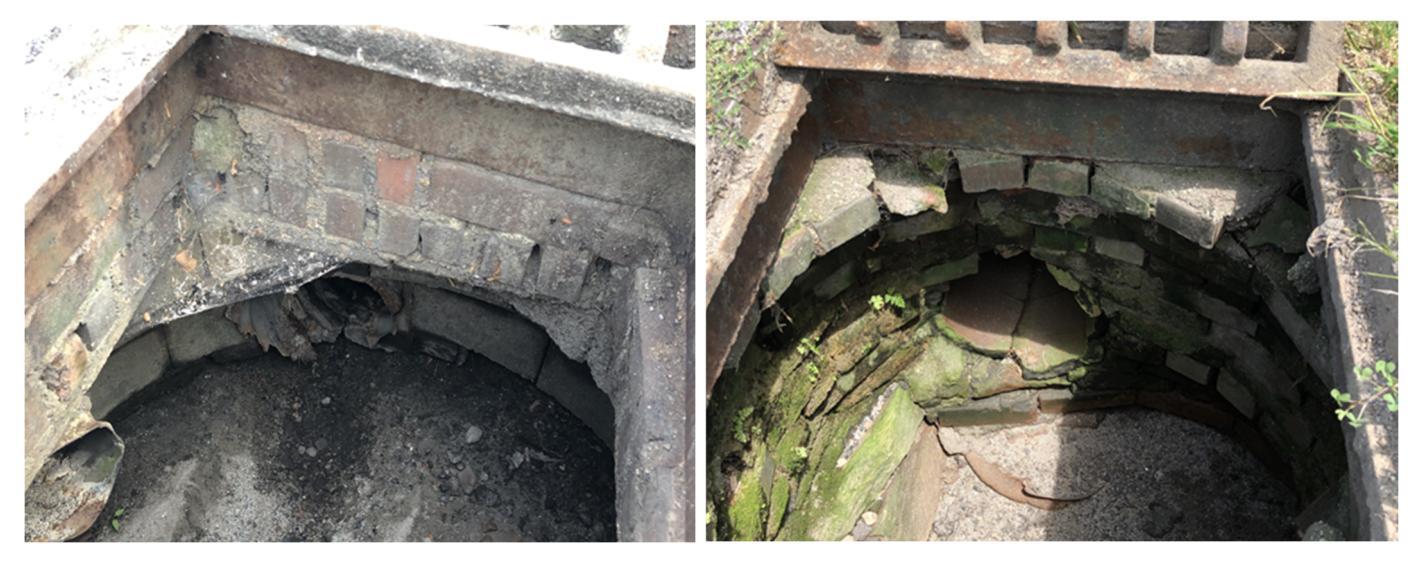
Photo 11: Fair Catch Basin

Photo 12: Poor Catch Basin

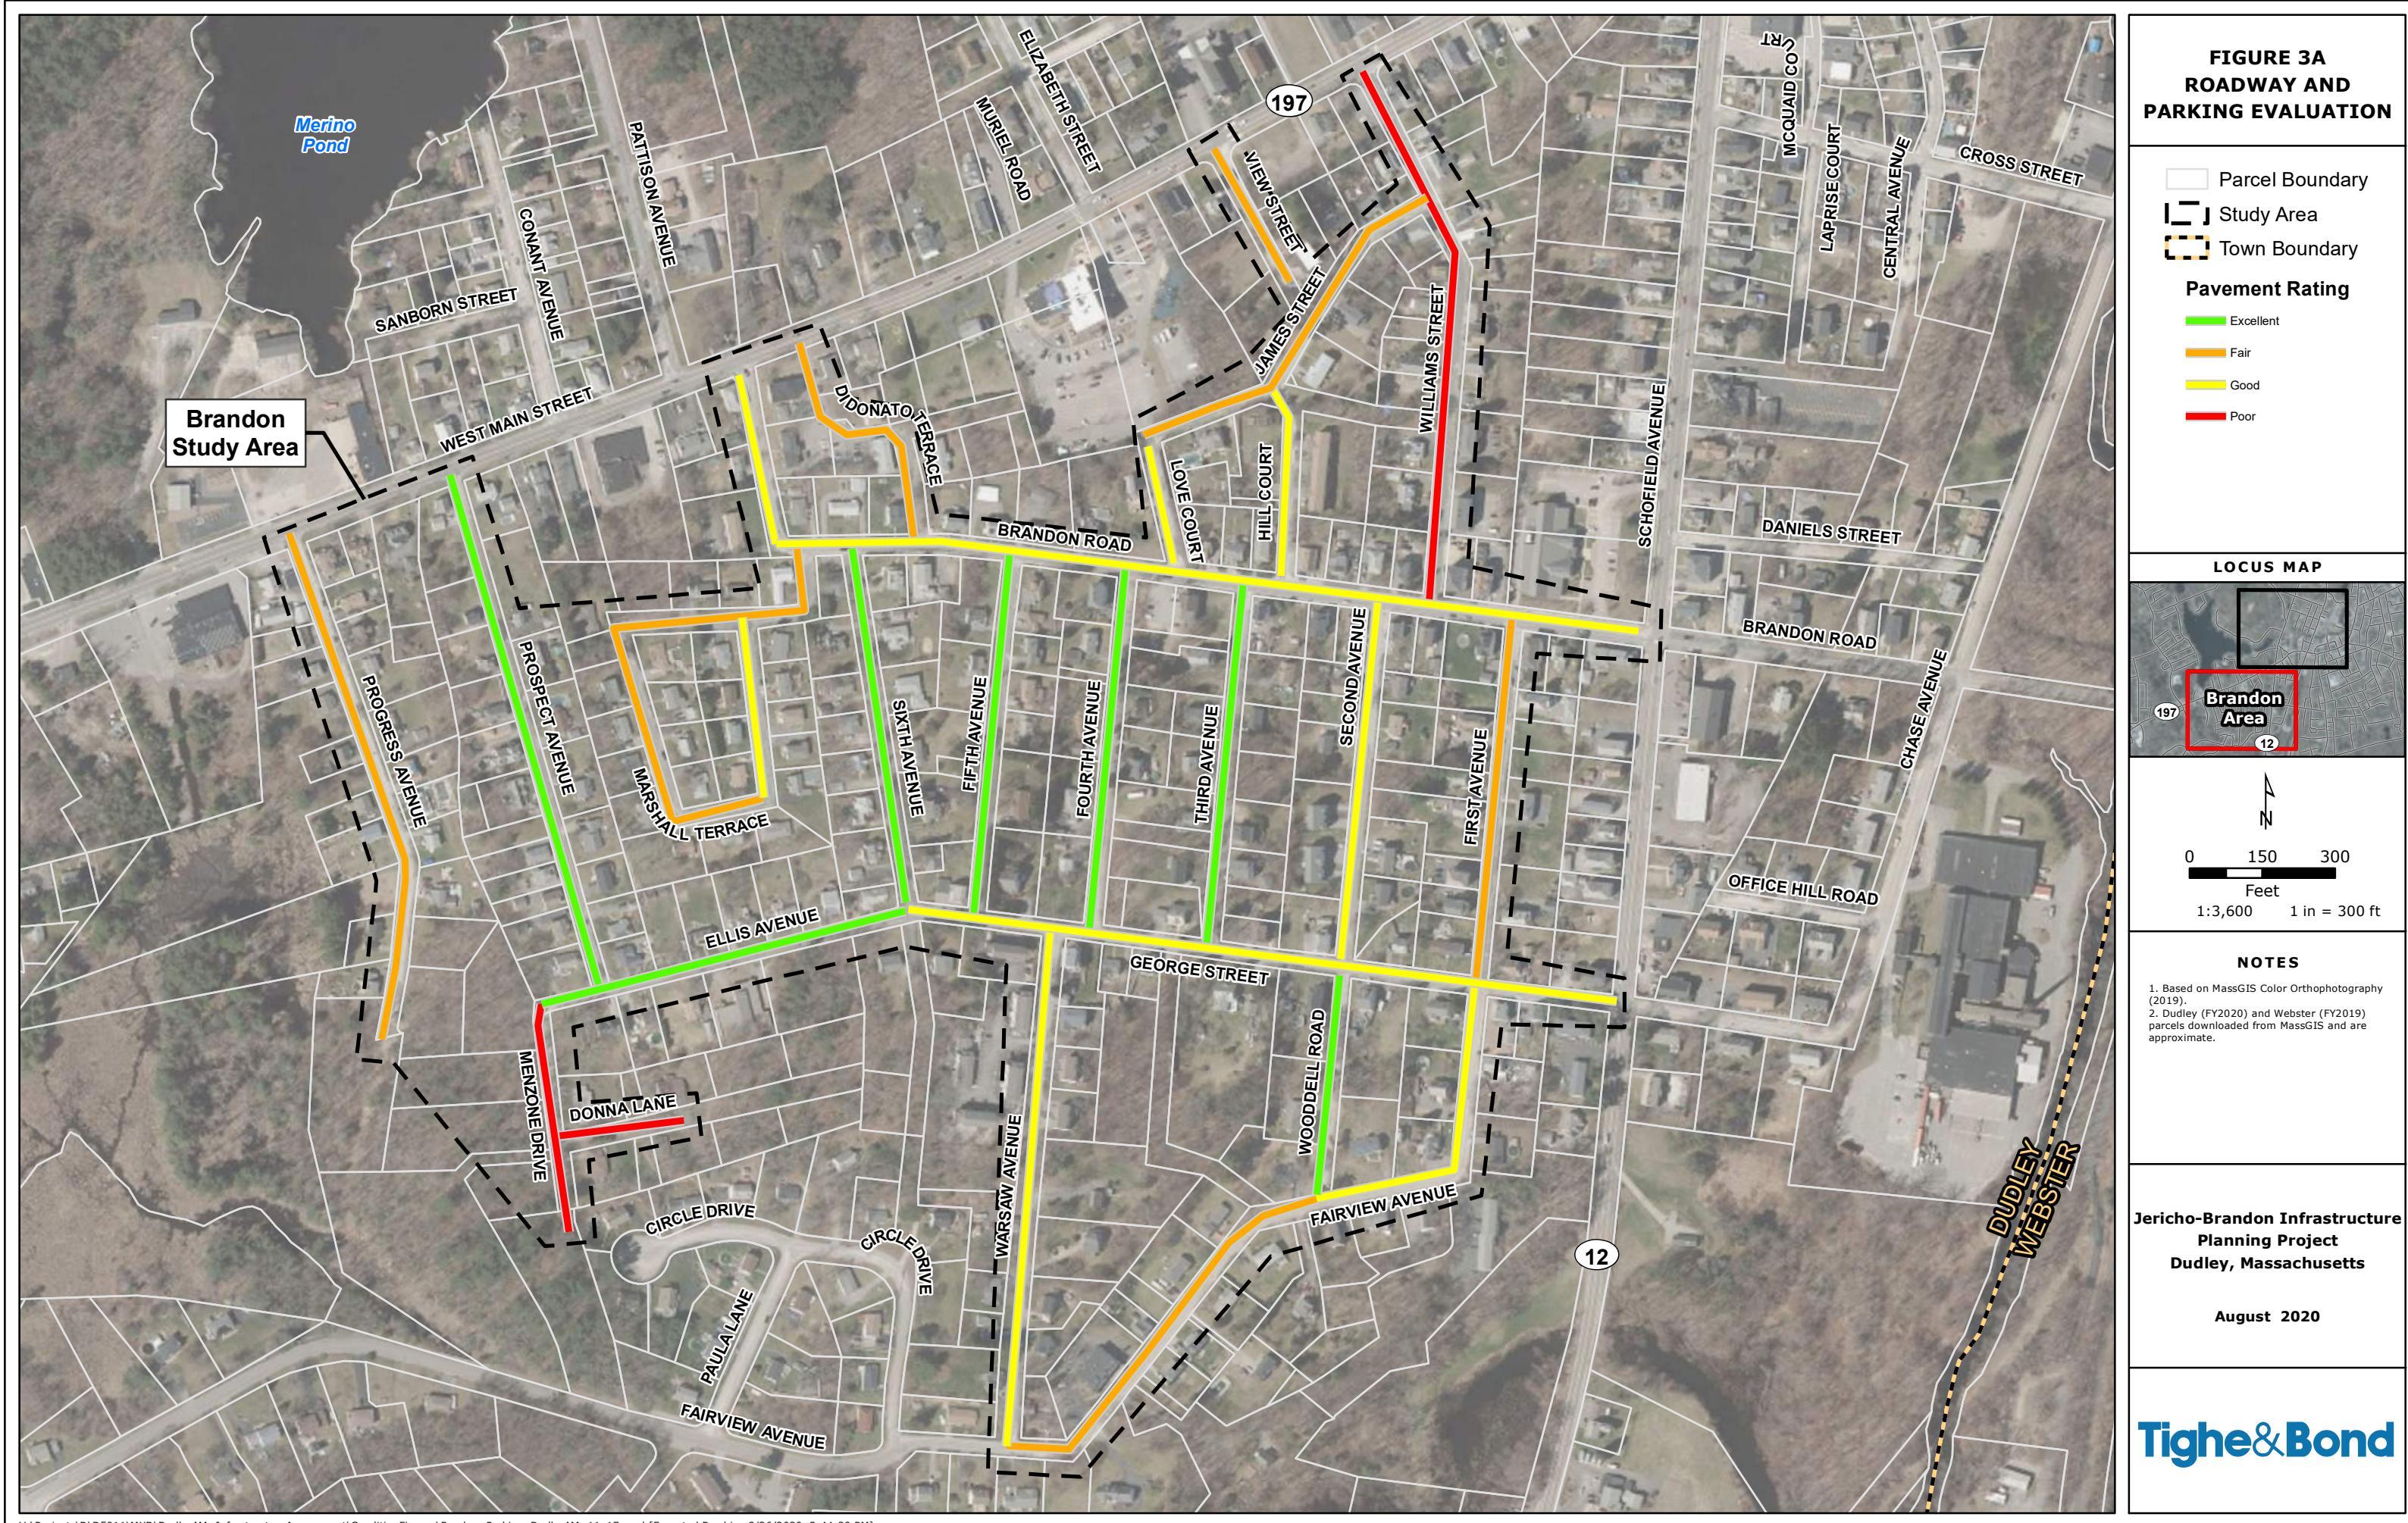
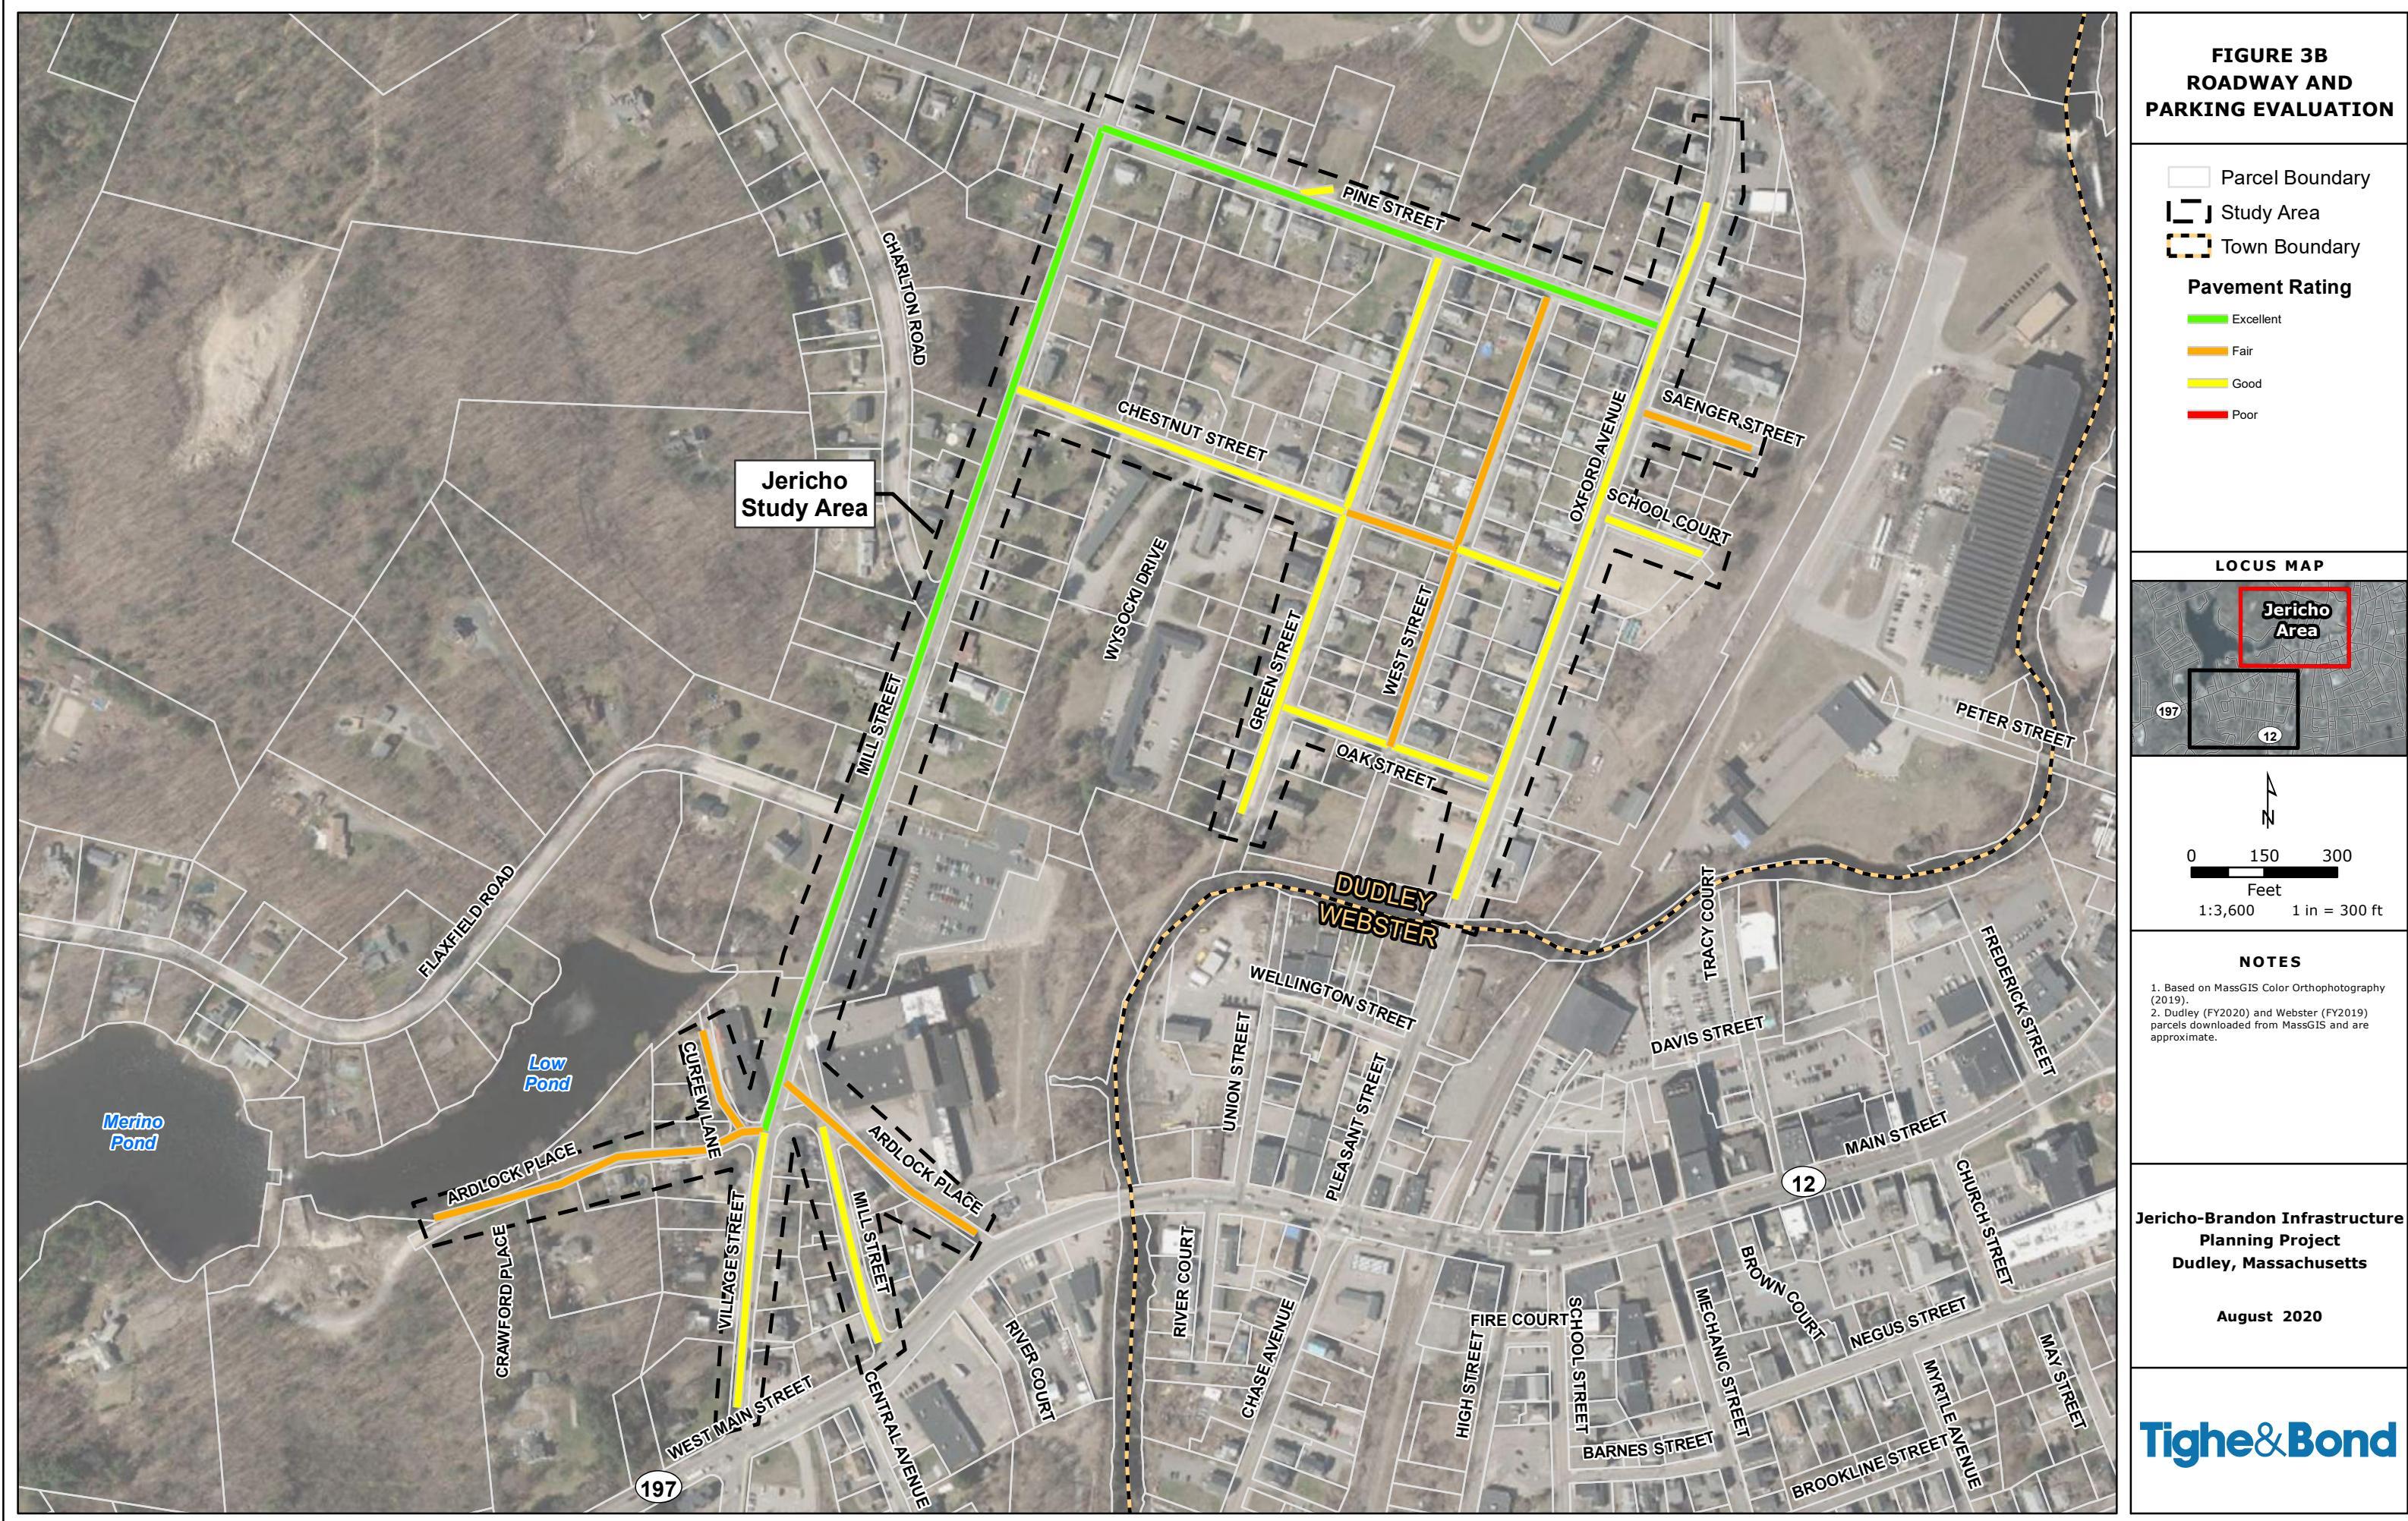
Figures 3A and 3B provided in Appendix A, provide a graphical representation of roadway and parking lot surfaces' locations and classifications. Specific roadway condition data, broken down by road name, is provided in Appendix C, Table 1. Parking lot condition data is provided in Appendix C, Table 2.

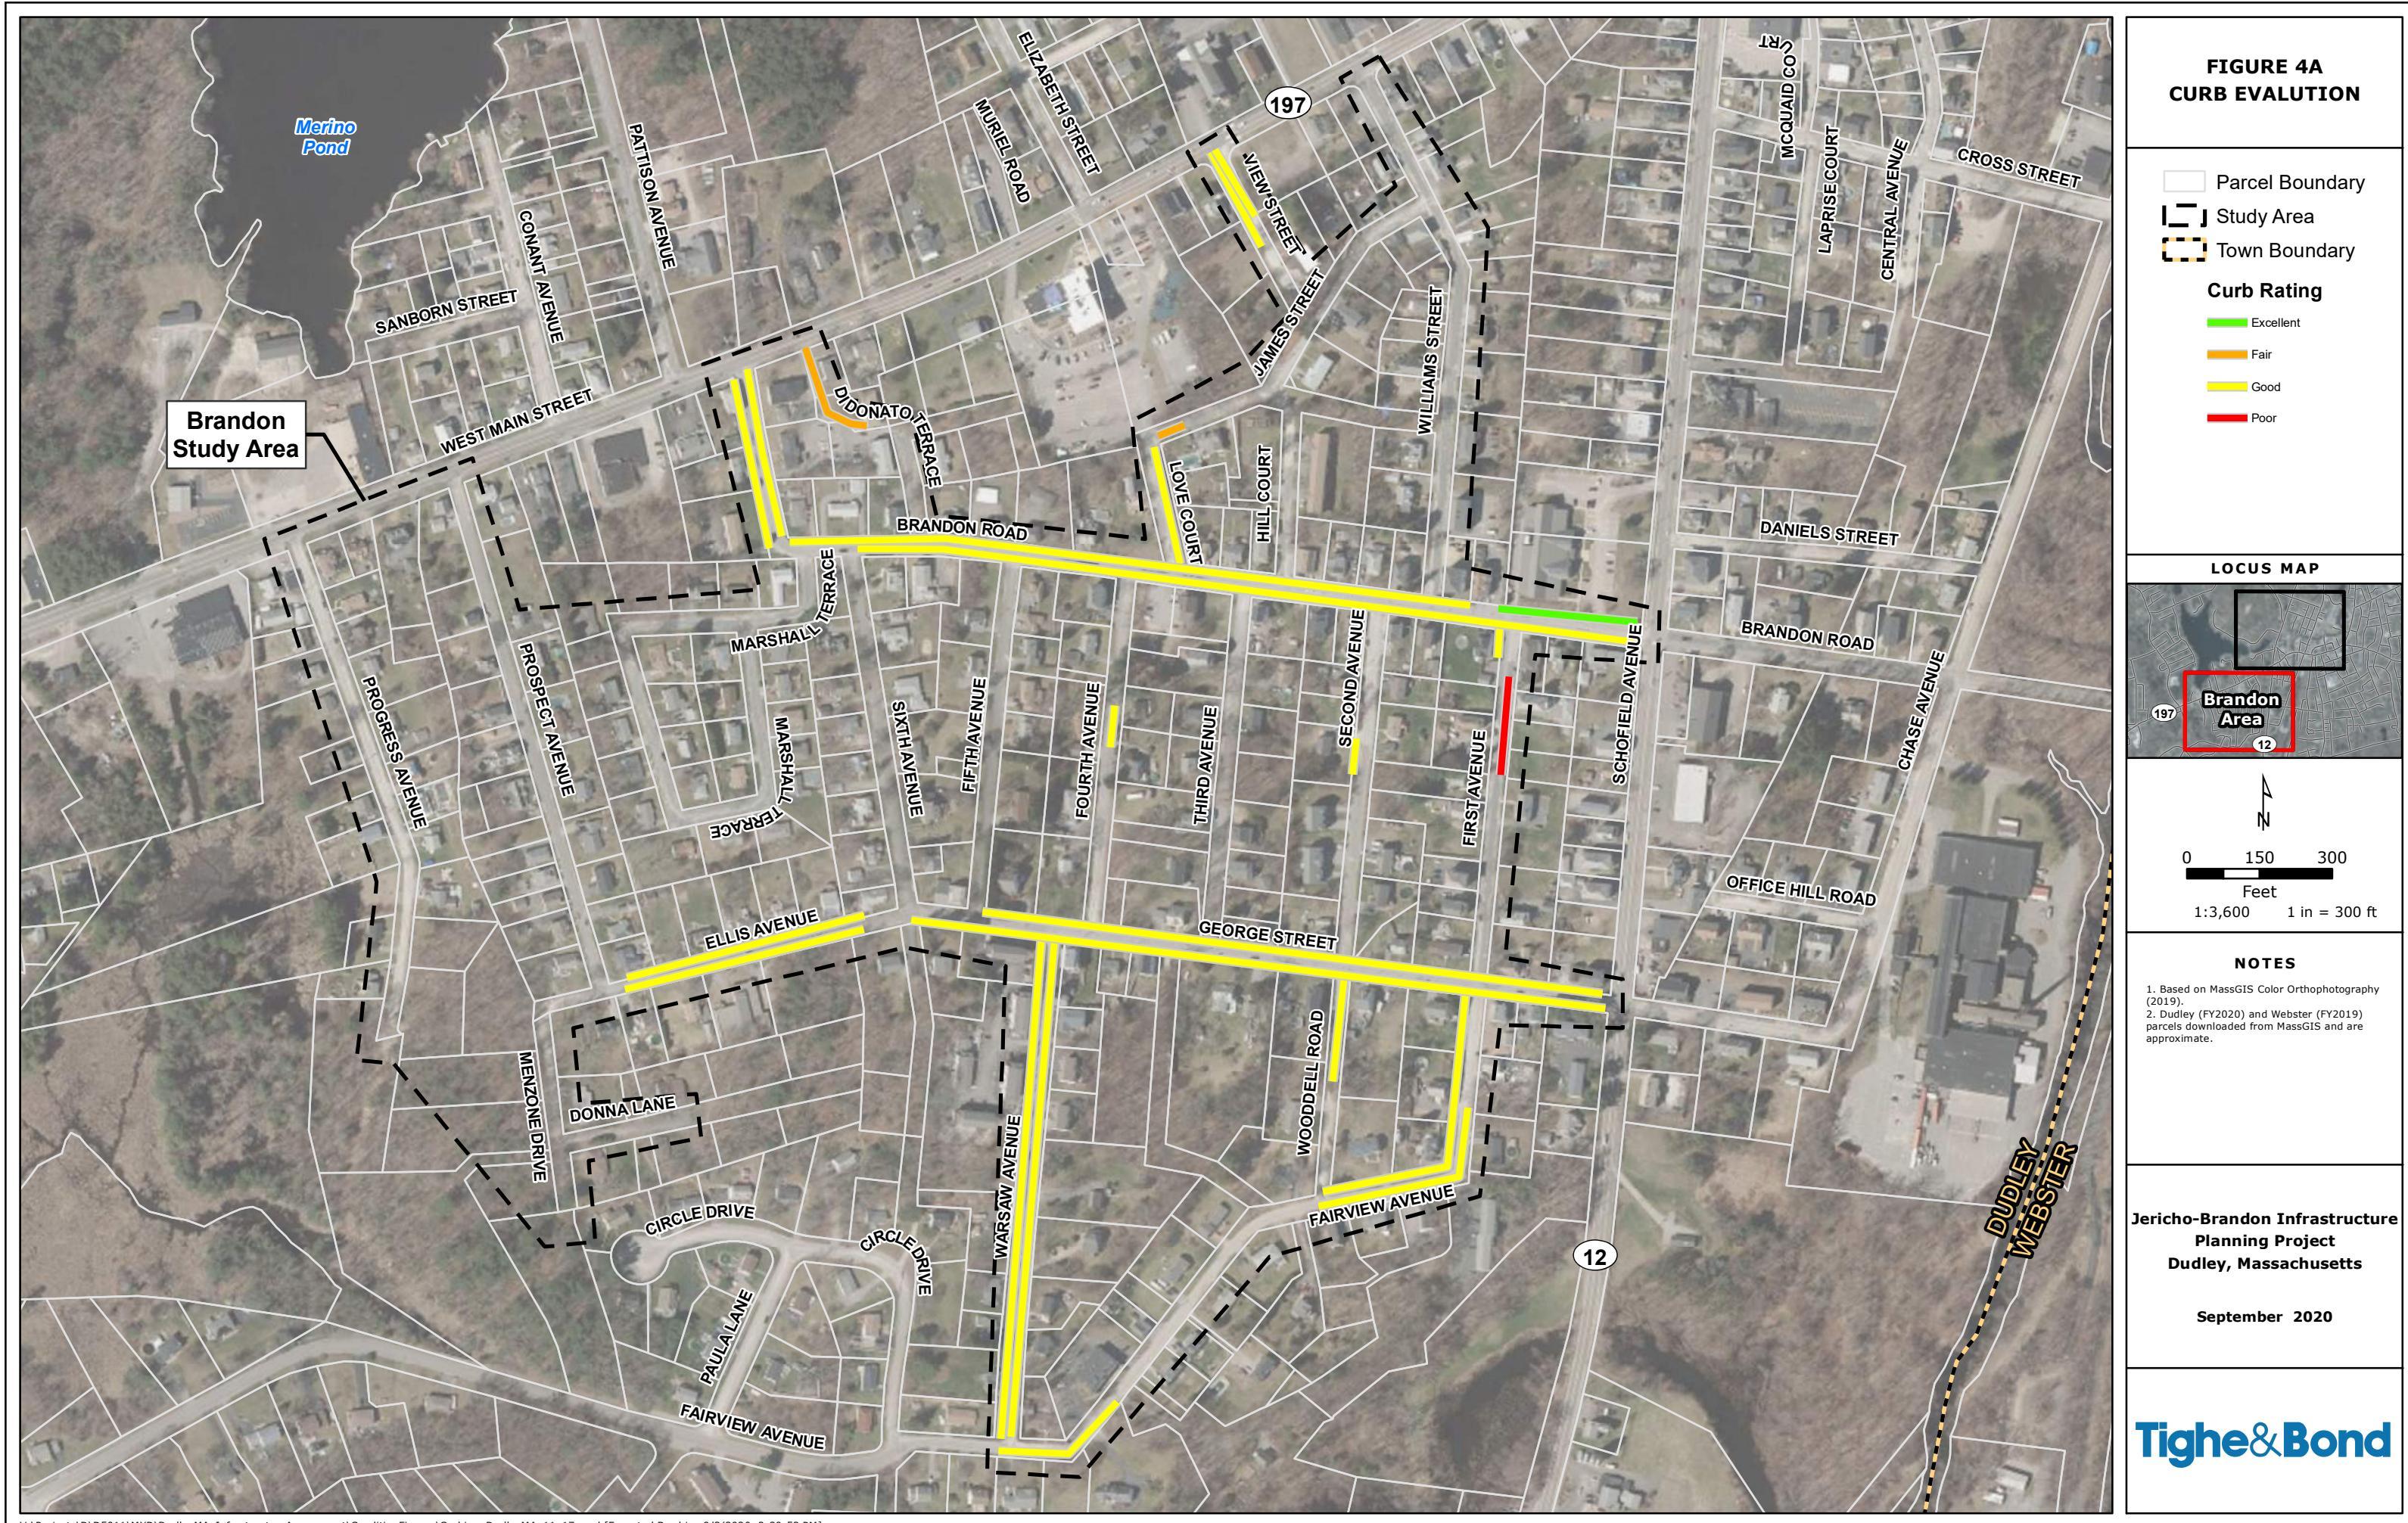
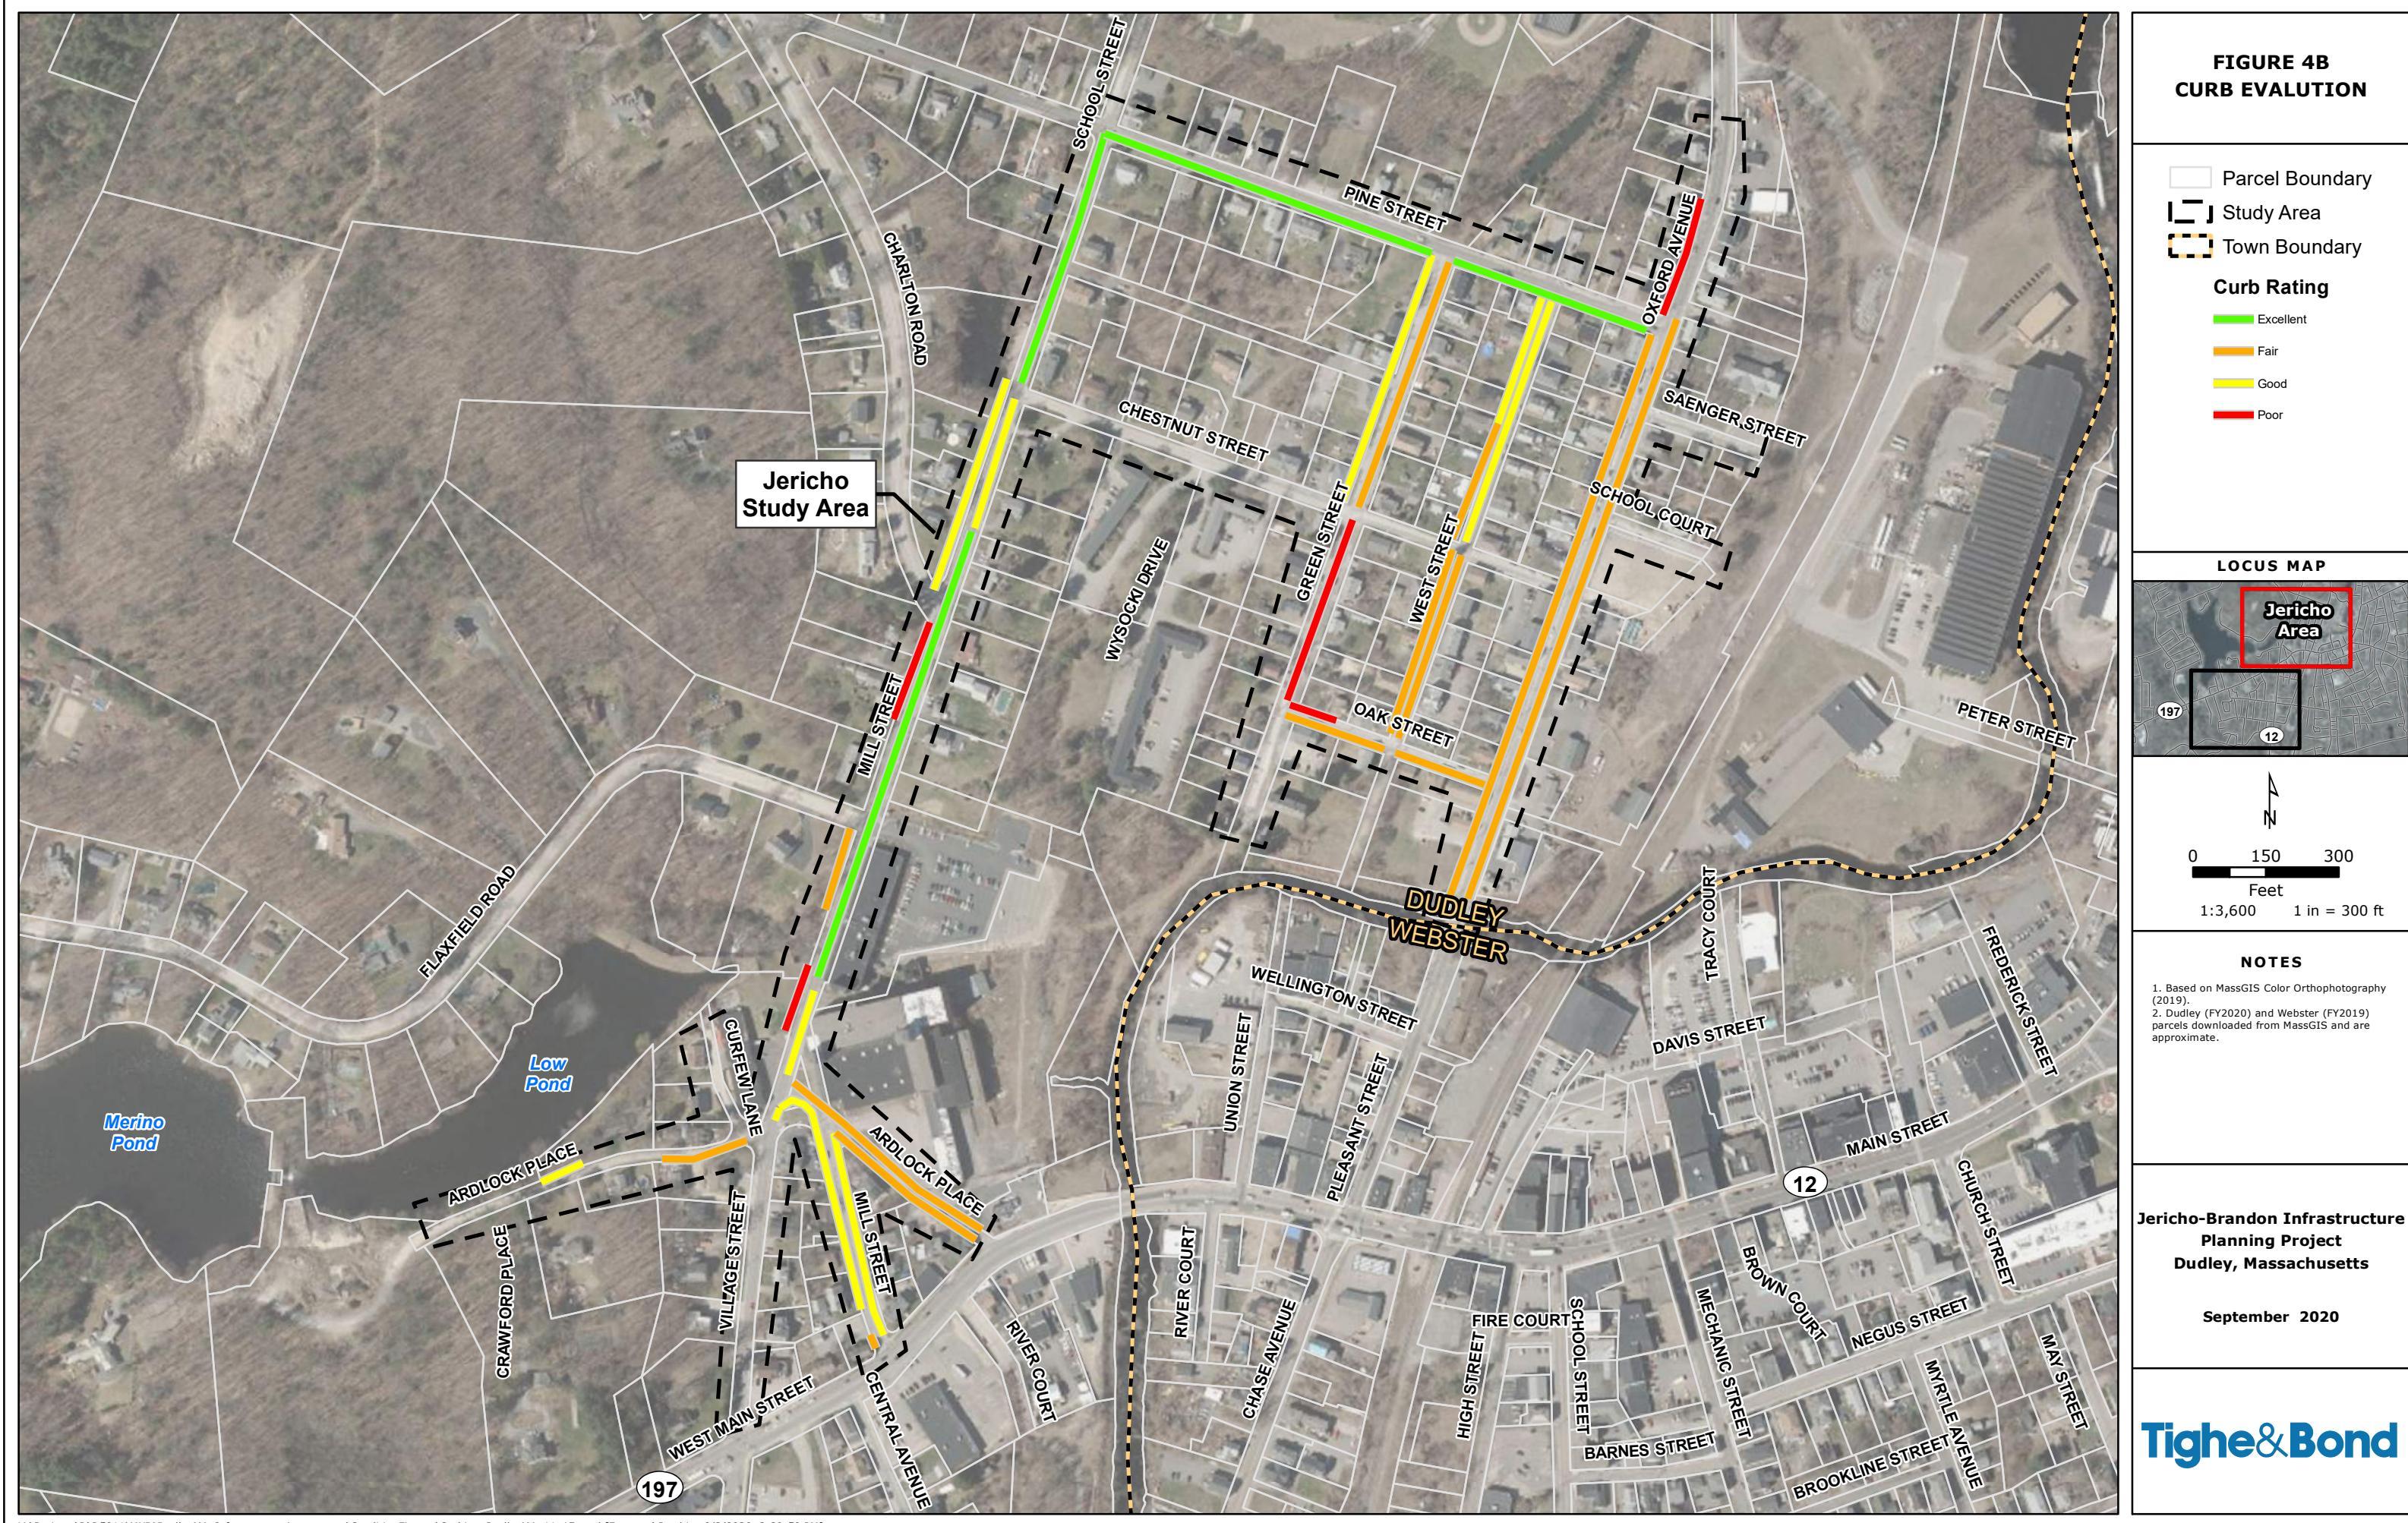
Figure 4A and 4B provided in Appendix A, provide a graphical representation of curbing locations and classifications. Curbing condition data, broken down by road name, is provided in Appendix C, Table 3.
