Jericho-Brandon Study Area Town of Dudley, Massachusetts

Jericho-Brandon Infrastructure Planning Project

Prepared For: Town of Dudley 71 West Main Street Dudley, Massachusetts

June 2021

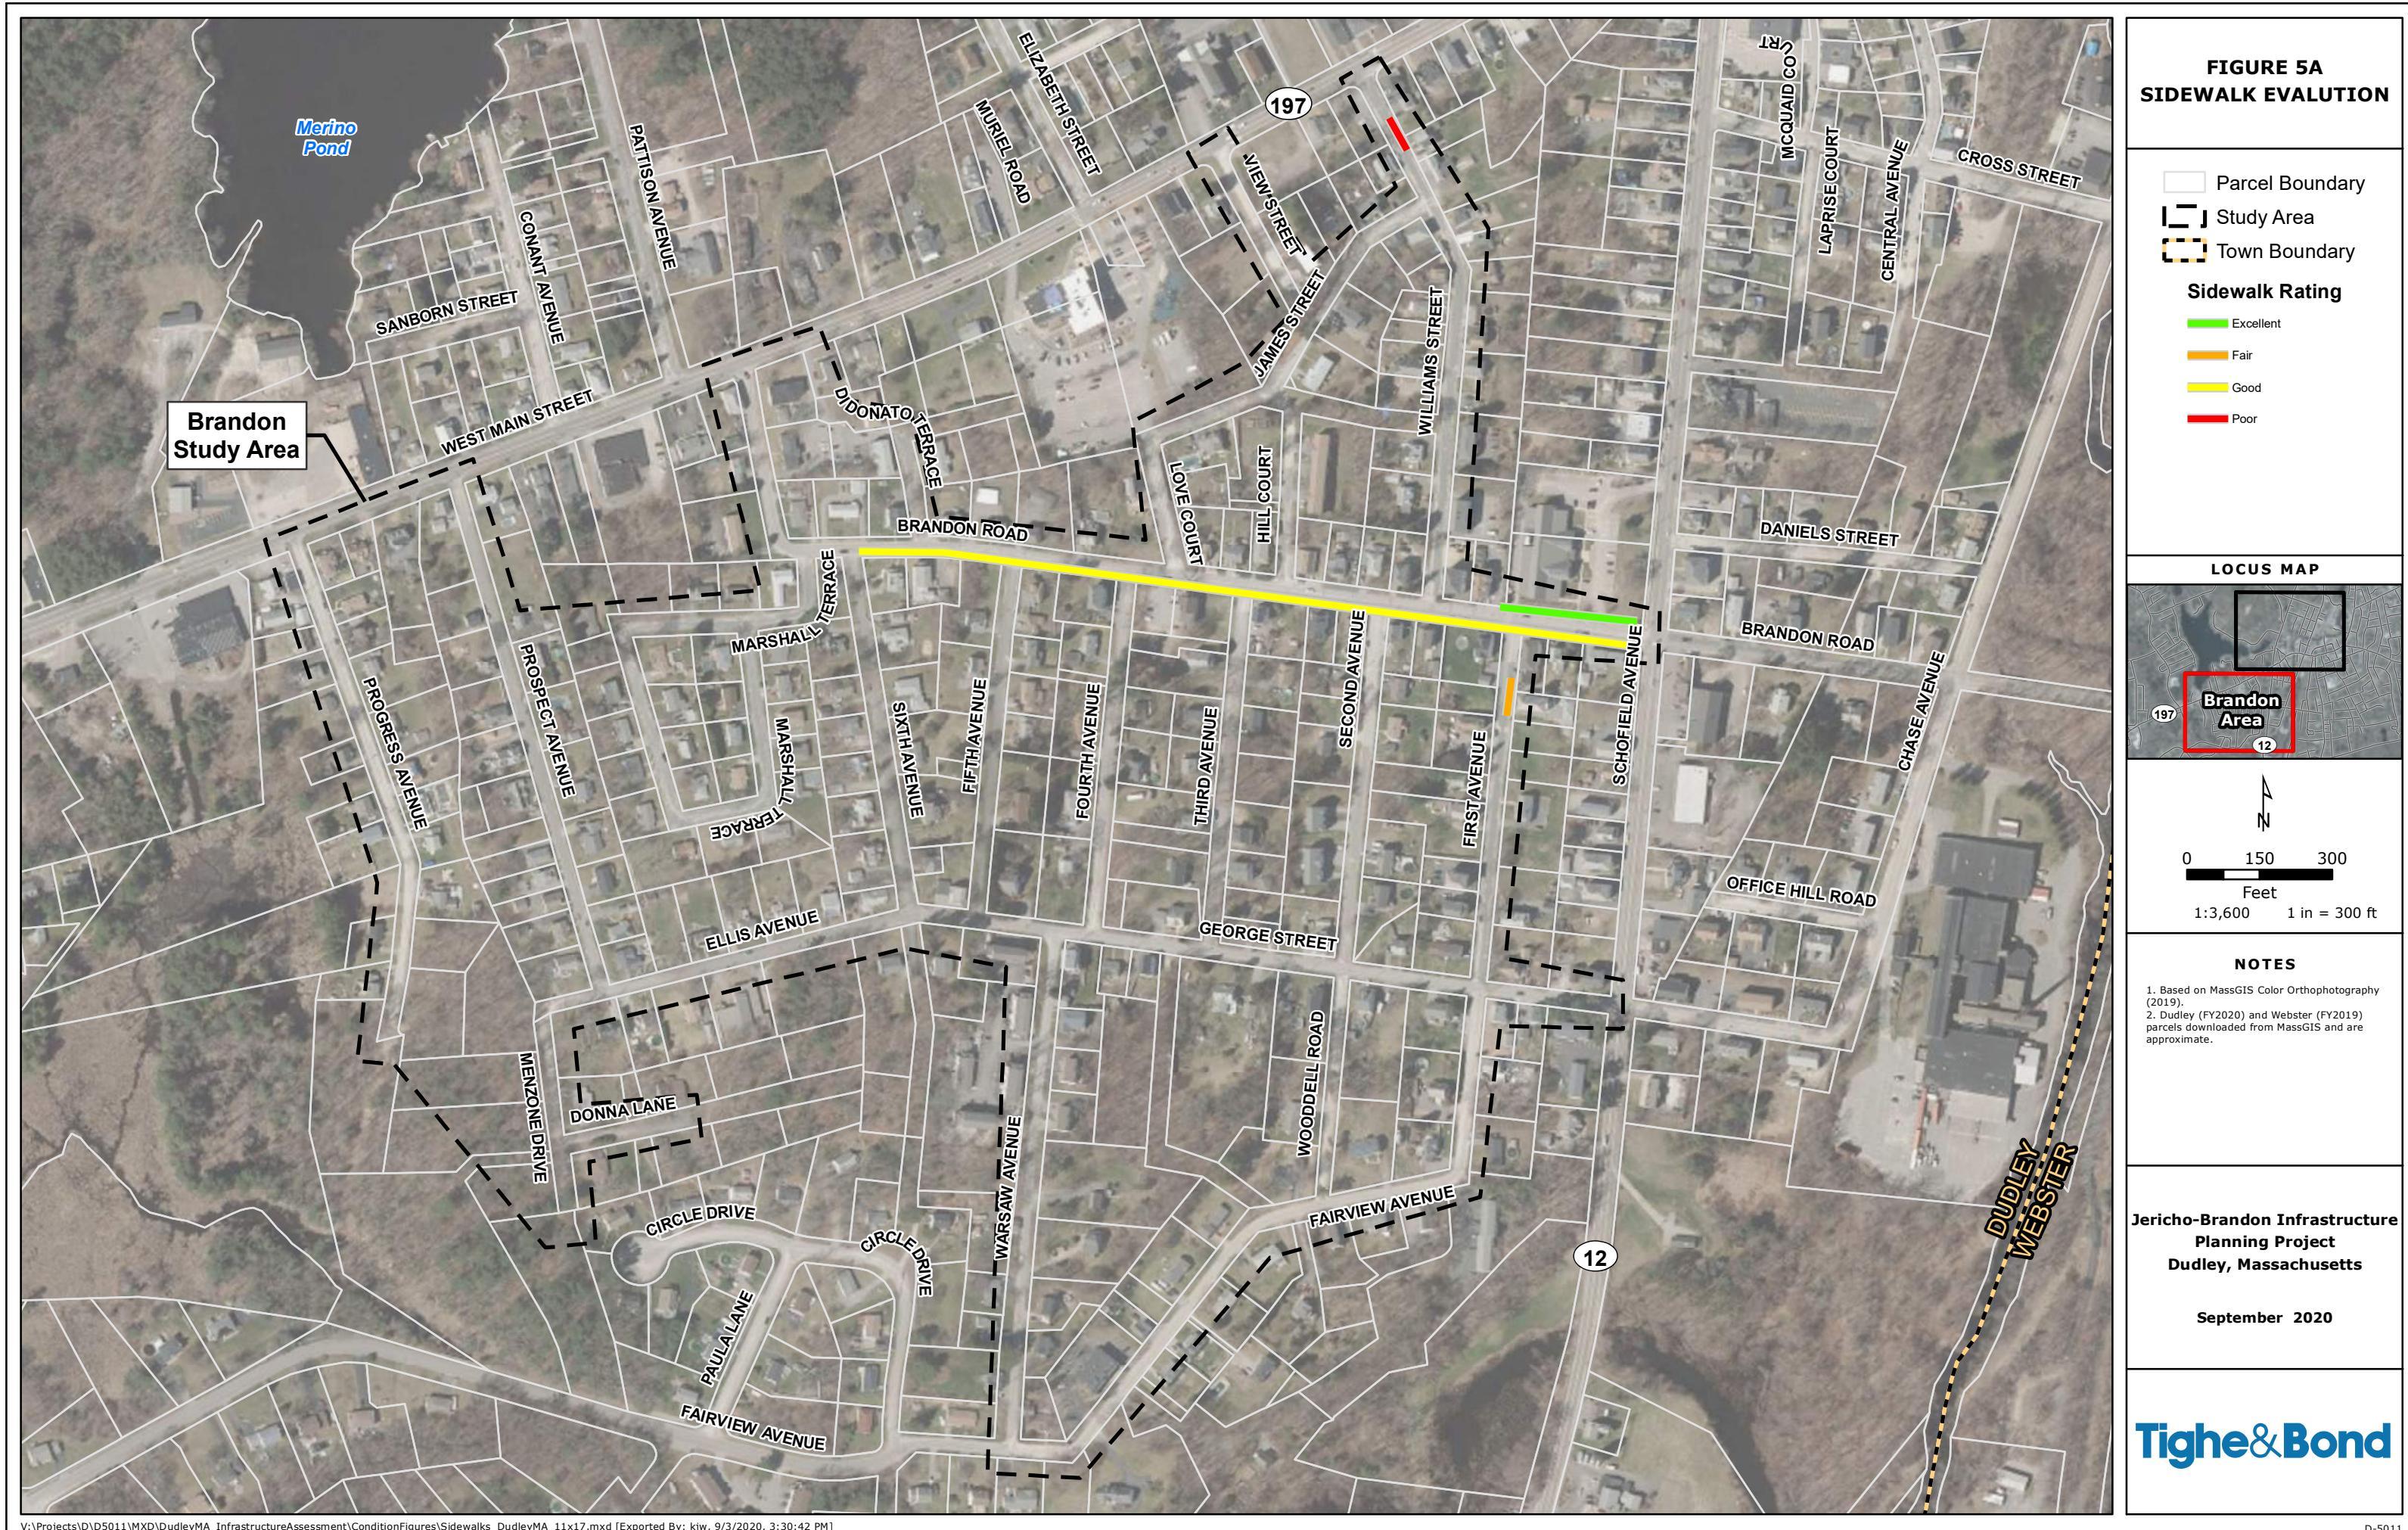
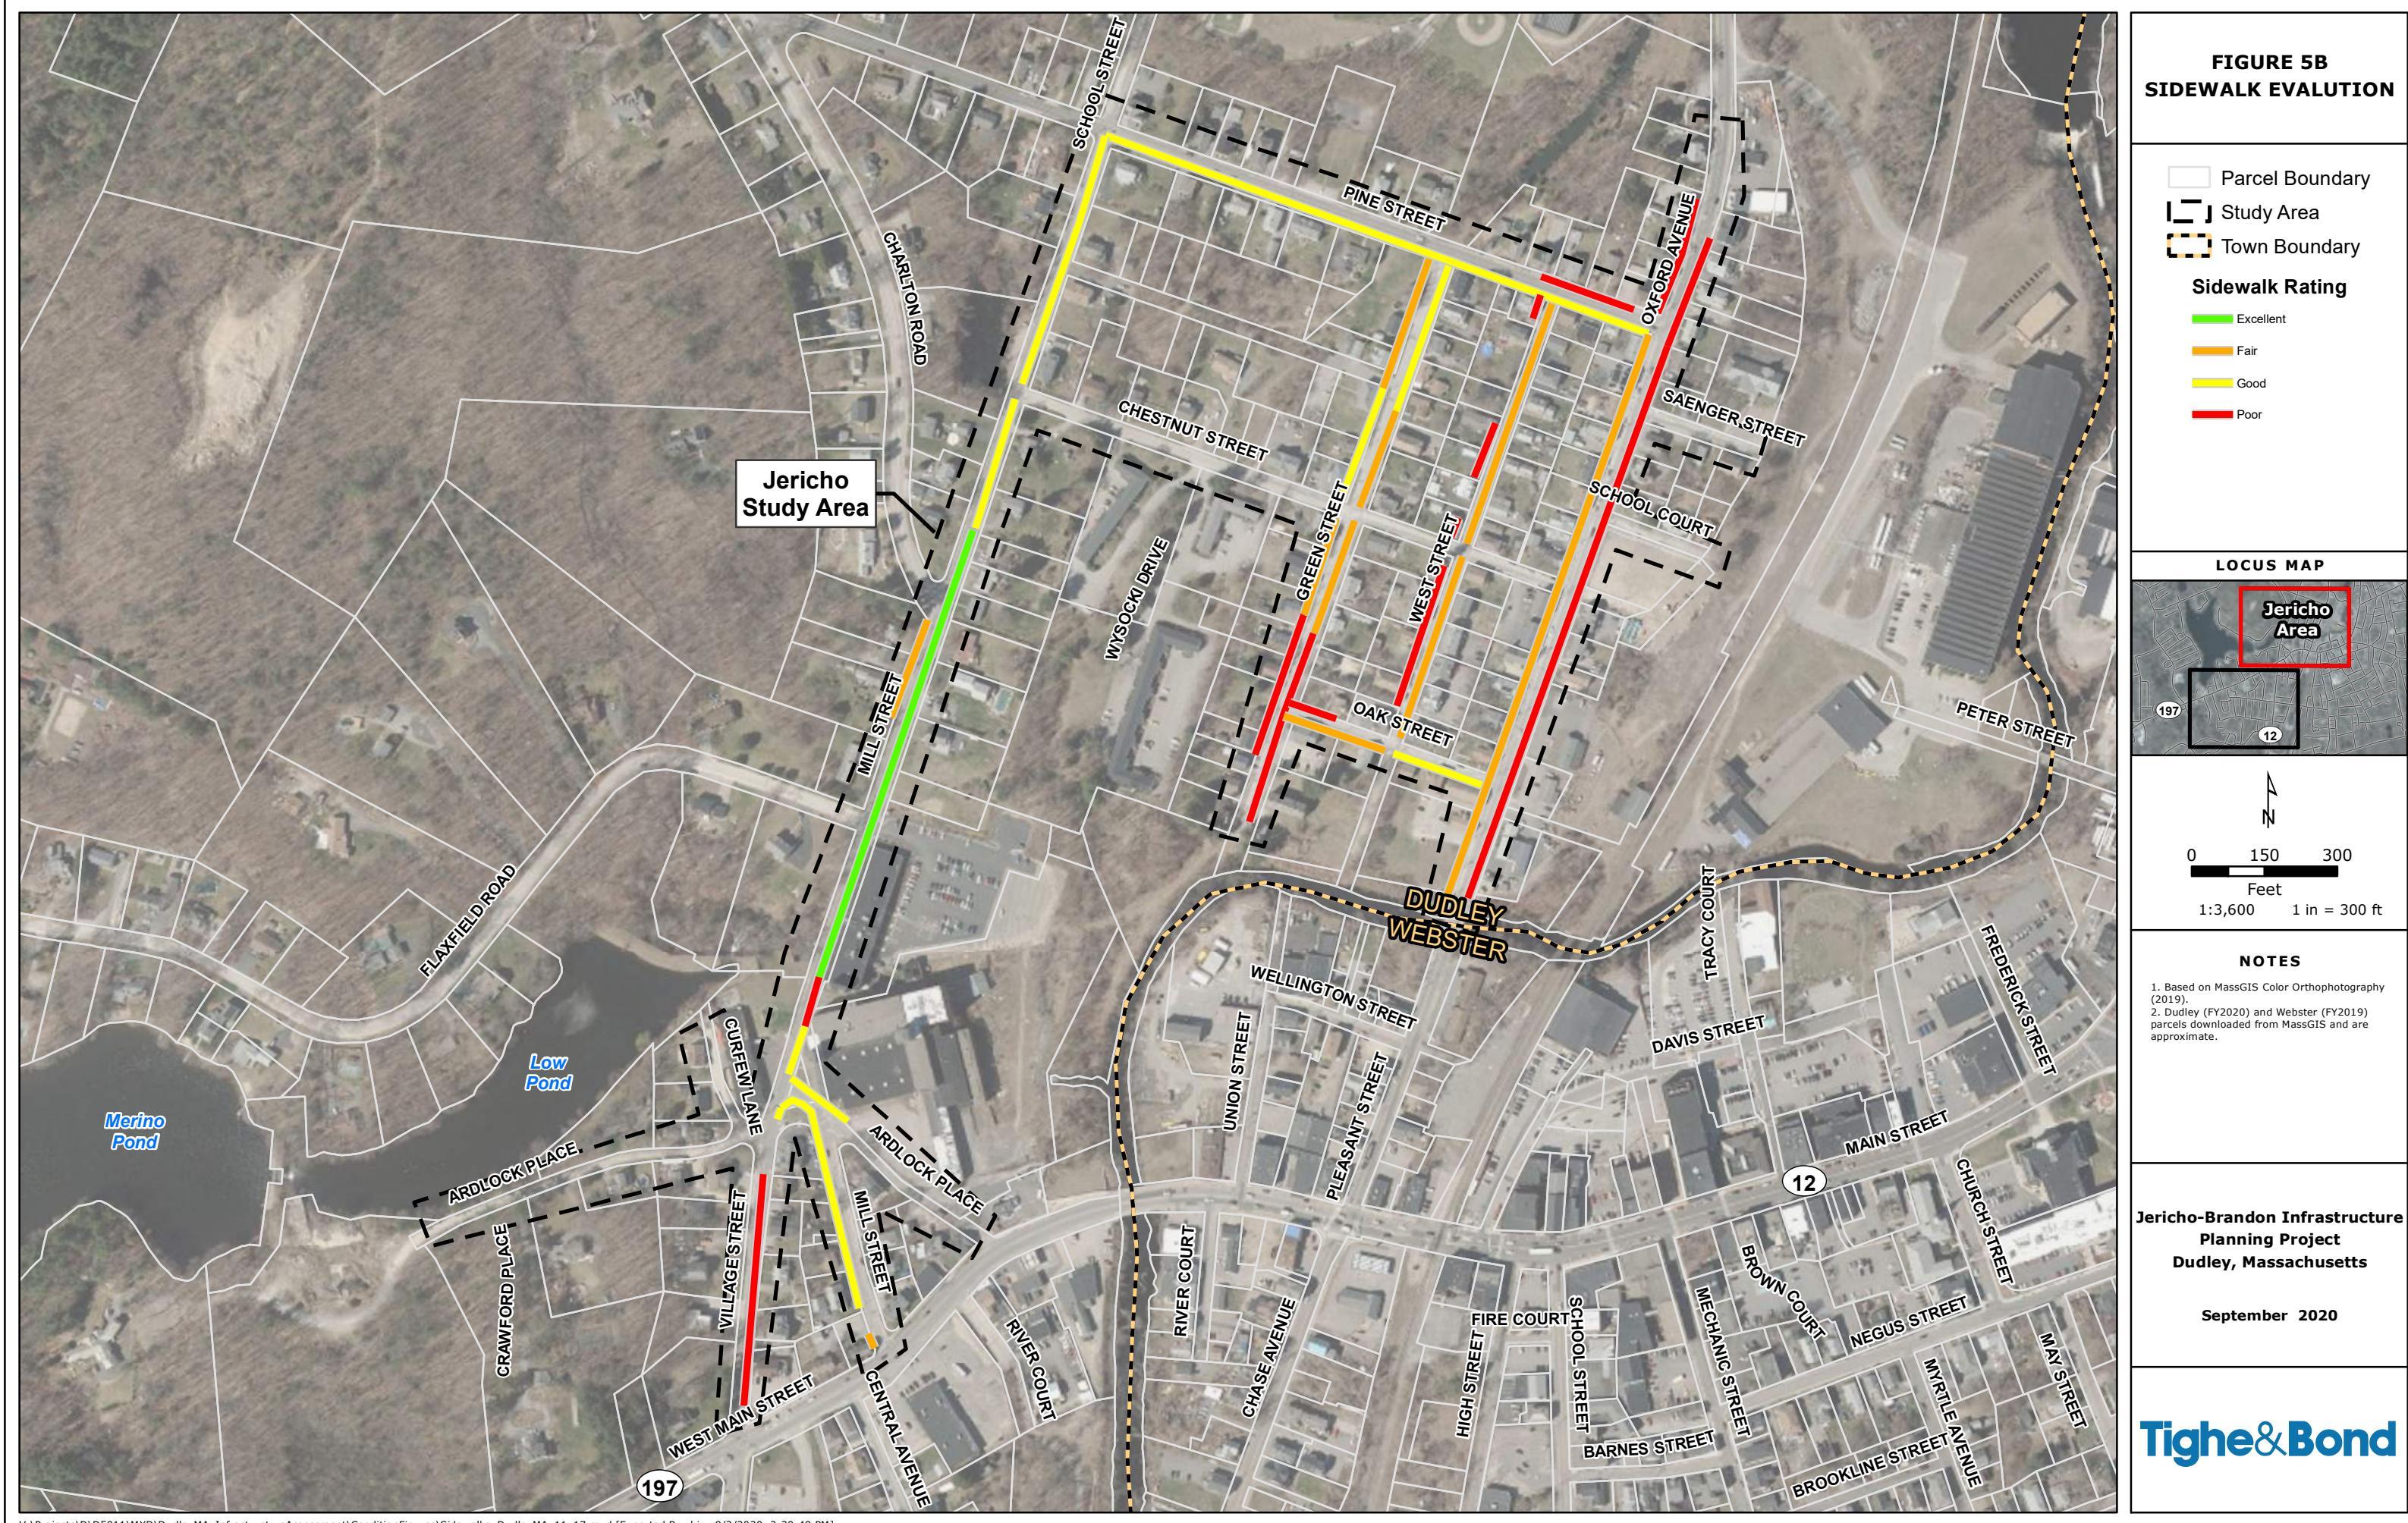
Figures 5A and 5B provided in Appendix A, provide a graphical representation of sidewalk locations and classifications. Sidewalk condition, broken down by road name, is provided in Appendix C, Table 4.

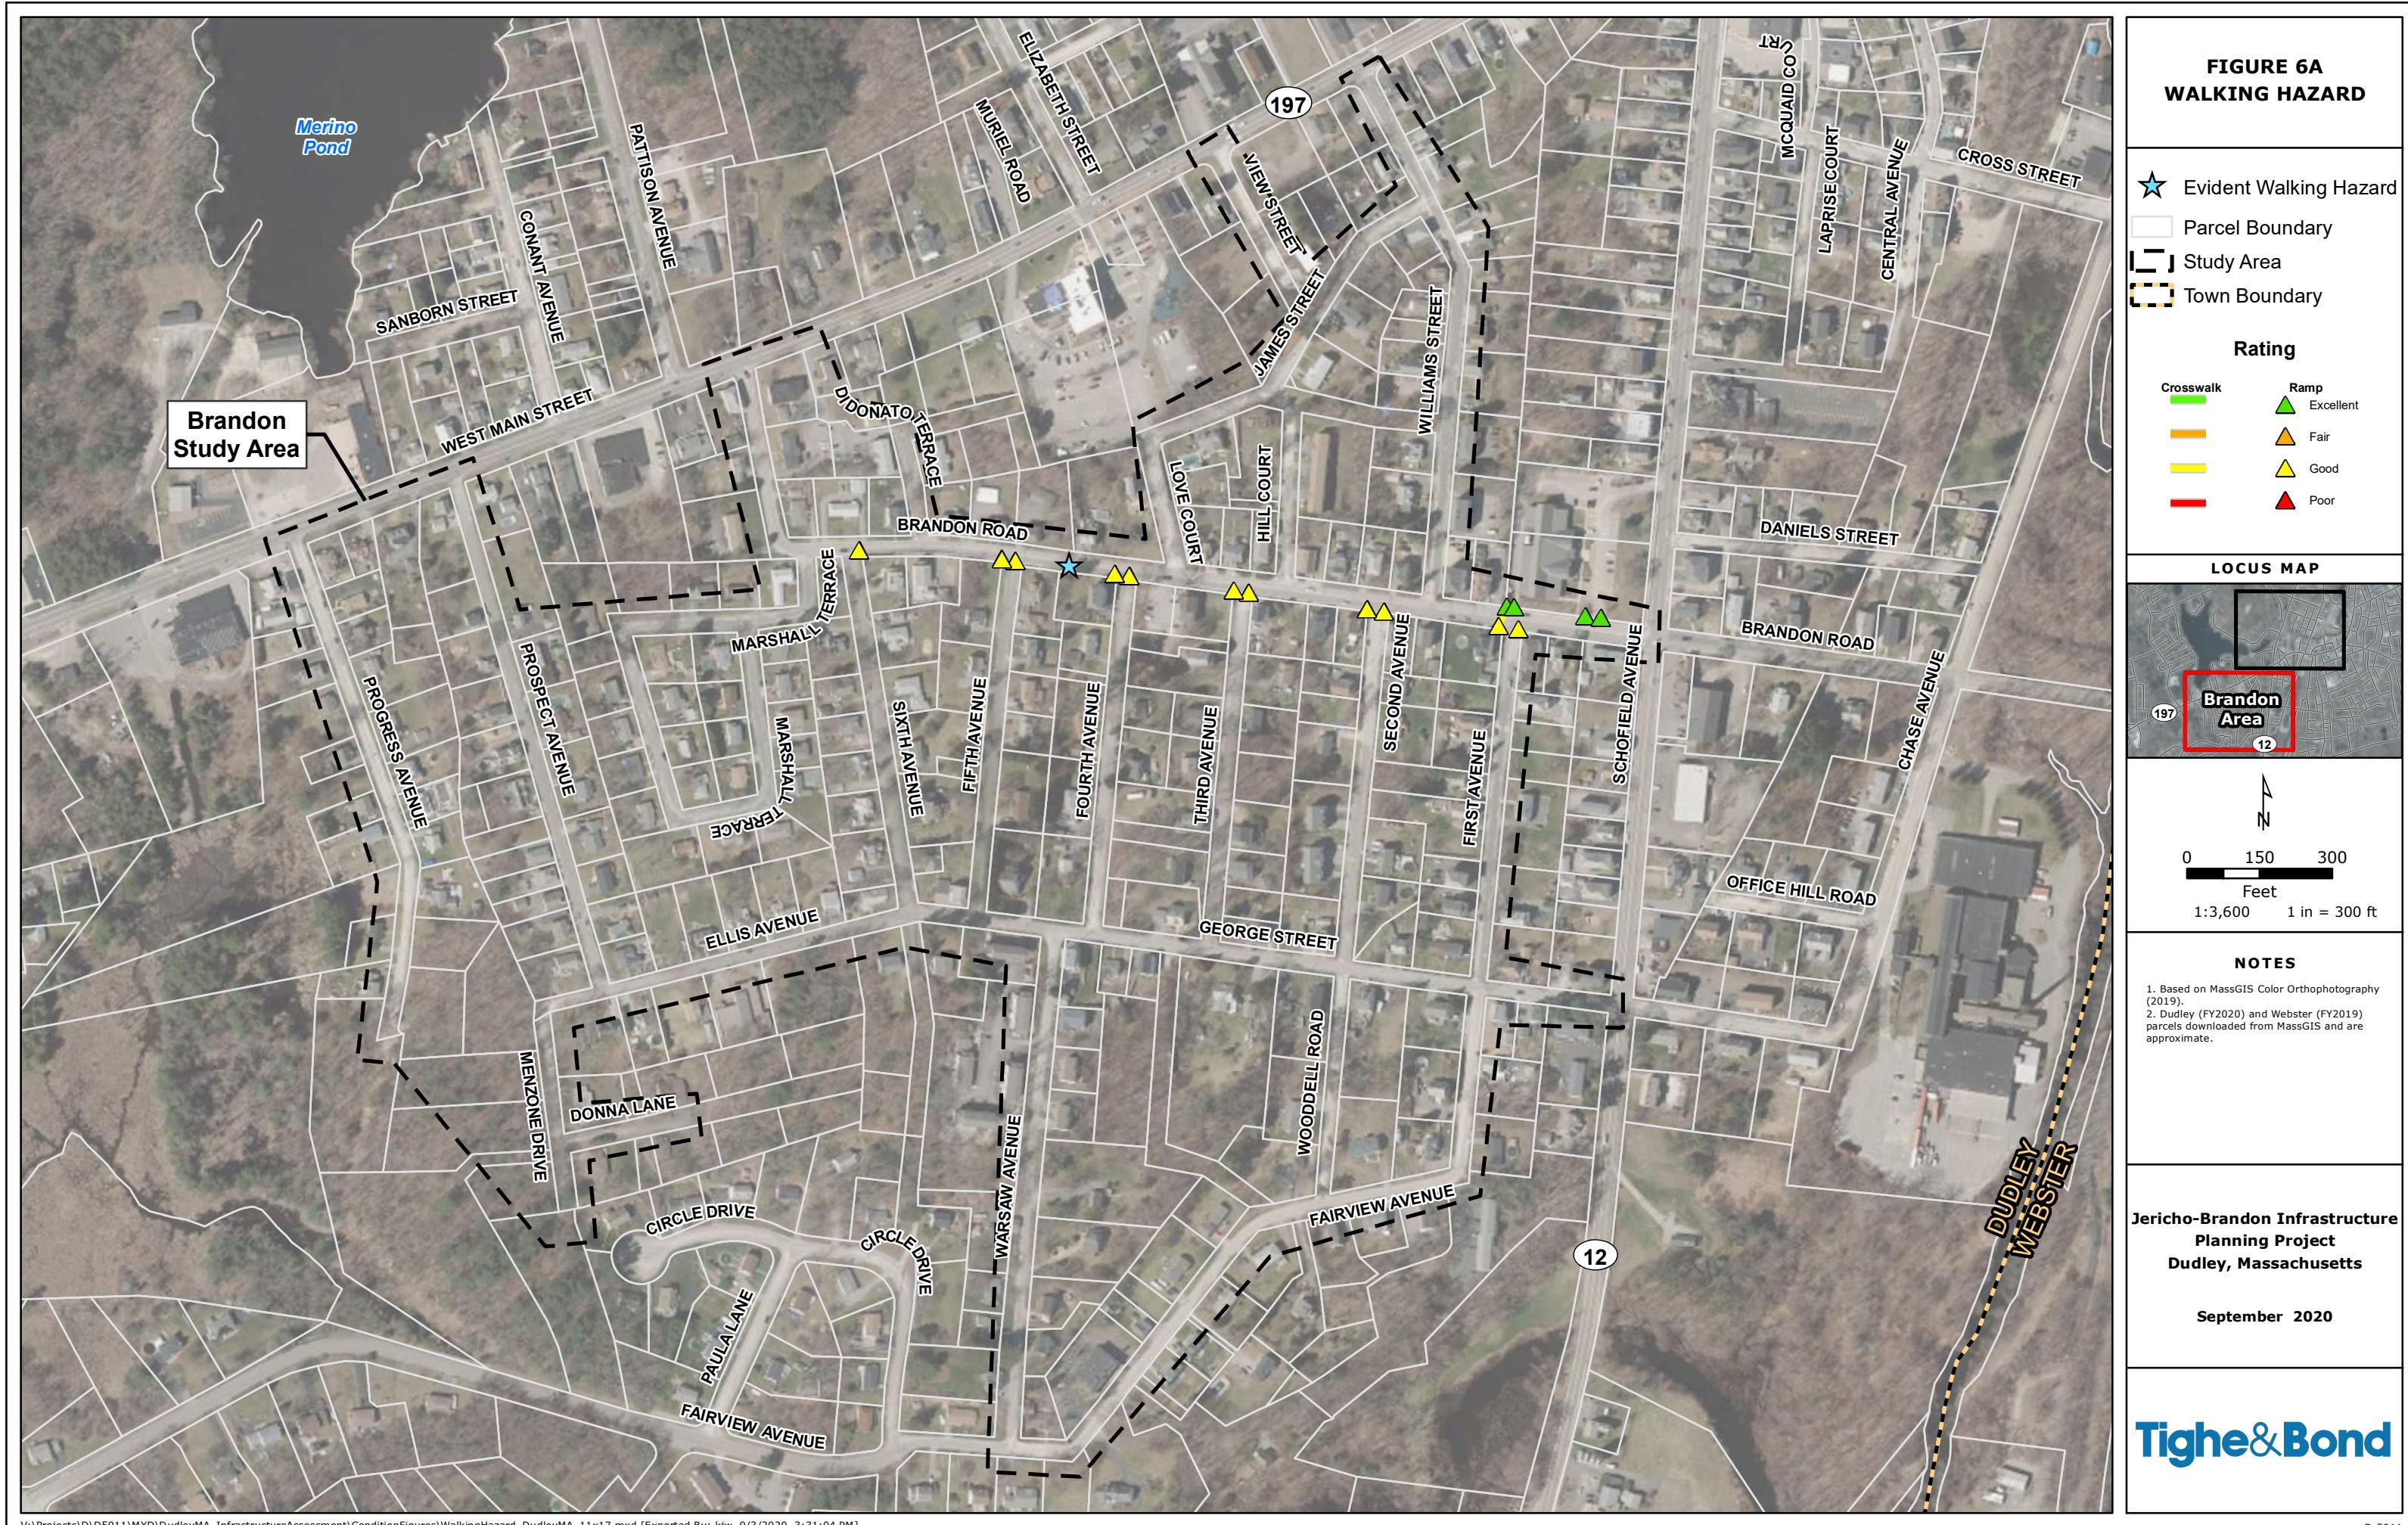
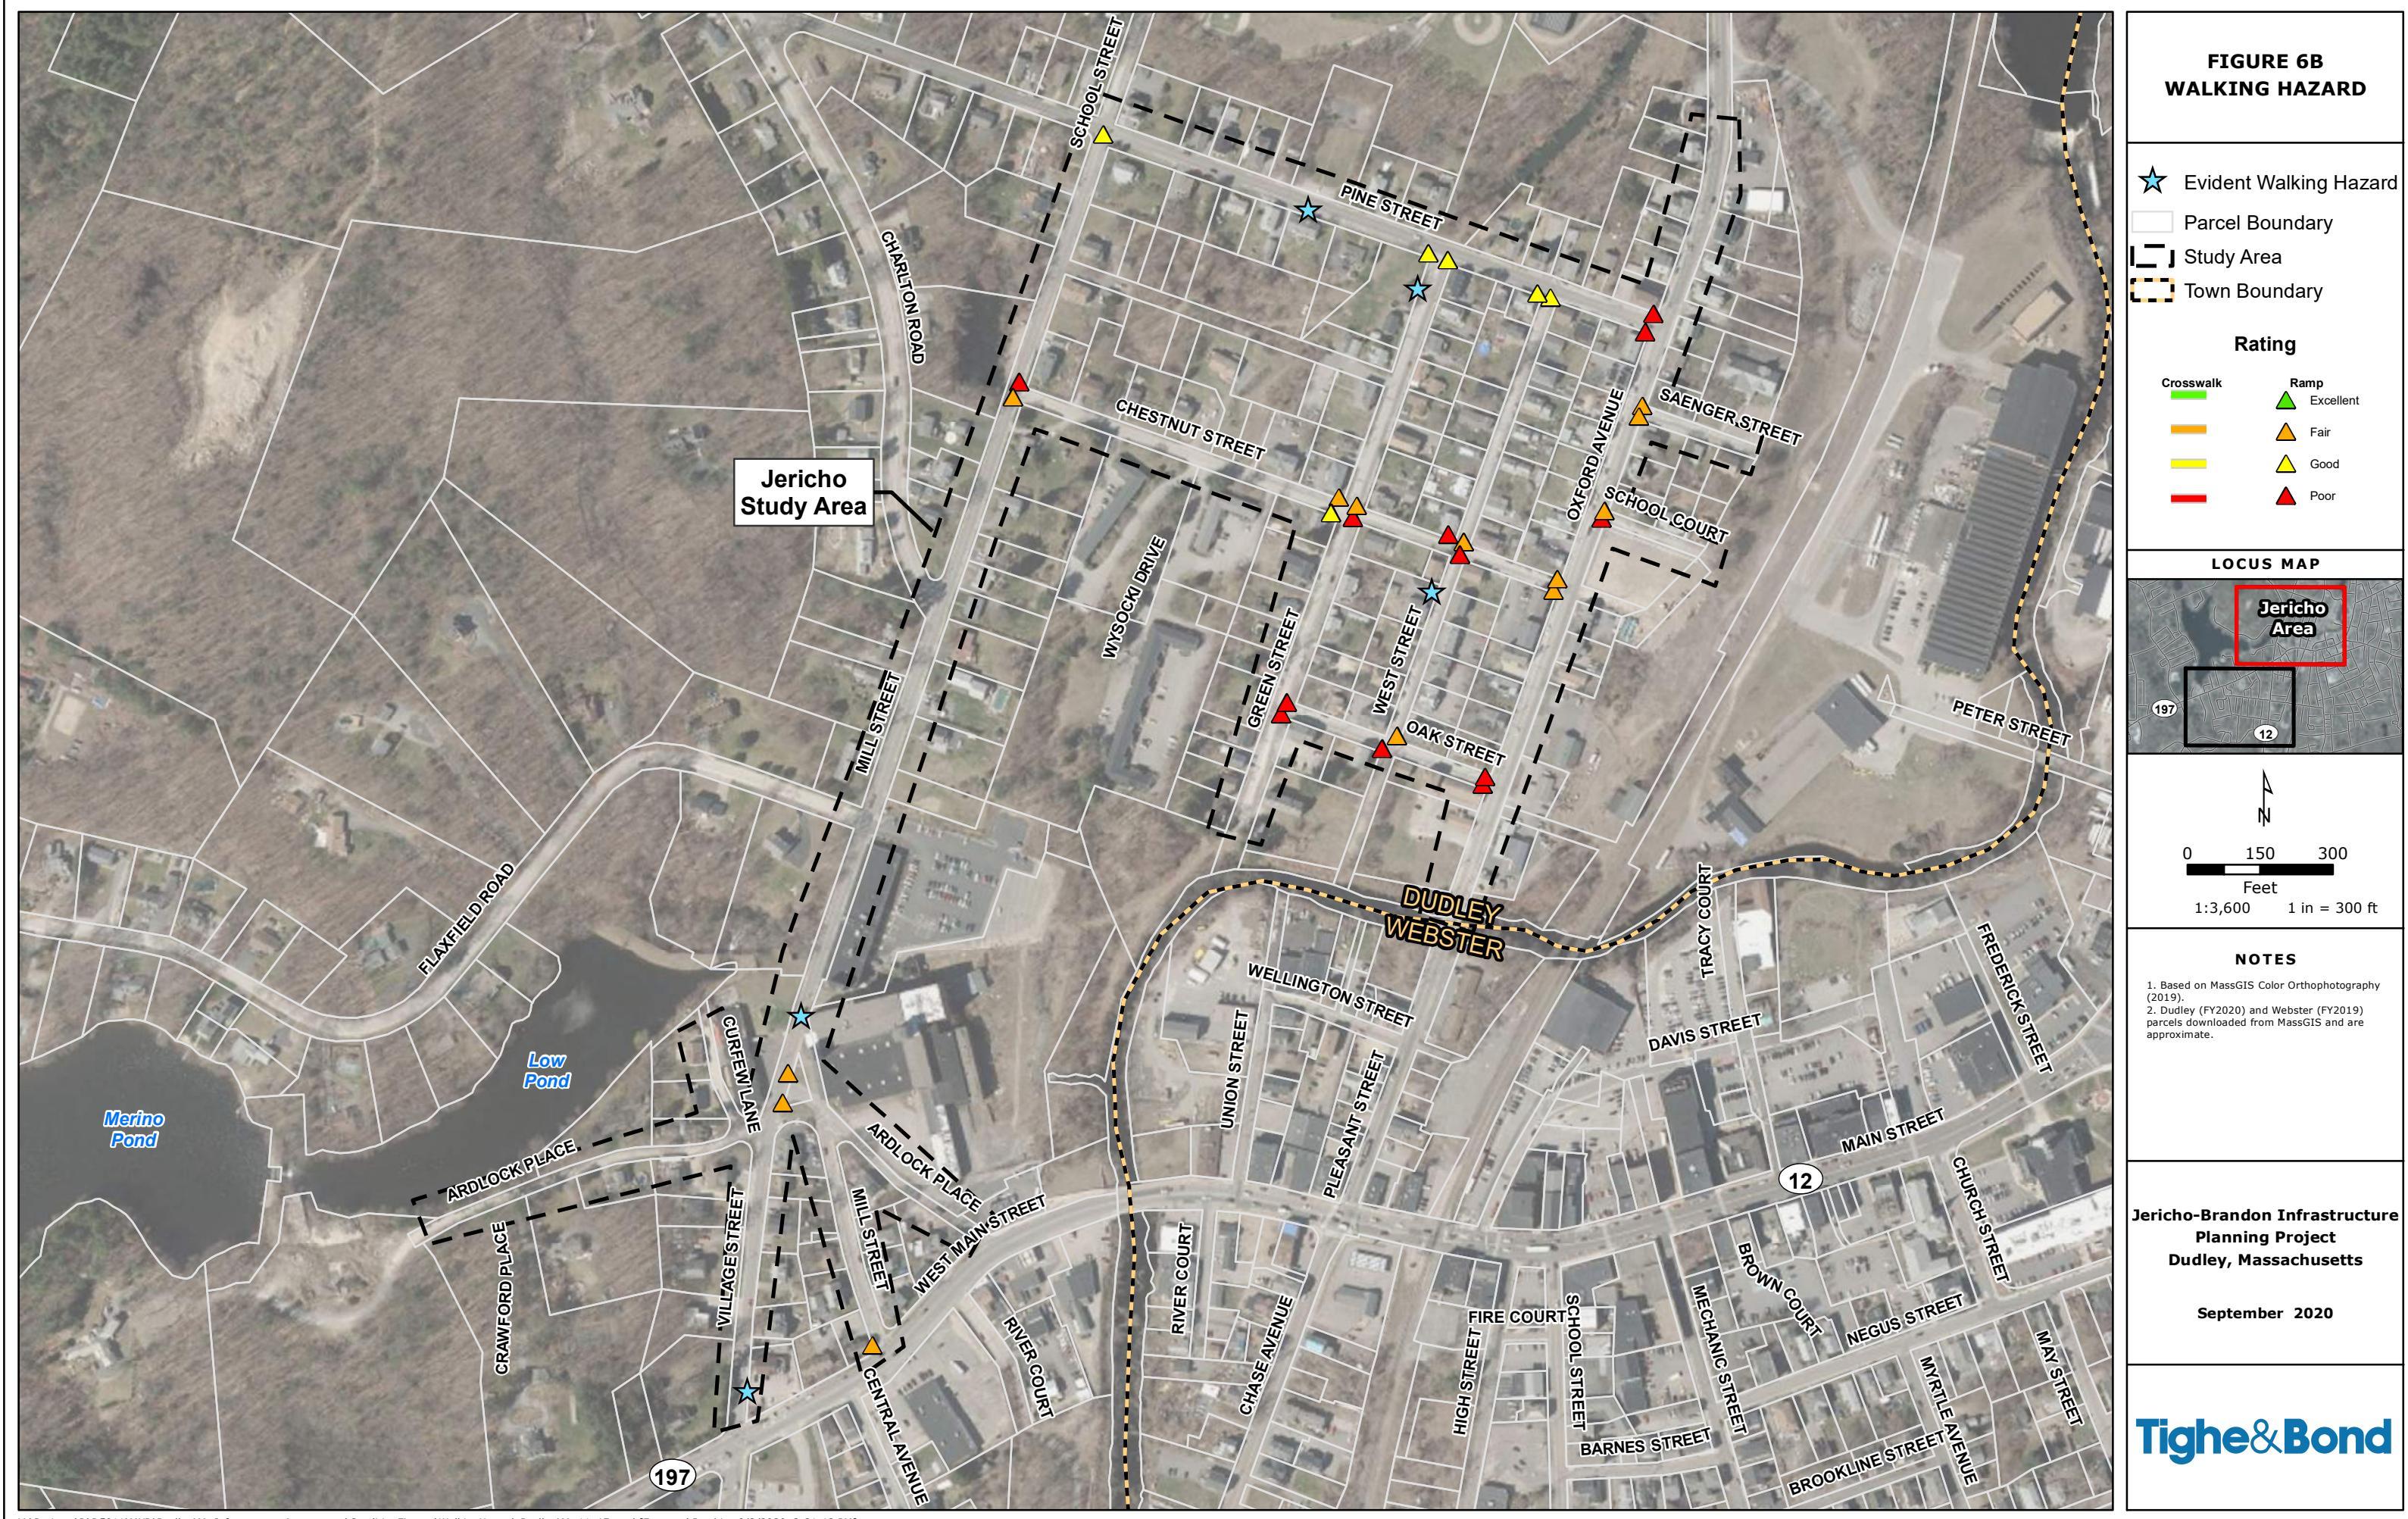
Figures 6A and 6B provided in Appendix A, provide a graphical representation of ramp locations and classification and evident walking hazard locations. Ramp condition, broken down by road name, is provided in Appendix C Table 5. Evident walking hazard detailed descriptions and field photographs are provided in Appendix C Table 6.
