Town of Dudley
Self-Evaluation and Transition Plan
January 2021

TOWN OF DUDLEY – SELF-EVALUATION AND TRANSITION PLAN

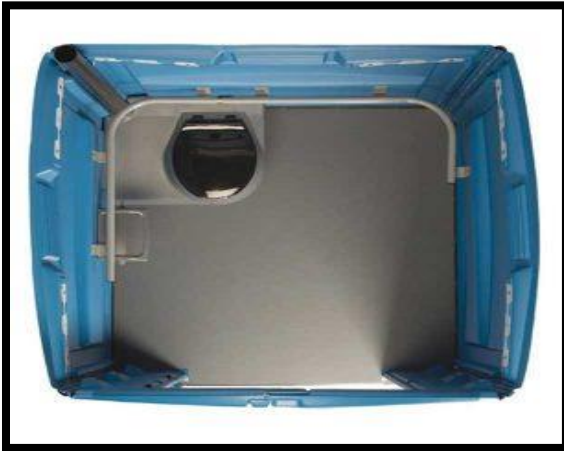
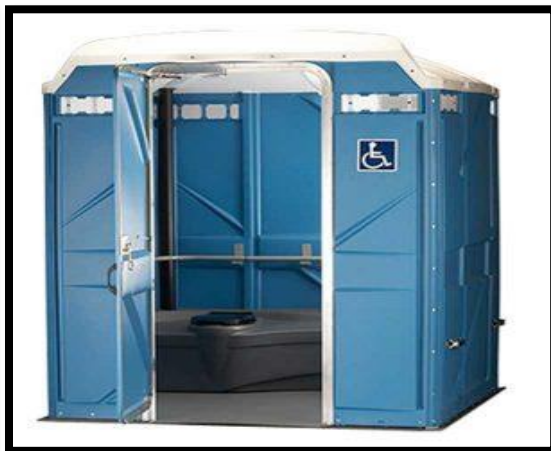
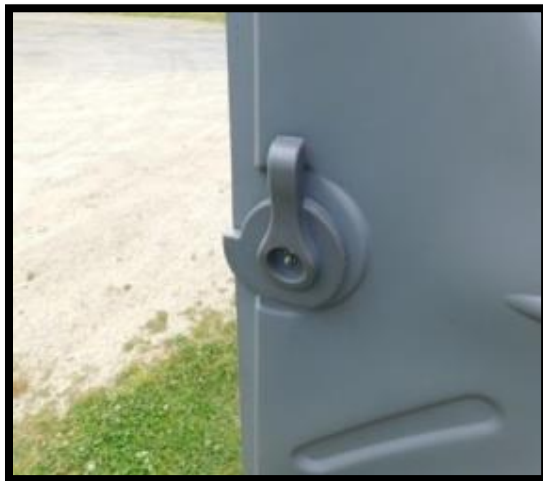
Representative Examples of an ADA Compliant Portable Toilet

If the town provides portable toilets for short-term events or for seasonal use, then they must be “ADA Compliant”. **An important distinction to note is that “ADA Compliant” is not synonymous with “Wheelchair Accessible.”** Wheelchair Accessible usually indicates a ramped or ground level entrance with a wide enough door for a wheelchair to gain entry. Clearances; setbacks; and dispenser, grab bar, and water closet heights do not necessarily meet ADA or 521 CMR Standards. “ADA Compliant”, however, generally means reinforced construction; ramped or ground level and wheelchair accessible entrance; spring loaded magnetic door that closes automatically; reinforced grab bars; dispensers, grab bars, and the water closet at the proper height and near, far and front setbacks; compliant door hardware; and enough interior space for a wheelchair to make a 360 degree turn that all fully comply with the 2010 ADA Standards and/or 521 CMR, whichever is more stringent. Illustrative examples of an “ADA Compliant” portable toilet are shown below.

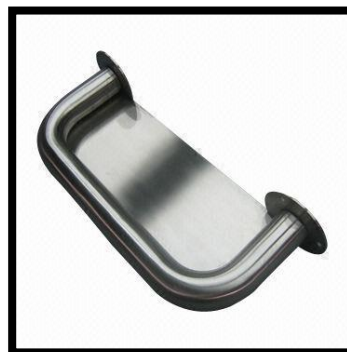
Both the 2010 ADA Standards (S. 604.5 Exception #3) 521 CMR (S. 15.8) provide exceptions for the requirement of grab bars in cells that are specifically designed without protrusions for purposes of suicide prevention. However, in recent years grab bars have been designed so they do not increase suicide risk. As shown, there are several ways for grab bars to be designed with adequate gripping surfaces, while ensuring that nothing can be tied onto them (see below). Consideration should be given (not required) to installing suicide proof grab bars in the accessible cell as feasible and necessary in the future.

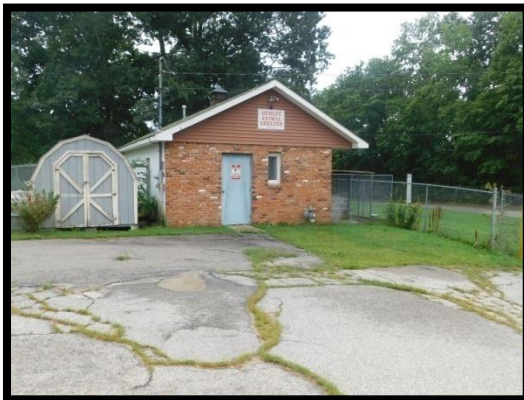
Photo 1: Animal Control

General Description or Obstacle Which Limits Mobility or Access: The Animal Control Building is secured with access limited to arrangements through the Animal Control Officer. There is no designated accessible parking at the building. The paved "accessible route" to the building is uneven due to heaving and there is a 1" abrupt change in level surface at the entrance threshold. The entrance door has knob-style hardware.

<u>Entrance Door</u> The entrance door has knob-style hardware.	404.2	26.11	Install lever-style or similar accessible compliant hardware on the front door.	1	2	I	\$75

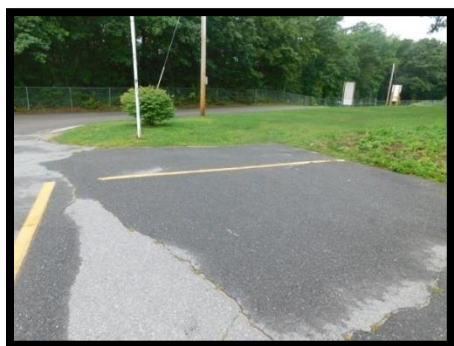
Photo Transfer 1

Description or Obstacle Which Limits Mobility or Access: There are no “public” buildings located at the transfer station. There are also no designated accessible parking spaces. [See Photo Transfer 1.](#)

General Description of Obstacle	2010 ADAAG	MAAB 521 CMR	Type of Action to be Taken	P	F	TF	Cost Estimate
Parking There is no designated accessible parking space inclusive of access aisle and signage. The sole accessible parking space must also be van accessible.	502	23.4 23.6	Stripe and designate a van accessible parking space with van accessible signage at a width of either 11’ with a 5’ access aisle or 8’ with and 8’ access aisle (2010 ADA Standards). Signage must be set such that the signage height should be a minimum of 60” high at the bottom (2010 ADAAG Standards) and a maximum of 96” at the top (MAAB 521 CMR) and located no more than 10’ in front of the space. The slopes should not exceed 2% in any direction.	1	2	I	\$250

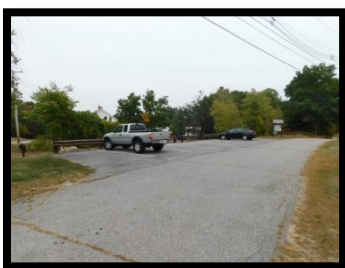
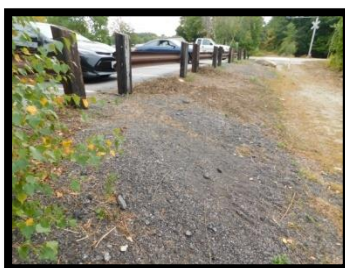
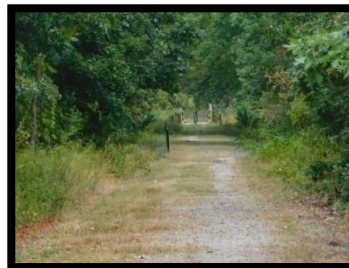
There are 7 paved parking spaces, none of which are designated as accessible. A kiosk, bike rack, bench, and trash receptacle are not on an accessible route of travel and the bench lacks a level hard surface space for a wheelchair. There is no accessible route from the parking area to the trail system. As noted above, the rail trail surface does not meet accessibility standards for wheelchair users or for those with other ambulatory problems.

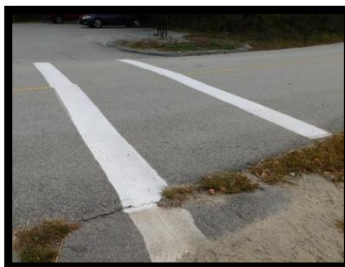
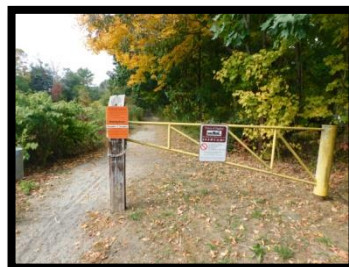
West Dudley Segment

There are 11 paved parking spaces, one of which is designated as accessible. The accessible space lacks signage. A bench and a trash receptacle are not on an accessible route of travel and the bench lacks a level hard surface space for a wheelchair. There are no detectable warning strips from the parking area across Rail Street to access the trail. Similar to the Schofield Avenue segment, the rail trail surface does not meet accessibility standards for wheelchair users or for those with other ambulatory problems.

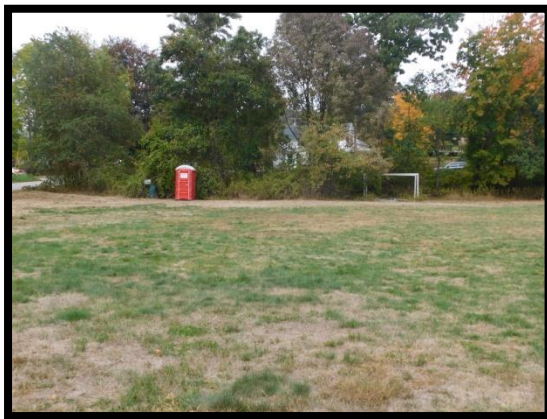
Photo Stevens Field 1

General Description or Obstacle Which Limits Mobility or Access: The facility lacks accessible parking. There is no accessible route to and around the soccer field, portable toilet, trash receptacle, and drinking fountain. The drinking fountain is not high-low and lacks knee clearance. The portable toilet is not ADA compliant and lacks sufficient interior space for a 360 degree turn, does not meet water closet setback and clearance requirements, and does not meet dispenser height requirements. *See discussion on Portable Accessible Toilets in Section IX of this plan.*

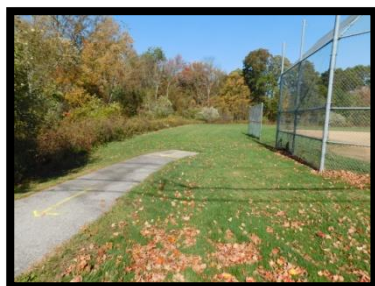
Photo Dudley MS 1

General Description or Obstacle Which Limits Mobility or Access: There are no accessible routes to and around the baseball field, soccer field, and multi-purpose field. If portable toilets are used during the sports seasons, compliance must be in accordance with the discussion *on ADA Compliant Portable Toilets in Section IX* of this plan.

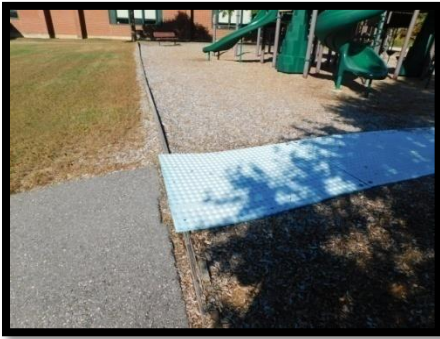
Photo Mason ES 1

General Description or Obstacle Which Limits Mobility or Access: There is no accessible route fully around the playground or within the playground area including to the play components, benches, and picnic tables. Although "Access Deck" matting is used in the interior of the playground as an accessible route of travel, it does not go to all components and amenities. Wood chips are used as a ground surface for the remaining areas of the playground. In addition, the primary access point to the playground has an 18.0% running slope and the secondary access point near the basketball court has a 4" abrupt change in level surface into the play area. Due to the location of a crossbar on the picnic tables, the knee depth is reduced to less than the required 19" knee depth. Apart for the two swings, the playground lacks accessible play components. The benches lack an adjacent level area for a wheelchair.

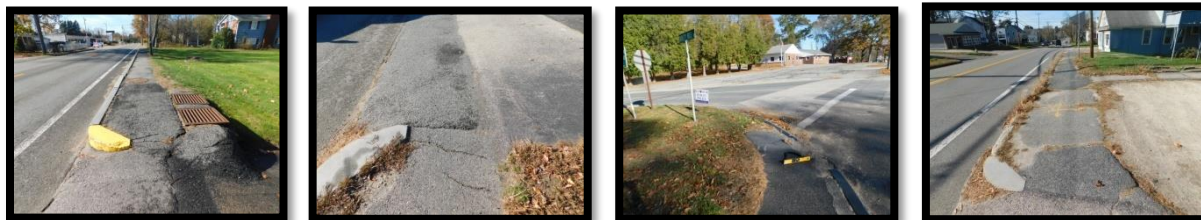
Pattison Avenue (11.1% and 16.5%). The Dudley Hill Road – West Main Street curb ramp also lacks a level landing.

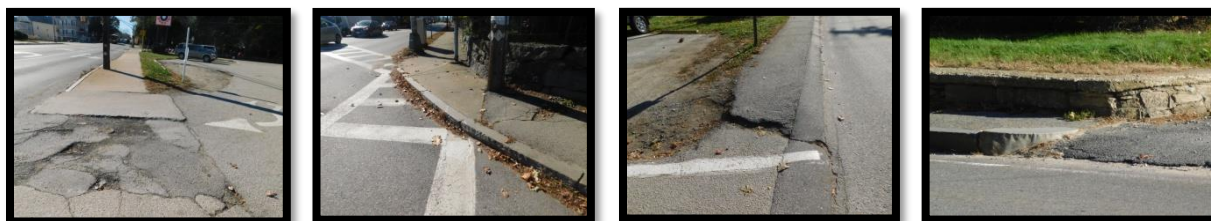
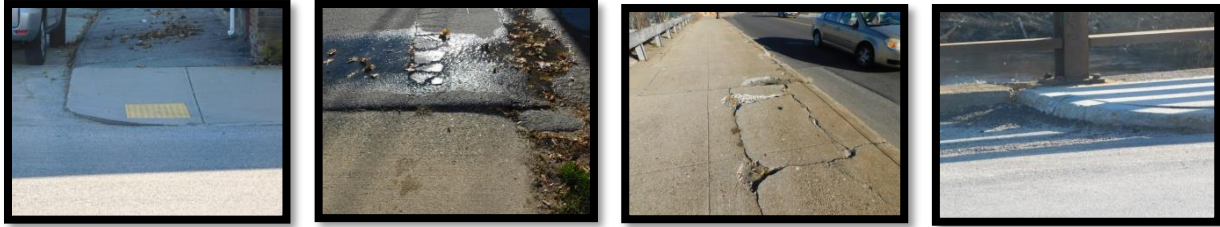
The Schofield Avenue-West Main Street intersection has numerous non-compliance concerns. The curb ramp at Dipping Donuts lacks a detectable warning strip and has a running slope of 11.2%. The south west curb ramps (2 on one side) lack level landings, lack detectable warning strips, has granite curbing at the crosswalk resulting in 4+ inch abrupt change in level surface, and has a running slope of up to 10.6%. The south east curb ramp at Schofield Avenue (library side) lacks a level landing, lacks detectable warning strips, and has a running slope of up to 10.1%. The sidewalk at Dipping Donuts on Village Street just past the intersection has a 2" abrupt change in level surface at the driveway due to deterioration and the clear width is reduced to only 31".

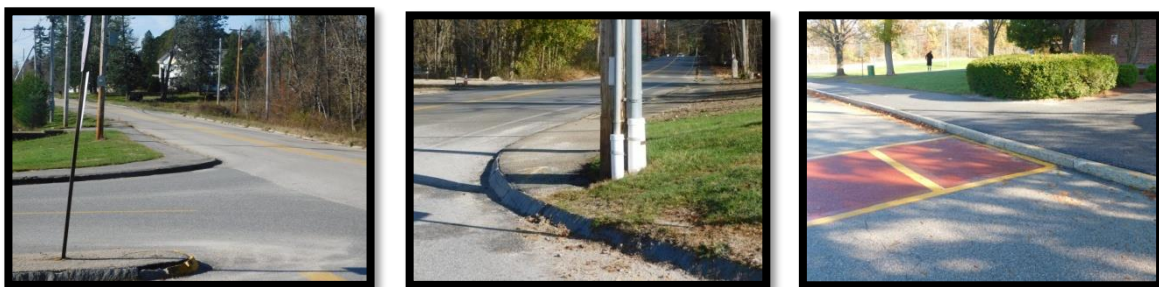
Mason Road Elementary School does not appear to have any non-compliant sidewalk and/or curb ramp issues. Dudley Elementary School appears to be complaint but for the sidewalks in front of Crawford Field which lack detectable warning strips and have a width of only 3 feet.

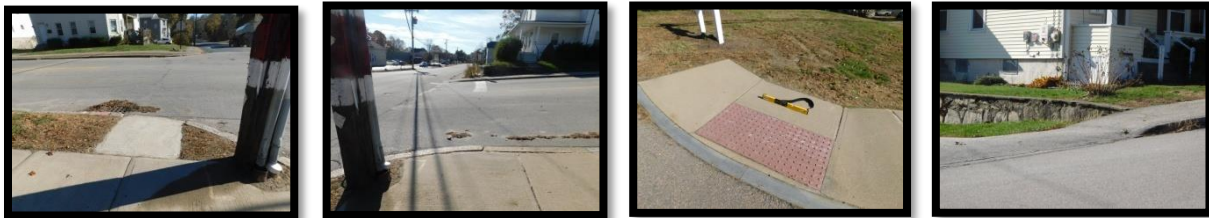
Overall, the sidewalks on Brandon Road are in good condition. The curb ramp at Schofield Avenue and Brandon Road and across Schofield Avenue has a running slope of 16.0% on one side and granite curbing with an excessive abrupt change in level surface due to granite curbing on the opposite side. Neither side has a detectable warning strip. There are no curb ramps (granite curbing), no detectable warning strips and the crosswalk is not striped at the crosswalk/curb ramps across Brandon Road at Schofield Avenue. The curb ramp on side at the Library and Brandon Road does not have a level landing with a 12.4% slope. The flared sides exceed that allowed but the accessible route terminates at the flare so no other action is required. The remainder of the Brandon Road curb ramps are asphalt with no detectable warning strips. The 1st Avenue crosswalk has granite curbing at the sidewalk on both sides of up to 5"+. The 2nd Avenue curb ramp has a running slope in excess of 8.3% which exceeds that allowed.

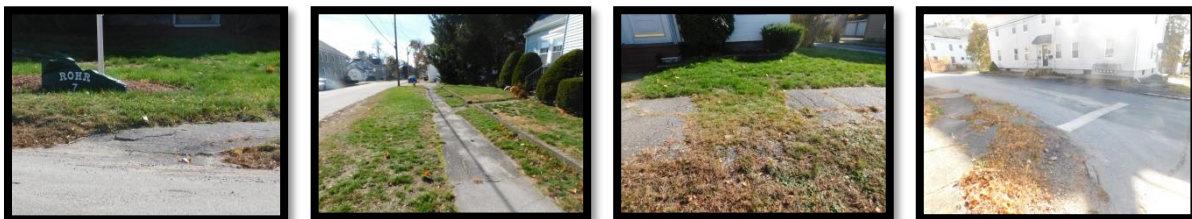
Green Street to Oak Street has sidewalk widths which are reduced to 24" to 36" with abrupt changes in level surface, deteriorated asphalt and overlays, and limited maintenance with overgrowth. In some areas, there is upheaval due to tree roots. Curb ramps are asphalt and lack detectable warning strips. The crossing at Green and Chestnut Streets has a 17.6% running slope at the curb ramp on one side and an abrupt change in level surface of 1"+ on the opposite side. The crossing at Green and Pine Streets has a catch basin at the base of the asphalt curb ramp on one side and an abrupt change in level surface of up to 5" on the opposite side due to granite curbing. In addition, there are no level landings and clear width is reduced to 24".

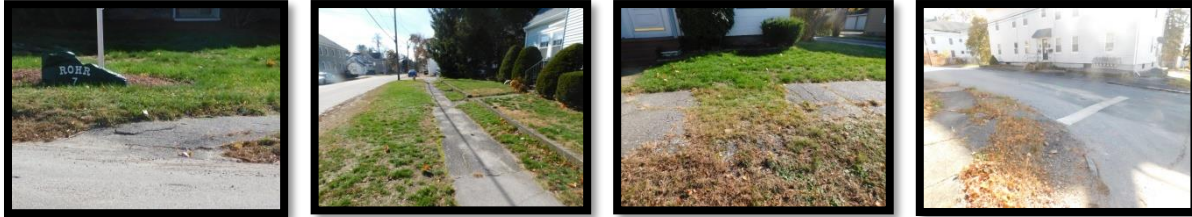
Oak Street has similar conditions as Green Street and also has an excessive sidewalk cross slope of up to 9.5% at #9 Oak Street. Curb ramps are asphalt, with no detectable warning strips. The crossing at #7 Oak Street has 6" granite curbing which restricts access.

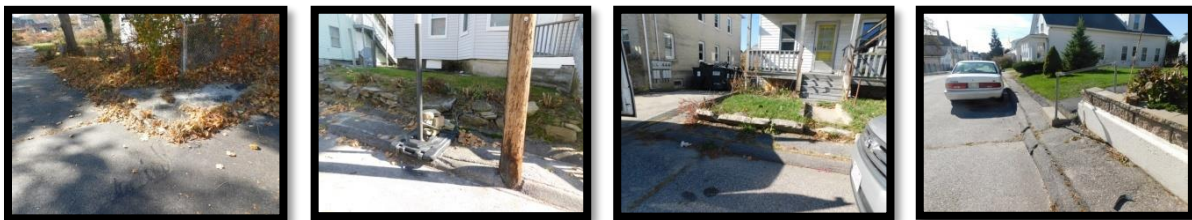
West Street sidewalks are generally in very poor condition. Sidewalk widths are reduced to less than 28" in areas due to overgrowth or retaining walls (odd side of street). A fire hydrant at #15 - #17 West Street reduces the sidewalk clear width to 24". The sidewalk at #9 Oak Street has a retaining wall which restricts clear width and then the sidewalk abruptly ends with no crossing or curb ramp. A basketball hoop in the sidewalk at #2 West Street restricts access entirely. In addition, a telephone pole in the vicinity of #2 West Street reduces the clear width to only 28". A water cover at the base of the stairs to #2 West Street creates an unsafe 1" abrupt change in level surface. The sidewalk cross slope between #2 and #4 West Street exceeds 8.0%. West Street curb ramps are asphalt with no detectable warning strips and no striped crosswalks. The curb ramp at Oak and West Street has a running slope in excess of 10.6%.

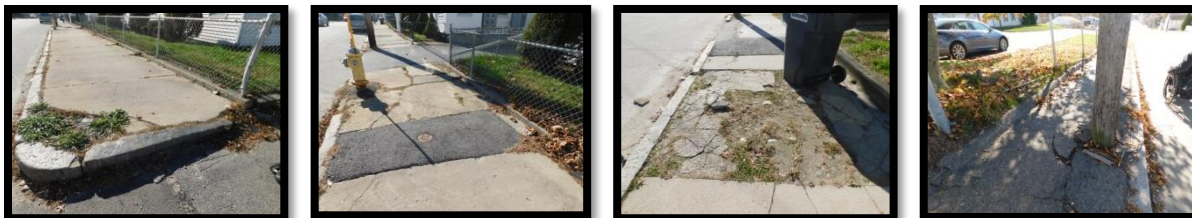
Oxford Avenue sidewalks are in overall fair to poor condition with broken concrete and asphalt overlay. In addition, water covers in the sidewalk and granite curbing at driveways (#14 Oxford Avenue) as well as general heaving and deterioration creates excessive abrupt changes in level surface. Oxford Avenue curb ramps are asphalt with no detectable warning strips and no striped crosswalks. The crossings at Oxford/School Street, Oxford/Oak Street, and Oxford/Pine Strret have abrupt changes in level surface of 2" to 6" due to granite curbing.
