# ROAD SAFETY AUDIT

Dresser Hill Road  
Town of Dudley  
June 2015

Prepared For:  
MassDOT

Prepared By:  
Chappell Engineering Associates  
201 Boston Post Road West

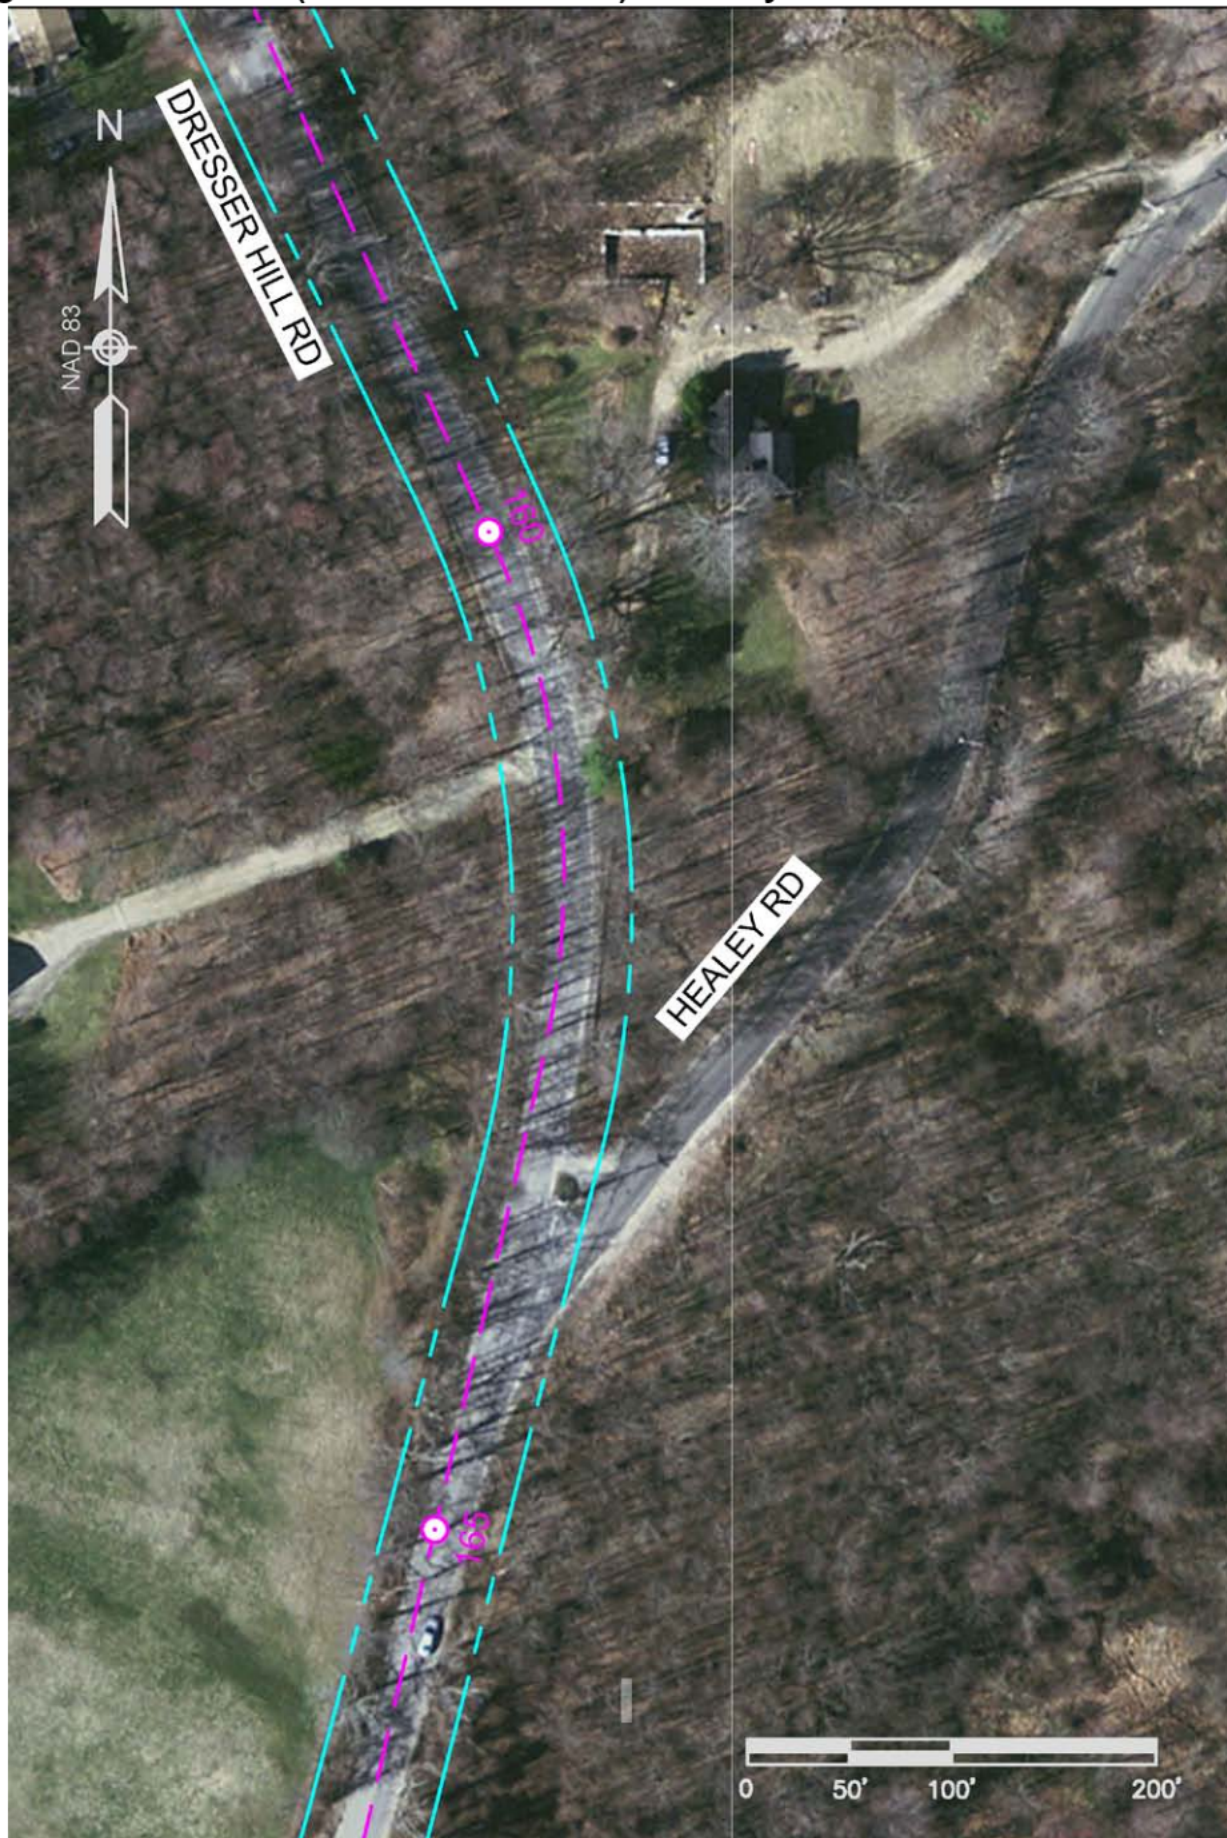
**Figure 2. Route 31 (Dresser Hill Road) at Healy Road**

**Route 31 (Dresser Hill Road) at Healy Road** is an unsignalized intersection with three approaches. The Healy Road stop-controlled southwest approach consists of one travel lane in each direction. Healy Road is classified as a local road under the Town of Dudley's jurisdiction. The Route 31 northbound and southbound approaches each consist of one travel lane in each direction. Healy Road intersects Route 31 from the northeast, creating an acute intersection angle. There is limited sight distance to vehicles traveling southbound on Route 31; and because of the angle of the intersection, vehicles turning north from Healy Road must cross into opposing traffic when turning onto Route 31. The profile of Healy Road is low to Route 31, thus restricting sight distance and awareness of an intersecting street for drivers traveling on Route 31. A utility pole located on the northeast corner also blocks sight into and out from the intersection. An aerial image of the intersection is shown in **Figure 2**.

- a. Consider altering the geometry of the Healy Road southwest-bound approach to Route 31 to create a right-angle intersection, which would improve motorists’ sight lines to the north and force motorists entering or exiting Healy Road to do so at slower speeds. Considered alterations should review both horizontal and vertical alterations to the approach so as to reduce both the horizontal intersection angle and the approach grade of Healy Road as illustrated in **Figures 6 & 7**.

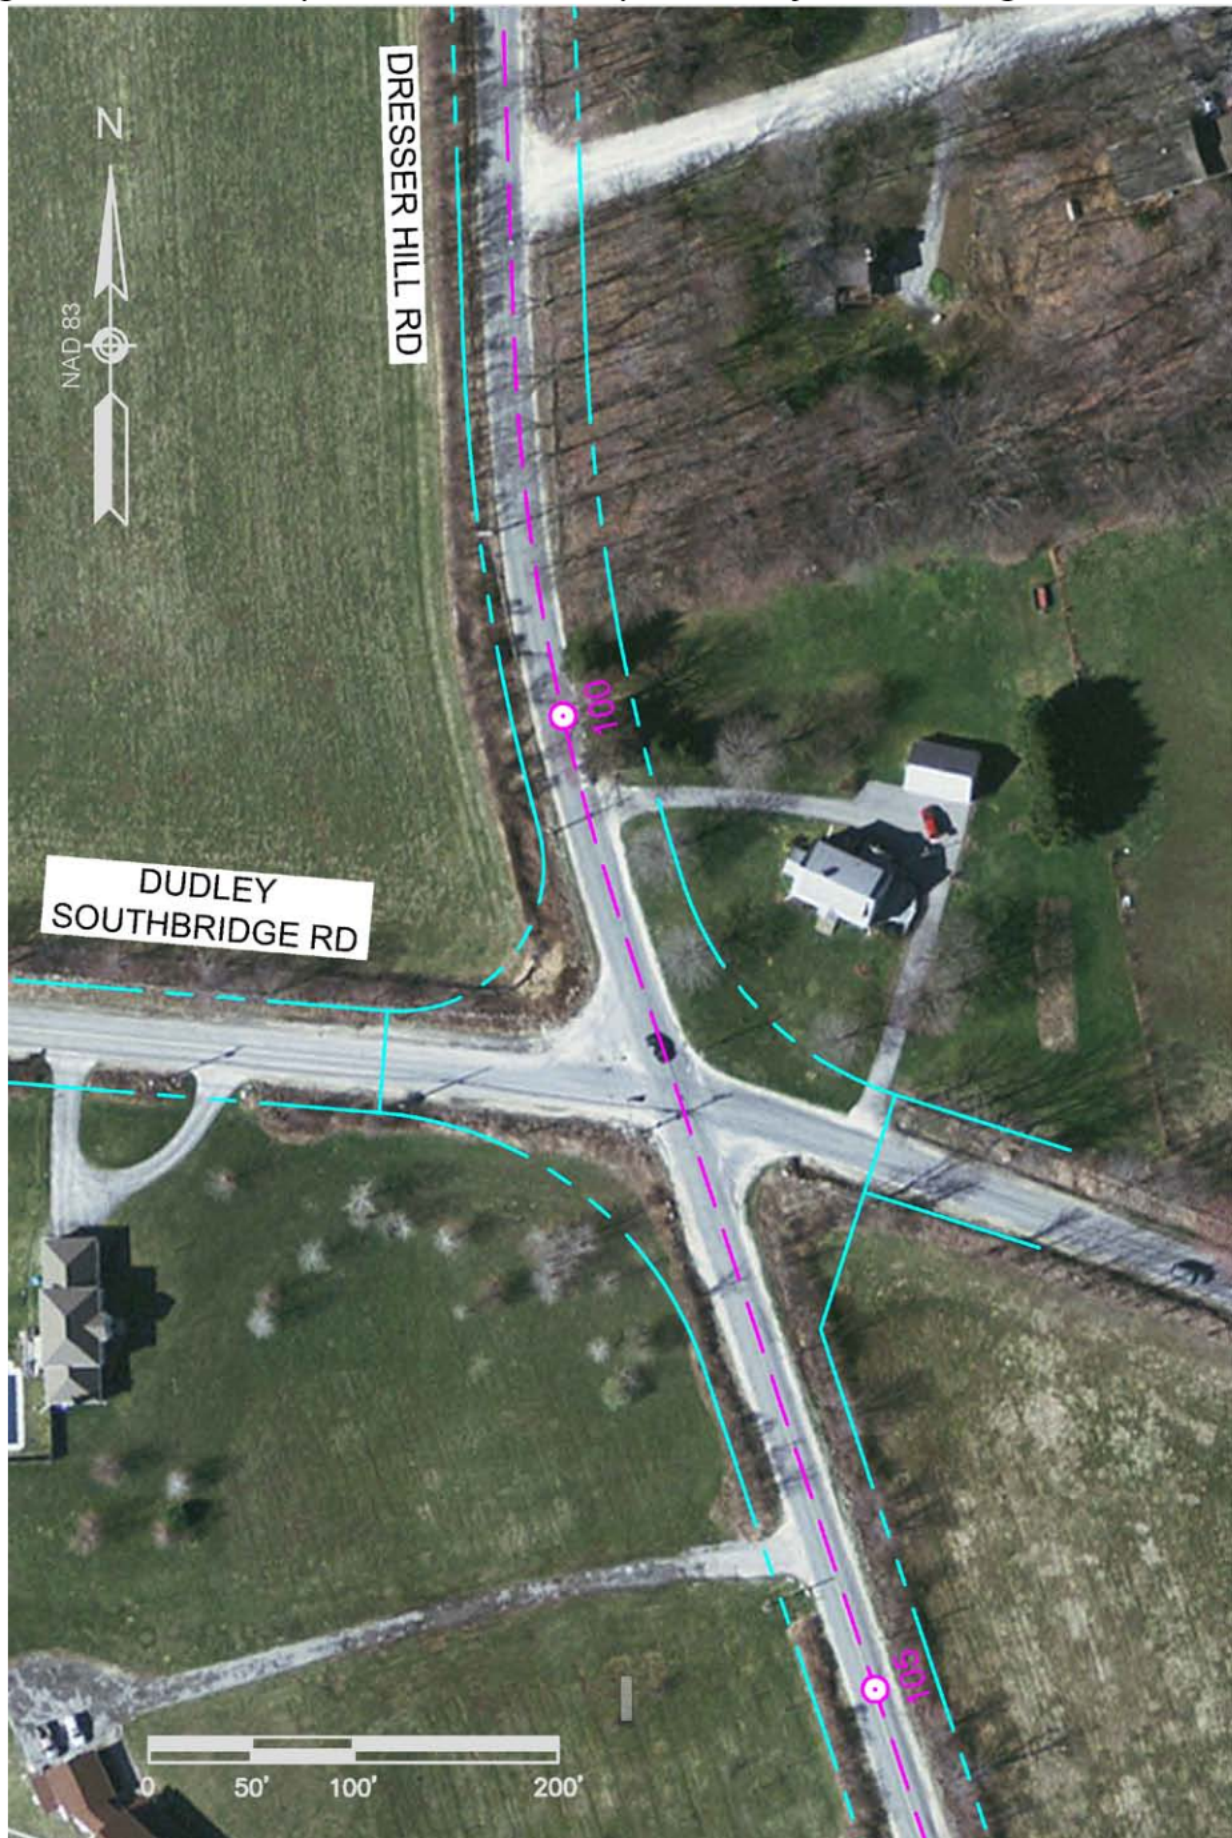
**Figure 3. Route 31 (Dresser Hill Road) at Dudley Southbridge Road**

**Route 31 (Dresser Hill Road) at Dudley Southbridge Road** is an unsignalized intersection with four approaches. Dudley Southbridge Road is classified as a local road under the jurisdiction of the Town of Dudley. The Dudley Southbridge Road east and westbound approaches are stop controlled and consist of one travel lane in each direction. The intersection is surrounded by trees which border fields on the southeast, southwest, and northwest corners. The intersection is also impeded by two utility poles, one on the southwest corner and one about 50 yards from the edge of the northwest corner, both of which block sightlines. A large house is located on the Northeast corner, set back from the road. In the front yard of this house, two large trees block sightlines to the north. To the south is a segment of straight road in Route 31. An aerial image of the intersection is shown in **Figure 3**.

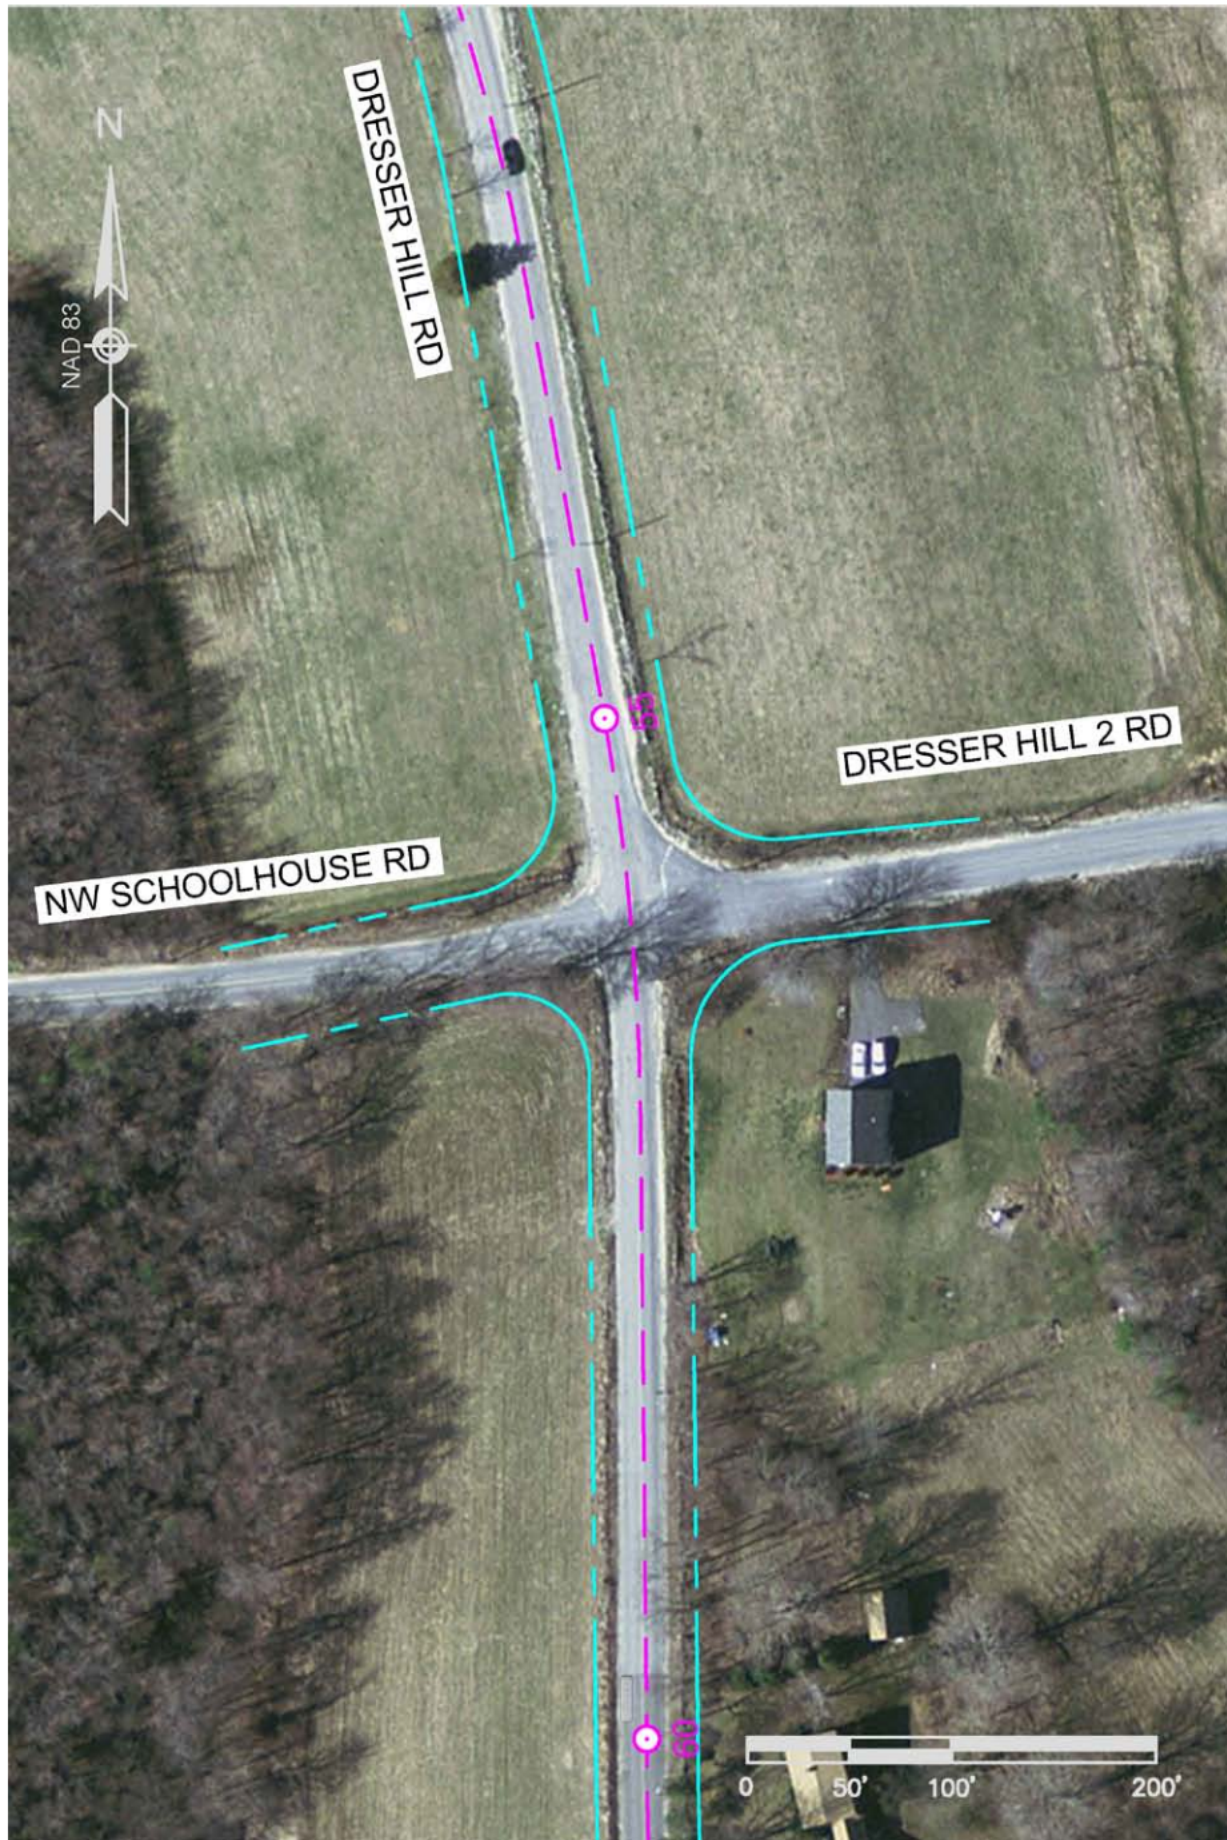
**Figure 4. Route 31 (Dresser Hill Road) at Dresser Hill Road #2 and NW Schoolhouse Road**

**Route 31 (Dresser Hill Road) at Dresser Hill Road #2/ NW Schoolhouse Road** is an unsignalized intersection with four approaches. The Dresser Hill Road #2 stop-controlled eastern approach and the NW Schoolhouse Road stop-controlled western approach each consist of one travel lane in each direction, and is classified as a local road under the jurisdiction of the Town of Dudley. Both Dresser Hill Road #2 and NW Schoolhouse Road are classified as local roads and fall under the jurisdiction of the Town of Dudley. The Route 31 northbound and southbound approaches also consist of one travel lane in each direction. The profiles of the side streets are low to Route 31, restricting sight distance and awareness of the intersecting roads for drivers traveling on Route 31. An aerial image of the intersection is shown in **Figure 4**.
