Jericho-Brandon Study Area Town of Dudley, Massachusetts

Jericho-Brandon Infrastructure Planning Project

Prepared For: Town of Dudley 71 West Main Street Dudley, Massachusetts

June 2021

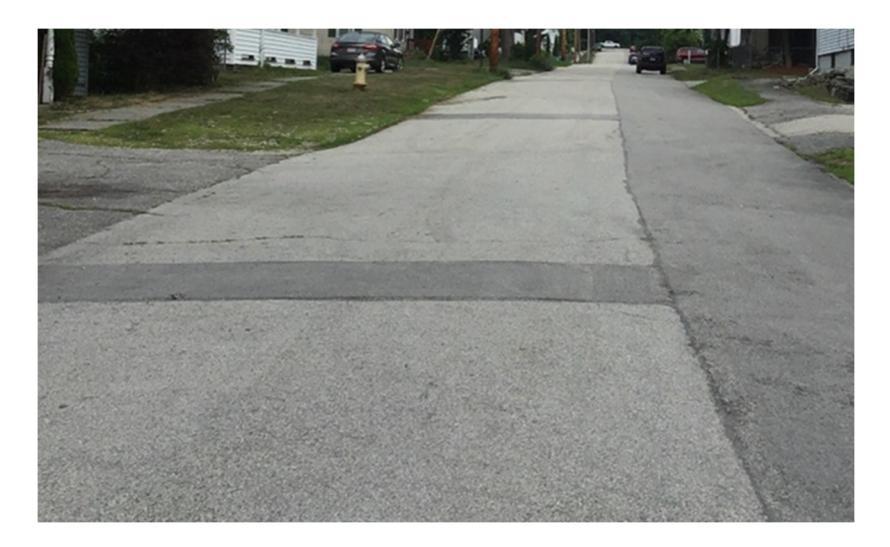
Photo 1: Good Pavement Surface

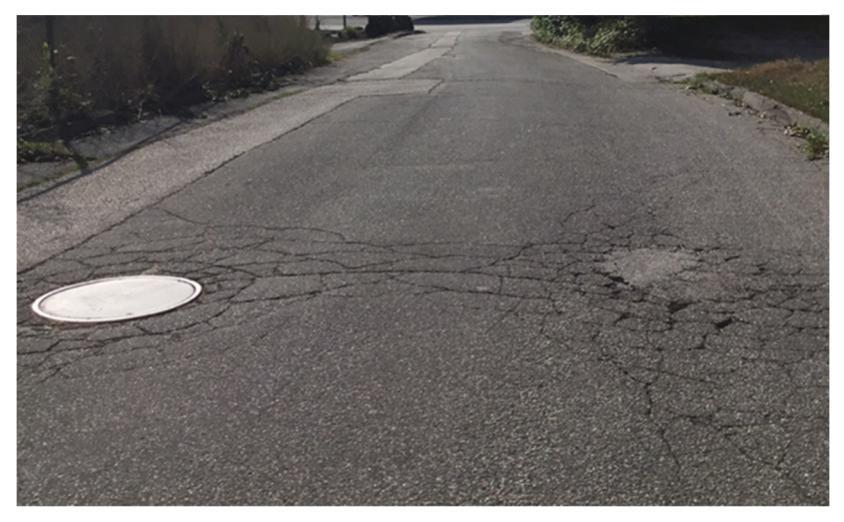
Photo 2: Fair Pavement Surface

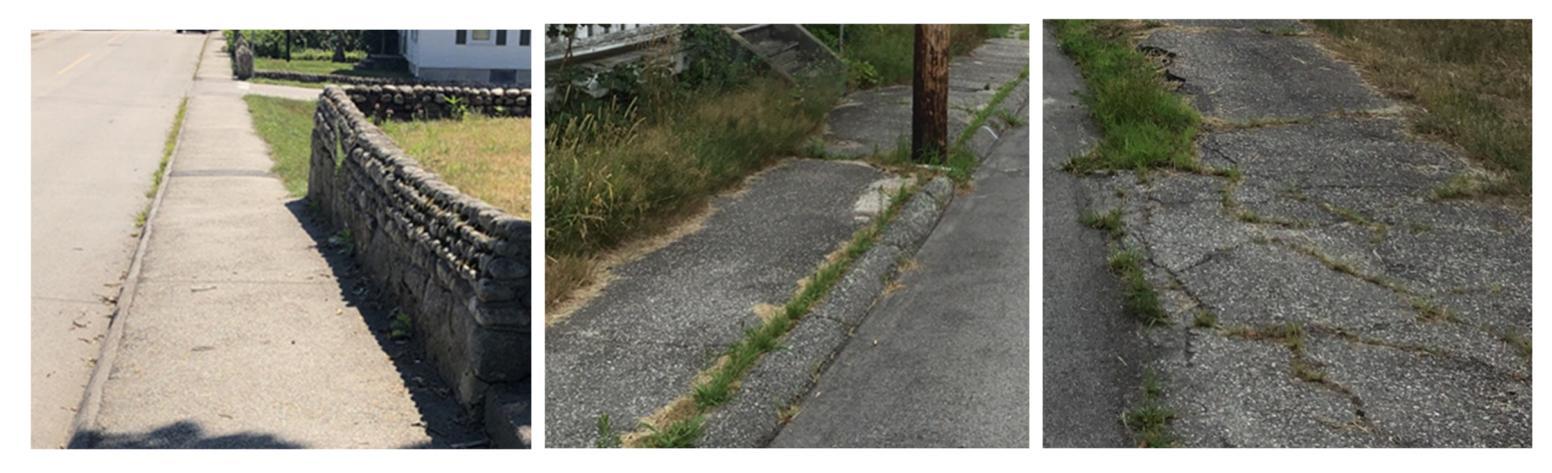
Photo 5: Good Sidewalk

Photo 6: Fair Sidewalk

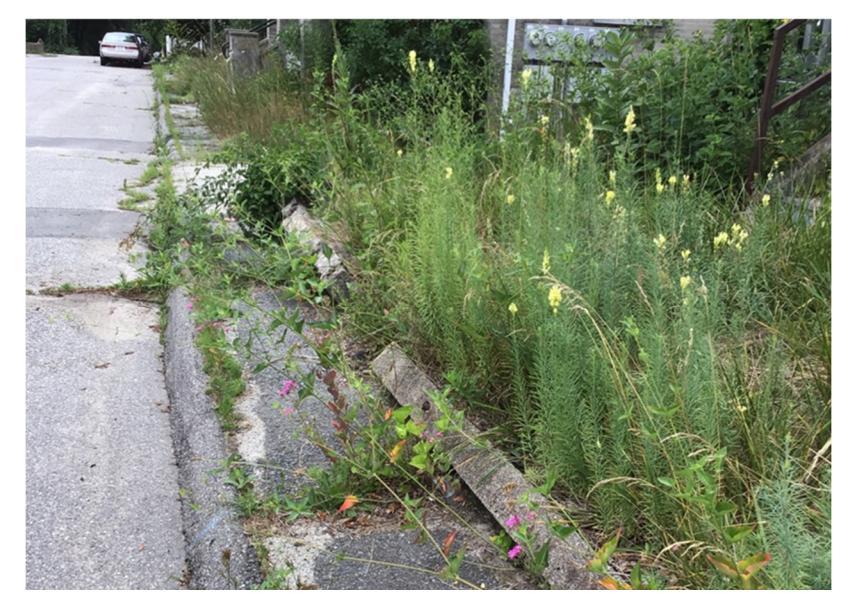
Obstacles can be present besides flawed sidewalks and ramps that cause walking hazards. Some of the obstacles to pedestrian traffic found in the Area were roots, vegetation, cars, and failing walls. In addition to the evident walking hazards observed, there is only one crosswalk in the Area located on Brandon Road. The large lack of crosswalks is a concern for pedestrian safety when crossing the roadways. Photo 10 is a wall and vegetation that is obstructing the sidewalk representing an evident walking hazard.

Photo 10: Evident Walking Hazard

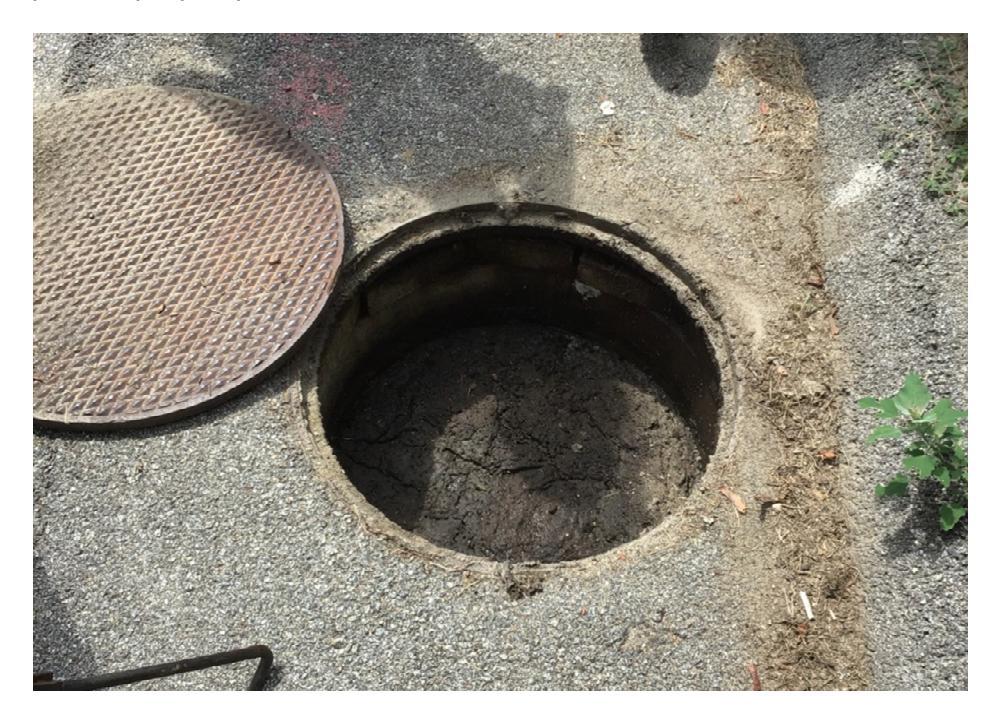
Photo 15: Full Sewer Manhole in front of 5 Mill Street

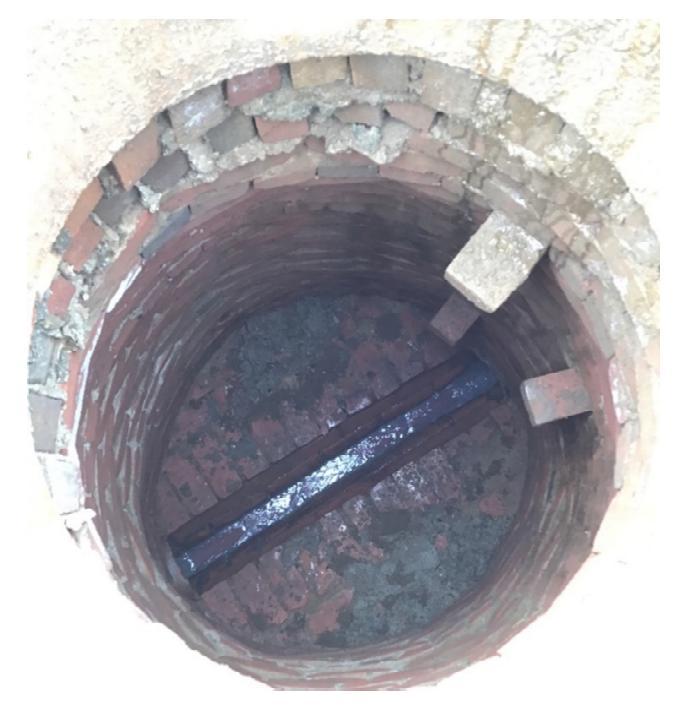
Photo 16: Good Sanitary Sewer Manhole

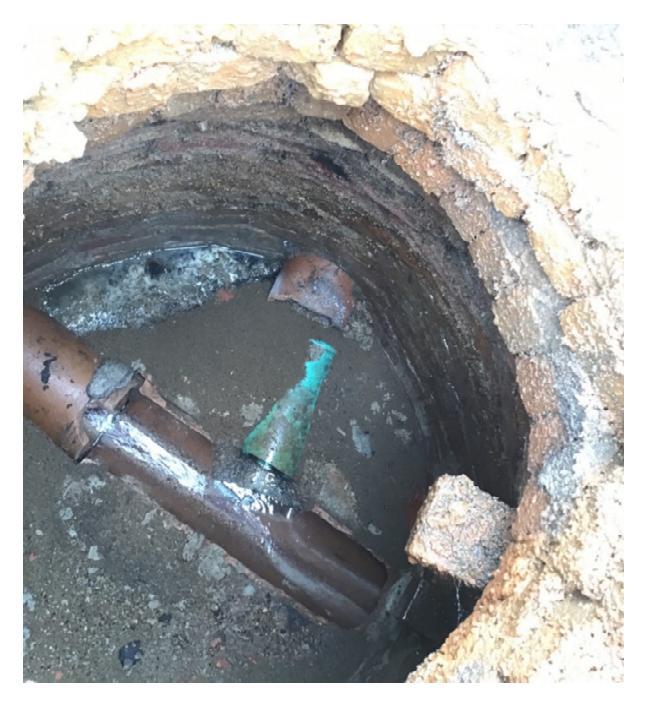
Photo 17: Fair Sanitary Sewer Manhole

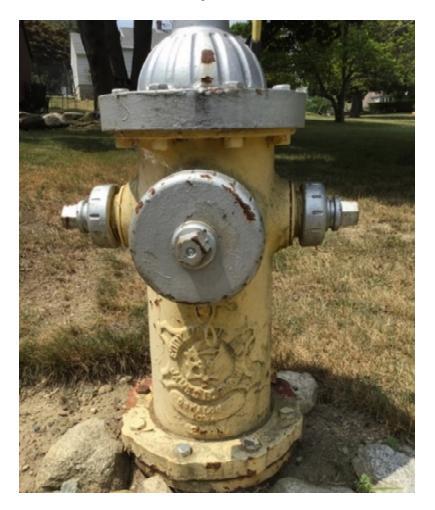
Photo 18: Representative Fire Hydrant

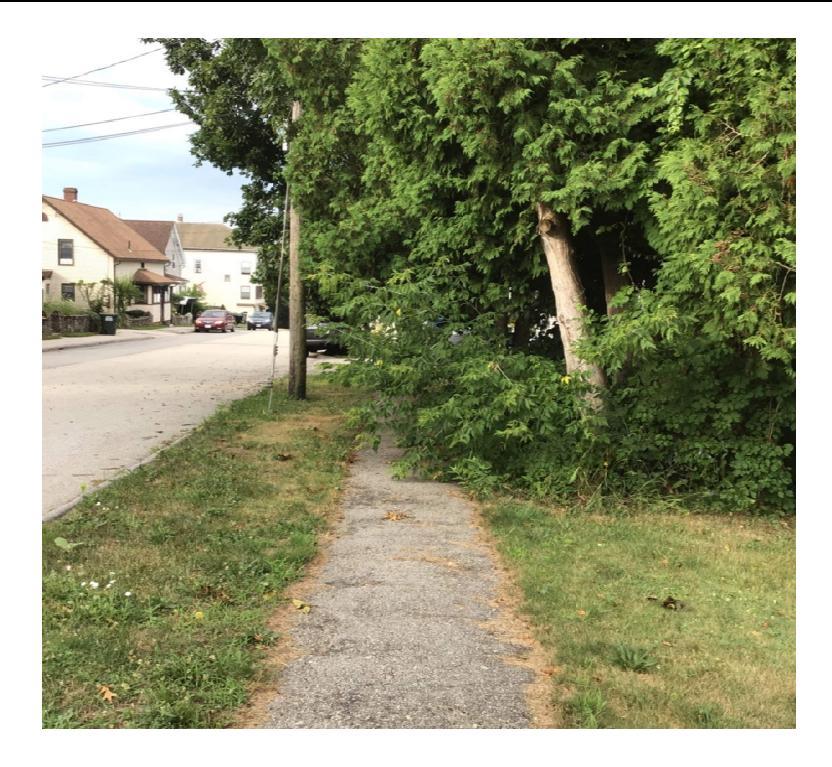
Street Name	Description
GREEN STREET	Vegetation protruding into the sidewalk.

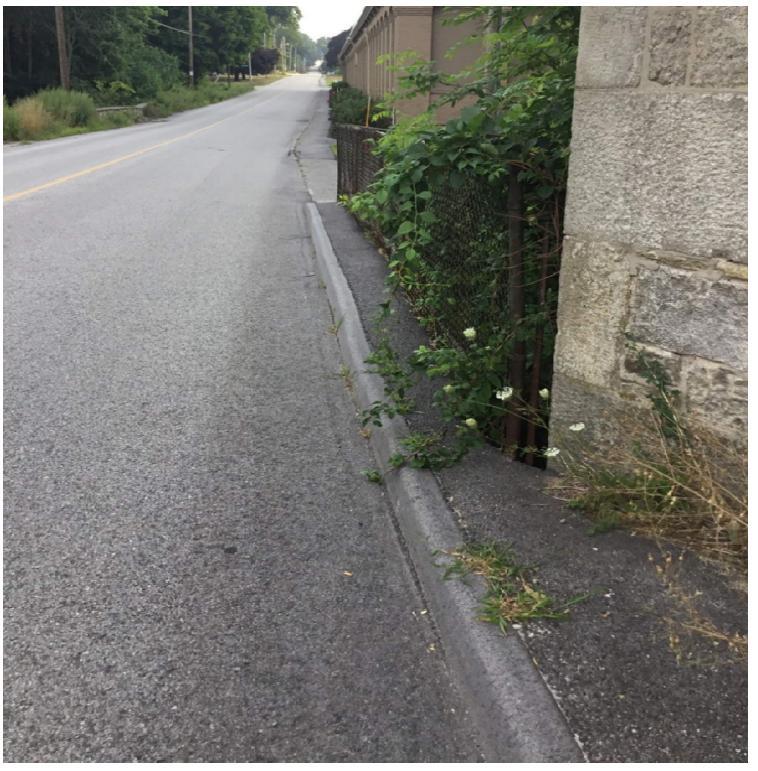
Street Name	Description
	Mill Street is a busy road and the sidewalk becomes extremely skinny that even a child
MILL STREET	can't safely walk on it.

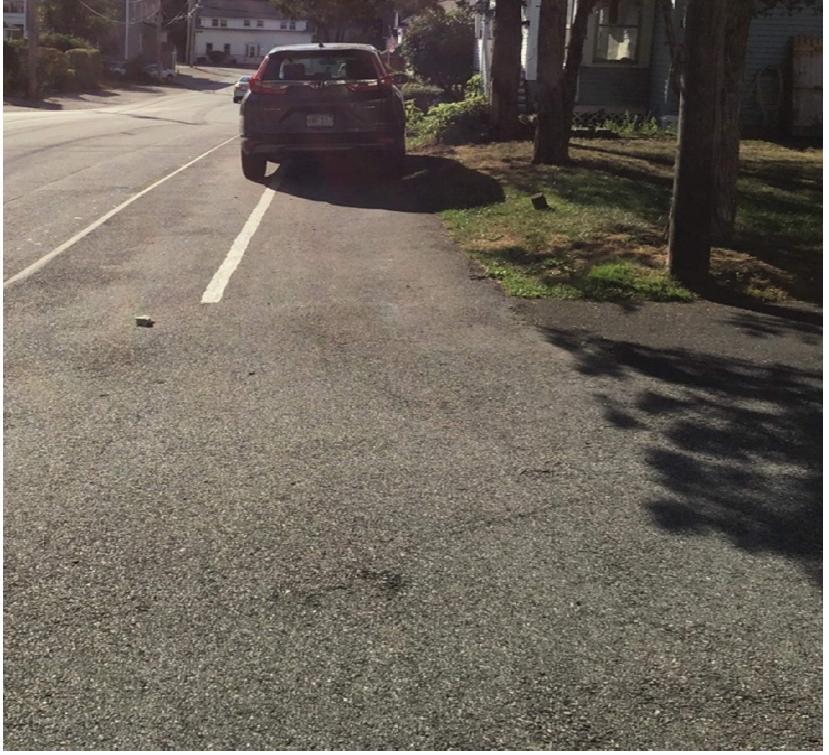
Street Name	Description
	Cars Parked on Sidewalk - Attempt was made to distinguish parking area from the
PINE STREET	sidewalk but many cars (a Tractor Trailer) are not in designated area.

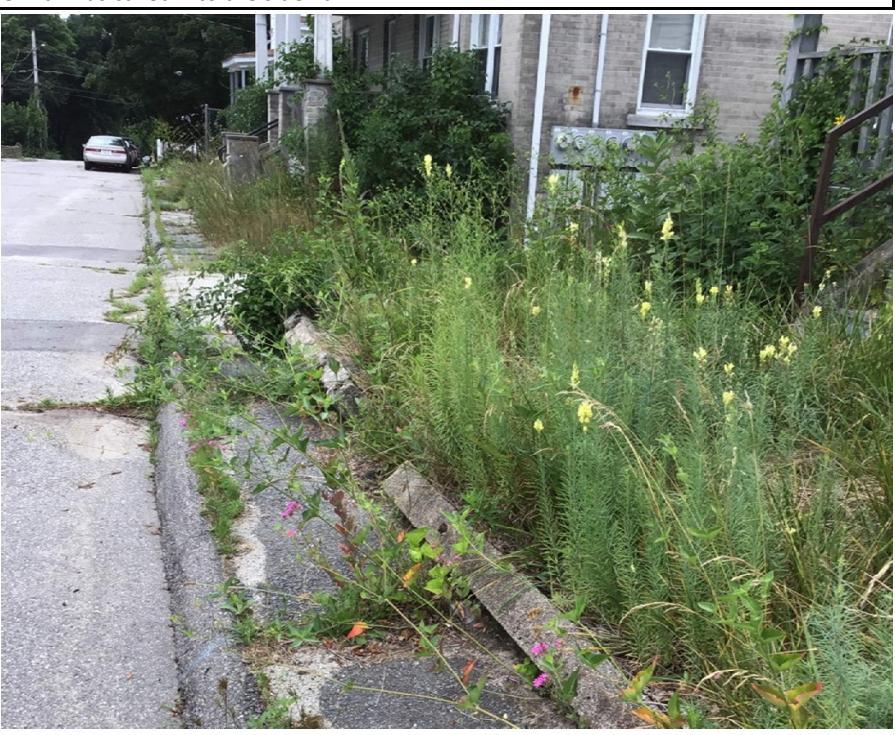
Street Name	Description
WEST STREET	The wall has caved into the sidewalk.

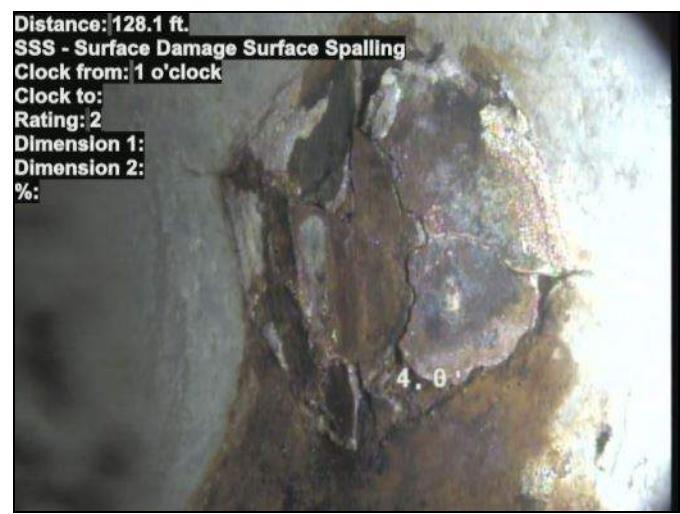
Photo:
 UNKNOWN-58-12032020-SSS-128.1 ft.-082331.JPG

At:
 128.098 ft.
 SSS - Surface Damage Surface Spalling 1/.

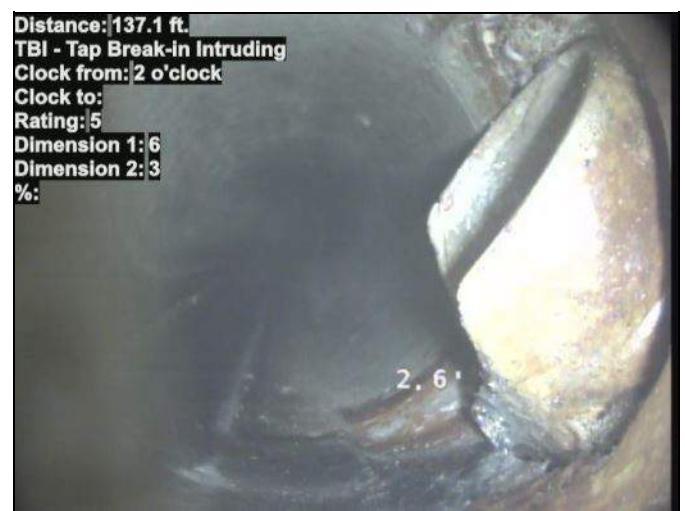
Photo: UNKNOWN-58-12032020-TBI-137.1 ft.-082435_1.JPG At: 137.105 ft. TBI - Tap Break-in Intruding 2/.

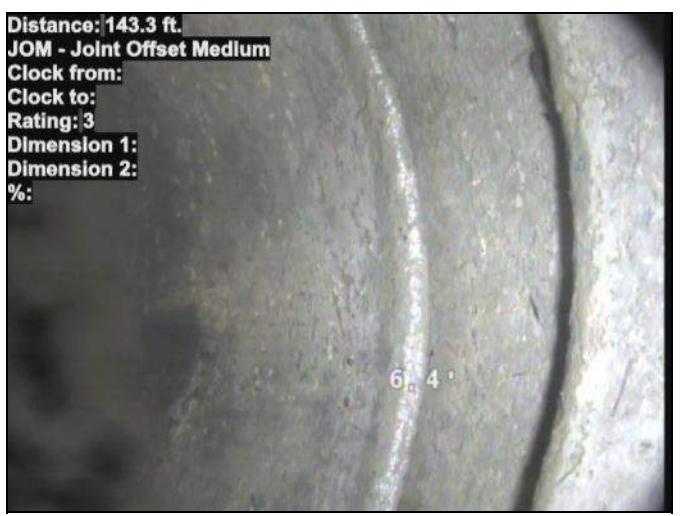
Photo:
 UNKNOWN-58-12032020-JOM-143.3 ft.-082600.JPG

At:
 143.31 ft.
 JOM - Joint Offset Medium

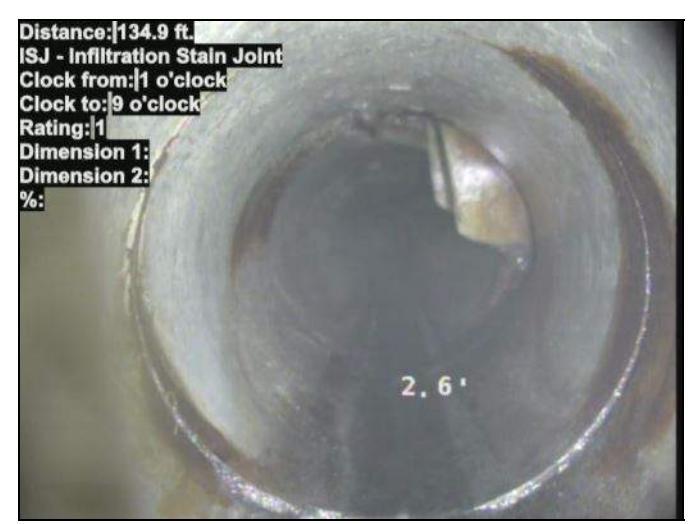
Photo:
 UNKNOWN-58-12032020-ISJ-134.9 ft.-082408.JPG

At:
 134.903 ft.
 ISJ - Infiltration Stain Joint

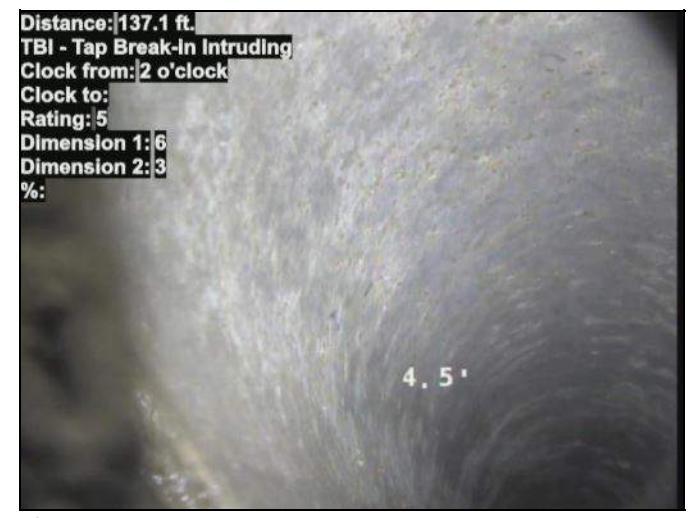
Photo: UNKNOWN-58-12032020-TBI-137.1 ft.-082435.JPG At: 137.105 ft. TBI - Tap Break-in Intruding 2/.

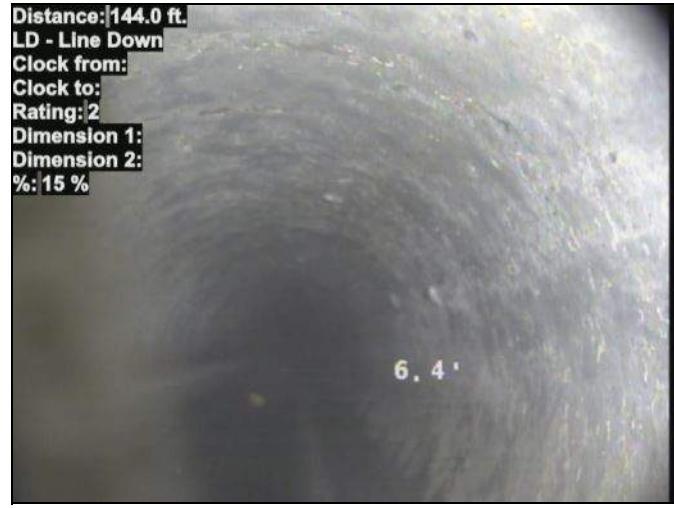
Photo:
 UNKNOWN-58-12032020-LD-144.0 ft.-082629.JPG

At:
 144.01 ft.
 LD - Line Down

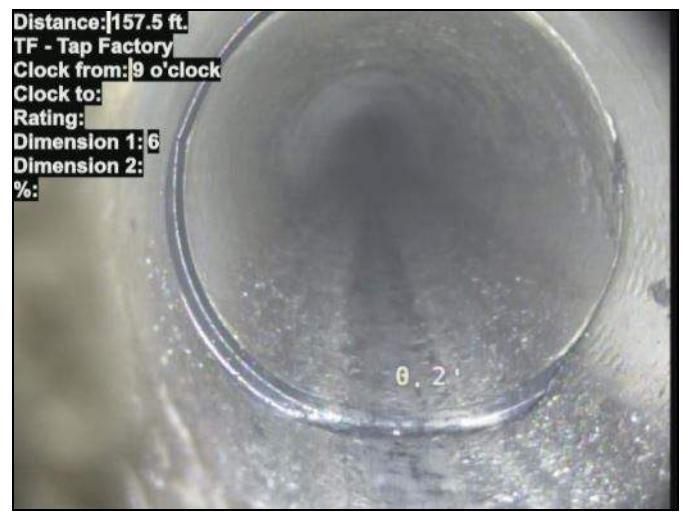
Photo: UNKNOWN-58-12032020-TF-157.5 ft.-082726.JPG At: 157.521 ft. TF - Tap Factory 9/. Joint: No

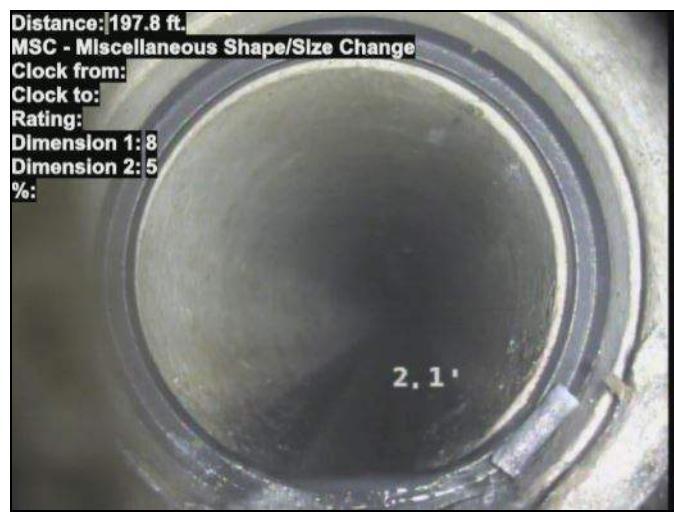
Photo:
 UNKNOWN-58-12032020-MSC-197.8 ft.-083030.JPG

At:
 197.751 ft.
 MSC - Miscellaneous Shape/Size Change

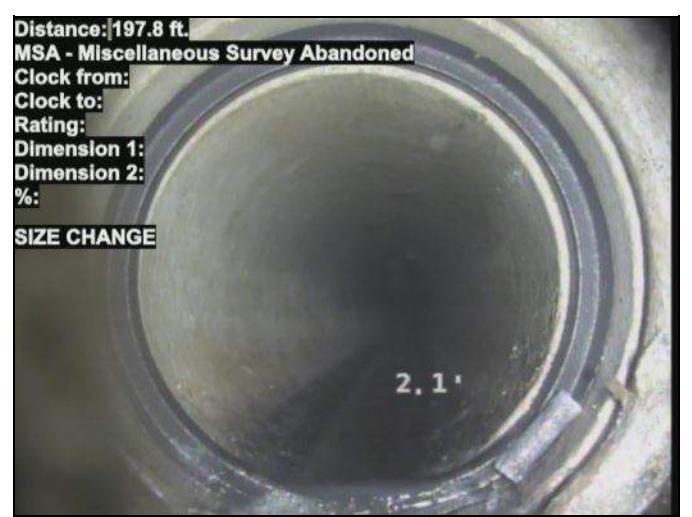
Photo:
 UNKNOWN-58-12032020-MSA-197.8 ft.-083112.JPG

At:
 197.751 ft.
 MSA - Miscellaneous Survey Abandoned

Joint:
 No
 SIZE CHANGE

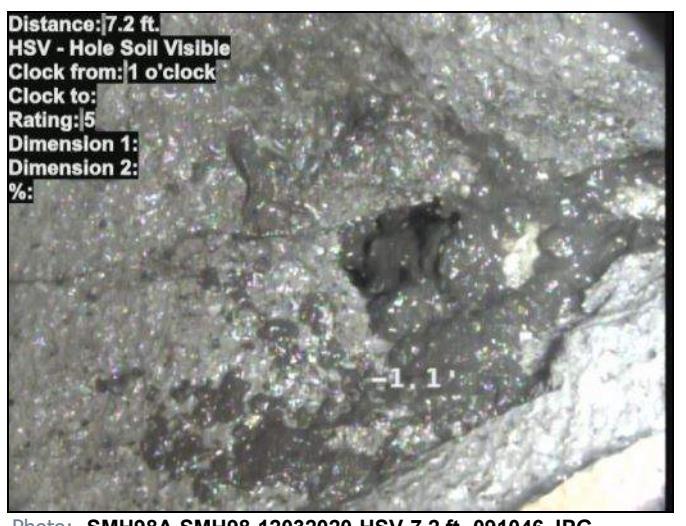
Photo:
 SMH98A-SMH98-12032020-HSV-7.2 ft.-091046.JPG

At:
 7.206 ft. 1/. HSV - Hole Soil Visible

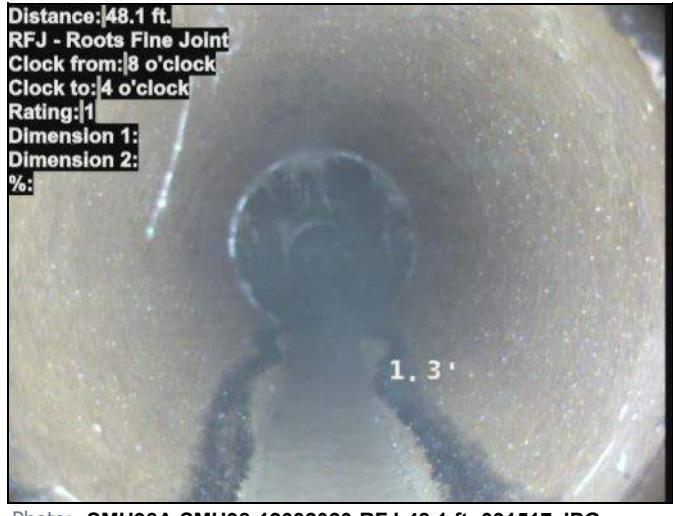
Photo: SMH98A-SMH98-12032020-RFJ-48.1 ft.-091517.JPG At: 48.137 ft. RFJ - Roots Fine Joint 8/4

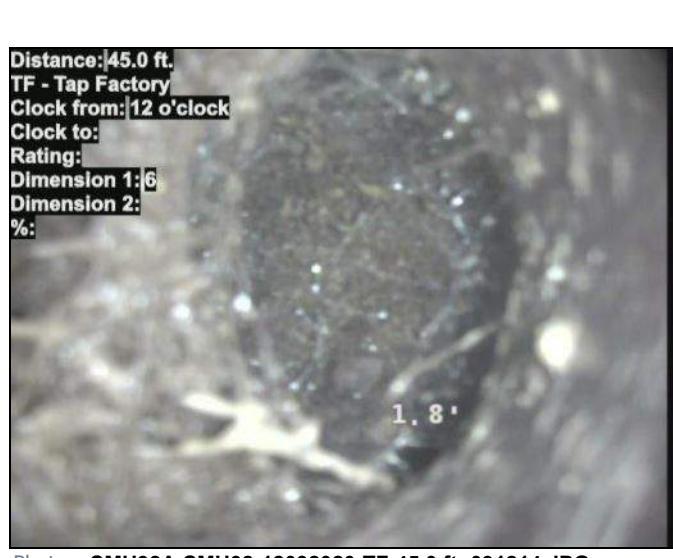
Photo:
 SMH98A-SMH98-12032020-TF-45.0 ft.-091214.JPG

At:
 45.034 ft.
 TF - Tap Factory

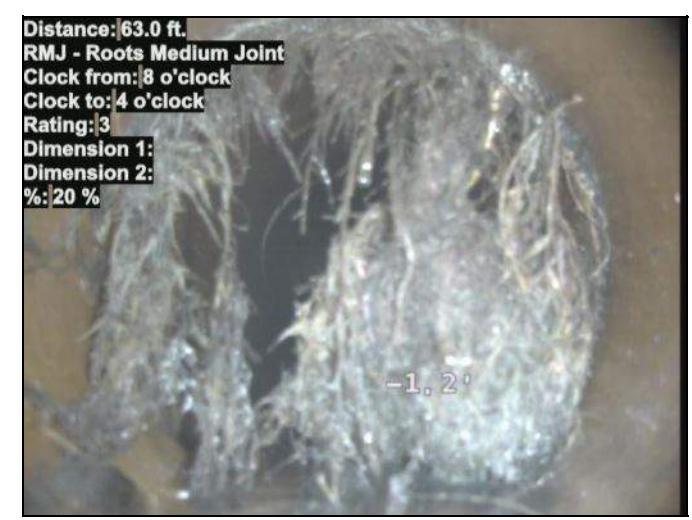
Photo: SMH98A-SMH98-12032020-RMJ-63.0 ft.-091554.JPG At: 63.048 ft. RMJ - Roots Medium Joint 8/4 Joint: Yes 20 %

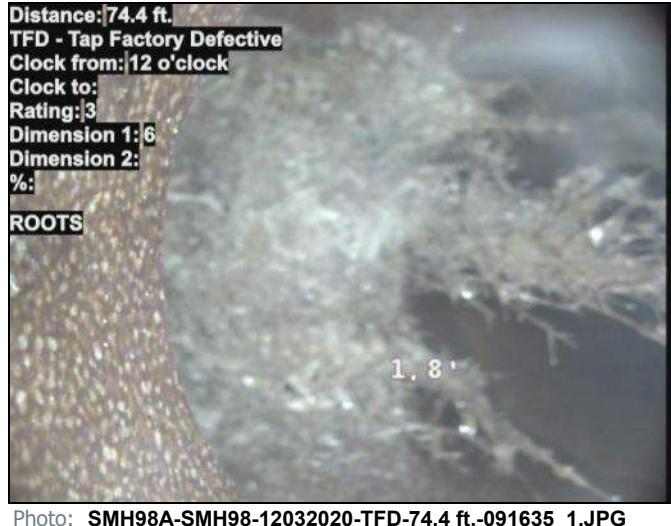
Photo:	SMH98A-SN	/H98-12032020-TFD-74.4 ft091635_1.JP
At:	74.357 ft. 12/.	TFD - Tap Factory Defective
Joint:	No	ROOTS

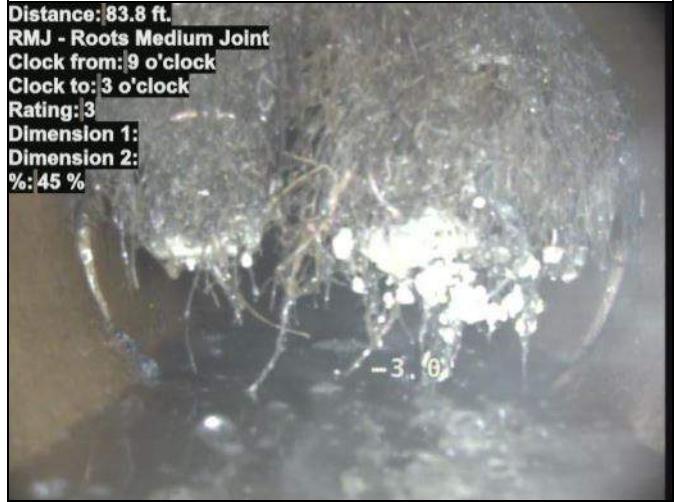
Photo: SMH98A-SMH98-12032020-RMJ-83.8 ft.-091715.JPG At: 83.764 ft. RMJ - Roots Medium Joint 9/3 Joint: Yes 45 %

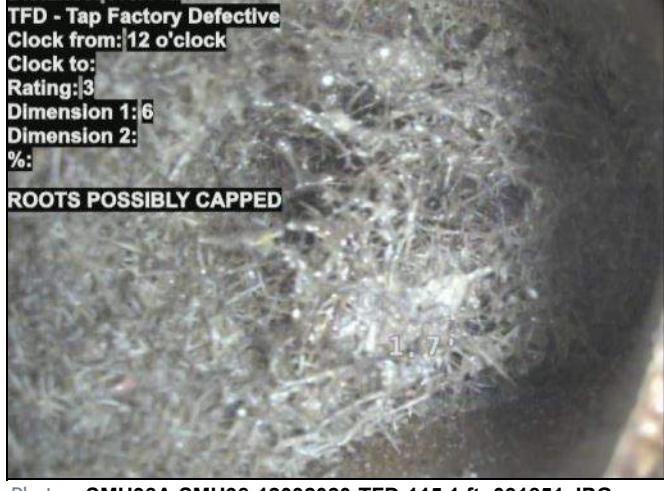
Photo:
 SMH98A-SMH98-12032020-TFD-115.1 ft.-091851.JPG

At:
 115.088 ft.
 TFD - Tap Factory Defective

12/.
 Joint:
 No
 ROOTS POSSIBLY CAPPED

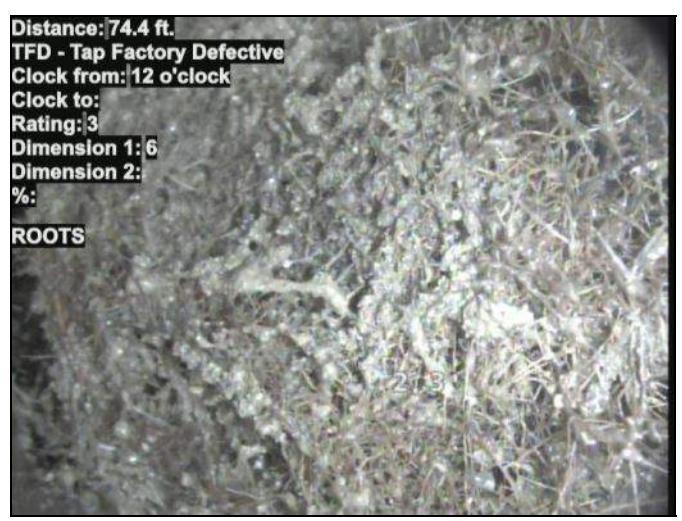
Photo:	SMH98A-S	MH98-12032020-TFD-74.4 ft091635.JPG
At:	74.357 ft. 12/.	TFD - Tap Factory Defective
Joint:	No	ROOTS

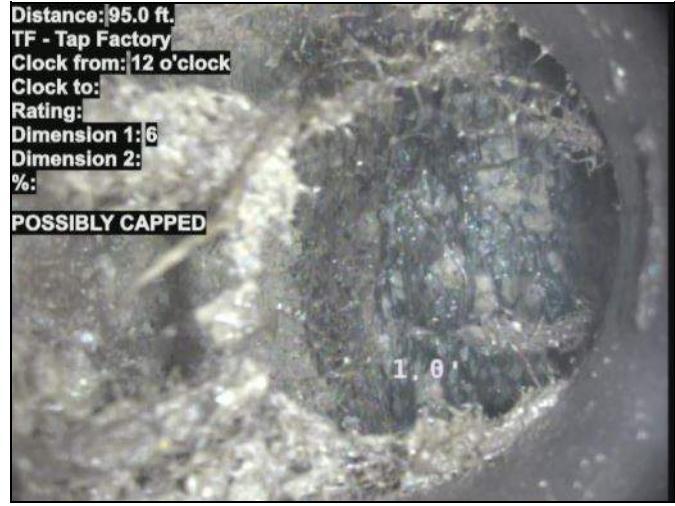
Photo: SMH98A-SMH98-12032020-TF-95.0 ft.-091755.JPG At: 94.973 ft. TF - Tap Factory 12/.

Joint: No POSSIBLY CAPPED

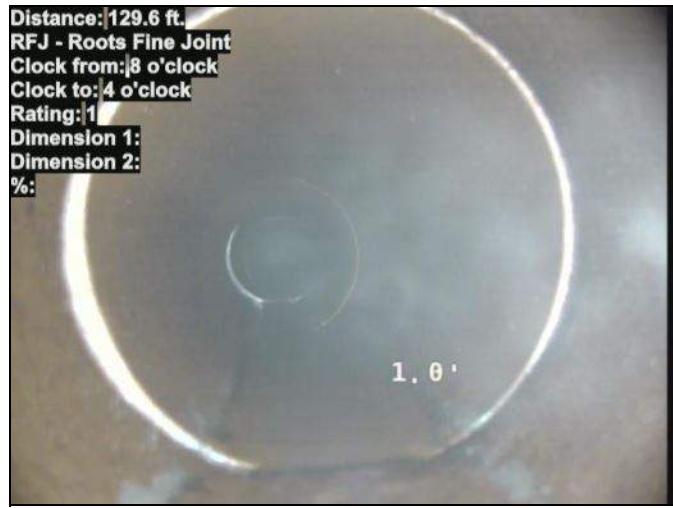
Photo: SMH98A-SMH98-12032020-RFJ-129.6 ft.-091950.JPG At: 129.599 ft. RFJ - Roots Fine Joint 8/4 Joint: Yes

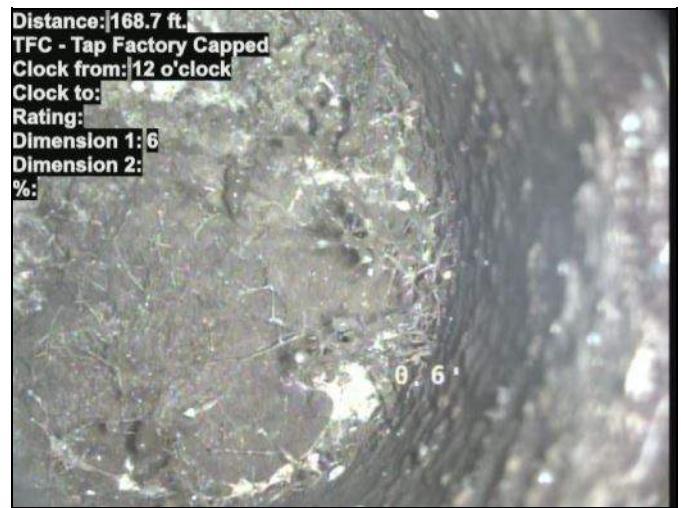
Photo: SMH98A-SMH98-12032020-TFC-168.7 ft.-092136.JPG At: 168.729 ft. TFC - Tap Factory Capped 12/.

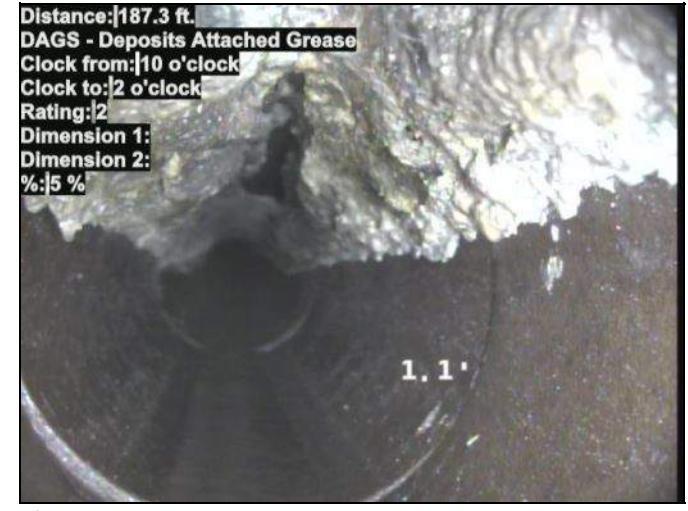
Photo: SMH98A-SMH98-12032020-DAGS-187.3 ft.-092313.JPG At: 187.343 ft. DAGS - Deposits Attached Grease 10/2

Joint: No 5%

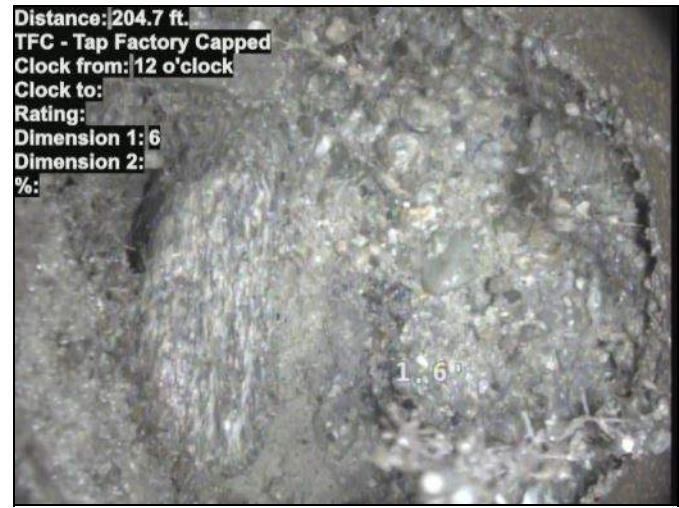
Photo:
 SMH98A-SMH98-12032020-TFC-204.7 ft.-092402.JPG

At:
 204.657 ft.
 TFC - Tap Factory Capped

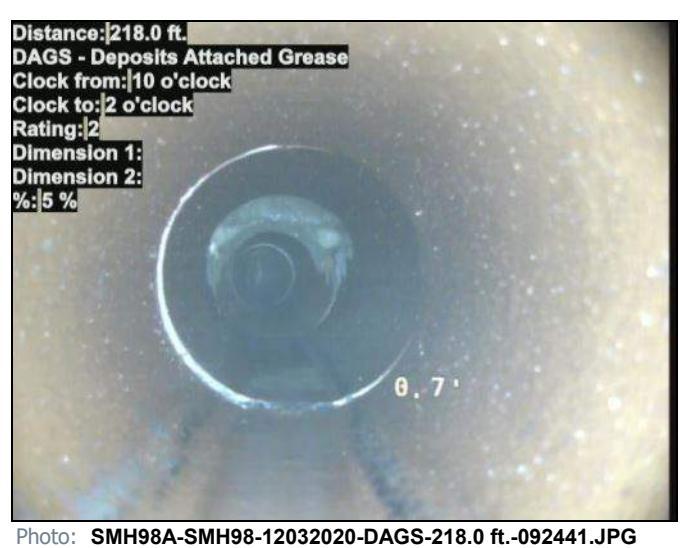
At: 217.967 ft. DAGS - Deposits Attached Grease 10/2 Joint: No 5 %

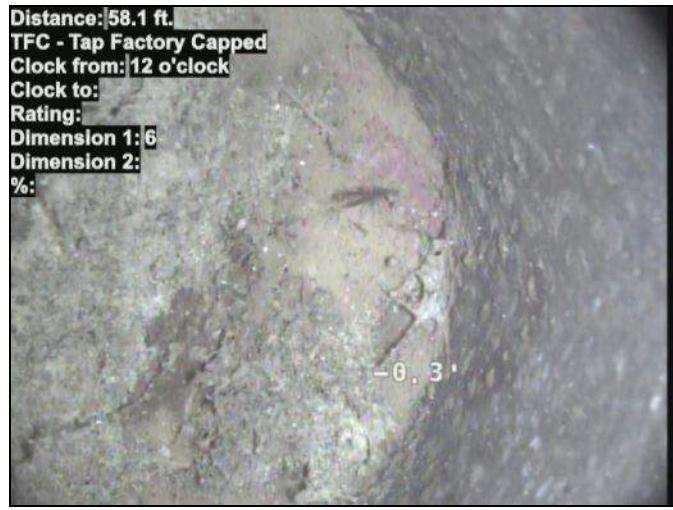
Photo:
 SMH98B-SMH98A-12032020-TFC-58.1 ft.-094041.JPG

At:
 58.145 ft.
 TFC - Tap Factory Capped 12/.

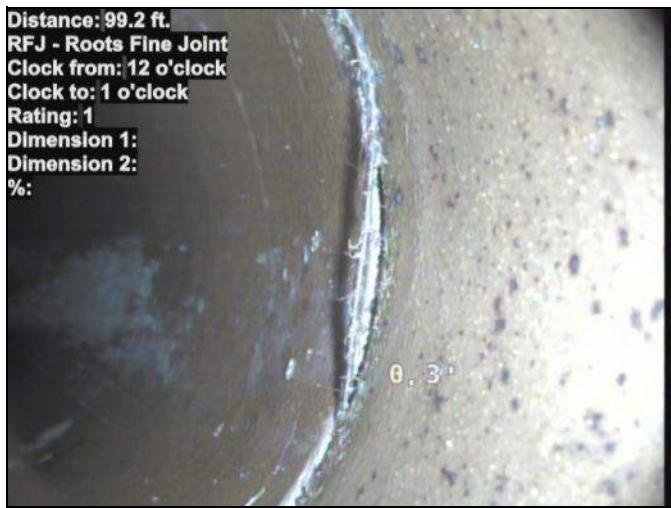
Photo: SMH98B-SMH98A-12032020-RFJ-99.2 ft.-094303.JPG At: 99.176 ft. RFJ - Roots Fine Joint 12/1

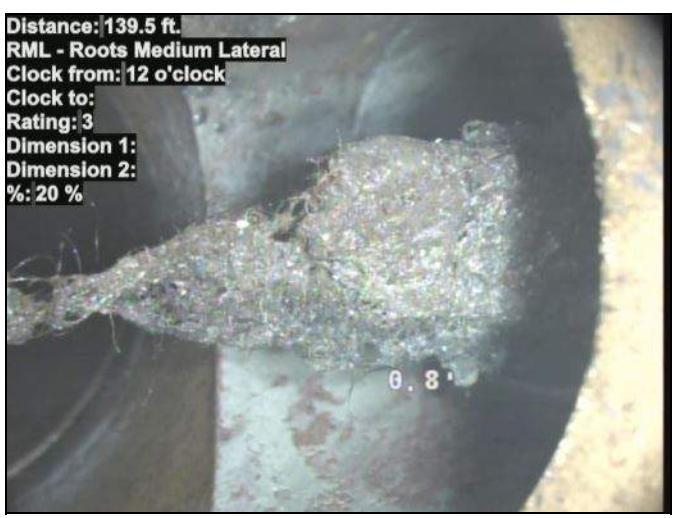
Photo: SMH98B-SMH98A-12032020-RML-139.5 ft.-095115.JPG At: 139.507 ft. RML - Roots Medium Lateral 12/. Joint: No 20 %

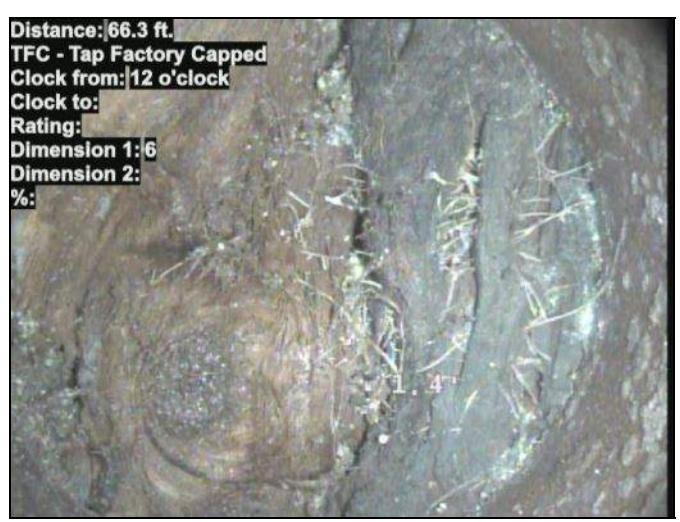
Photo: SMH98B-SMH98A-12032020-TFC-66.3 ft.-094119.JPG At: 66.251 ft. TFC - Tap Factory Capped 12/. Joint: No

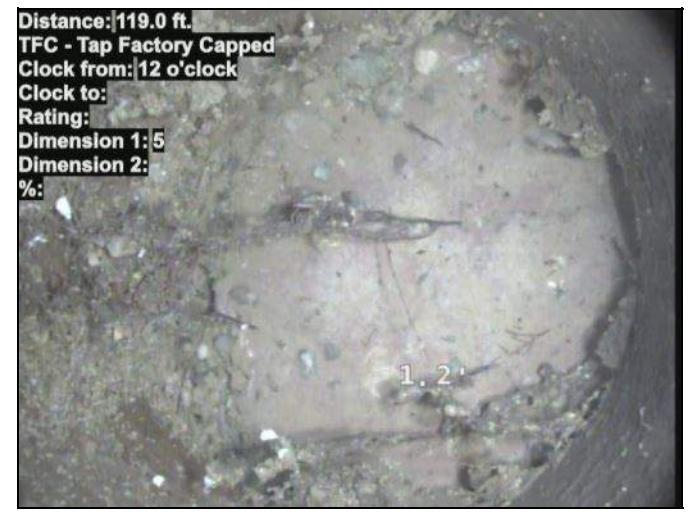
Photo: SMH98B-SMH98A-12032020-TFC-119.0 ft.-094533.JPG At: 118.991 ft. TFC - Tap Factory Capped 12/.

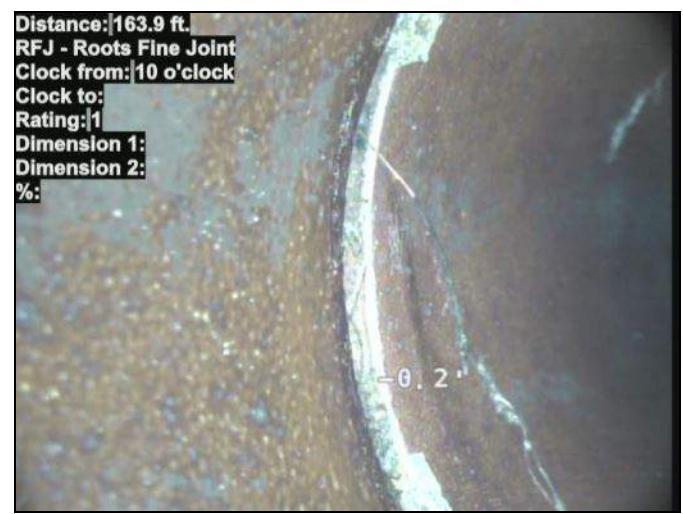
Photo: SMH98B-SMH98A-12032020-RFJ-163.9 ft.-095752.JPG At: 163.926 ft. RFJ - Roots Fine Joint 10/. Joint: Yes

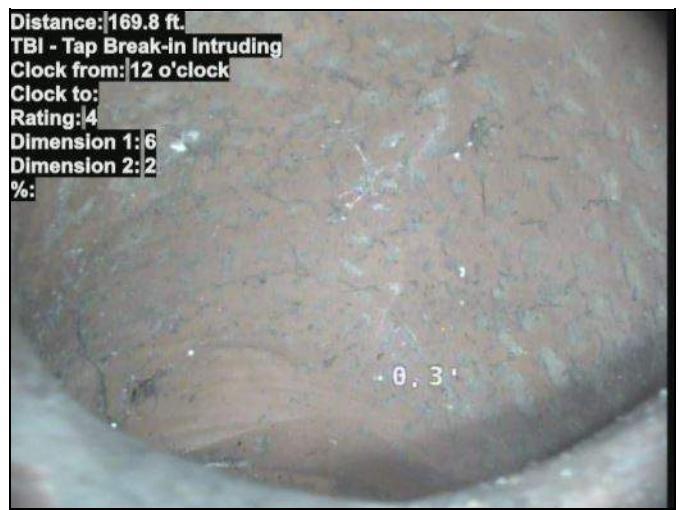
Photo: SMH98B-SMH98A-12032020-TBI-169.8 ft.-095816.JPG At: 169.83 ft. TBI - Tap Break-in Intruding 12/.

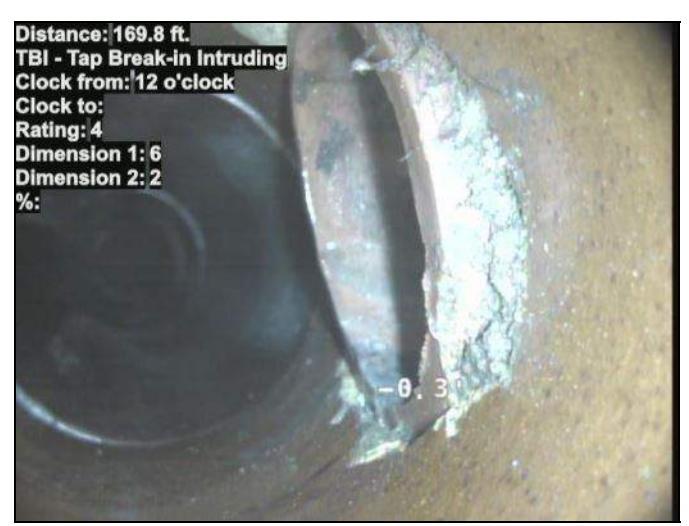
Photo: SMH98B-SMH98A-12032020-TBI-169.8 ft.-095816_1.JPG At: 169.83 ft. TBI - Tap Break-in Intruding 12/. Joint: No

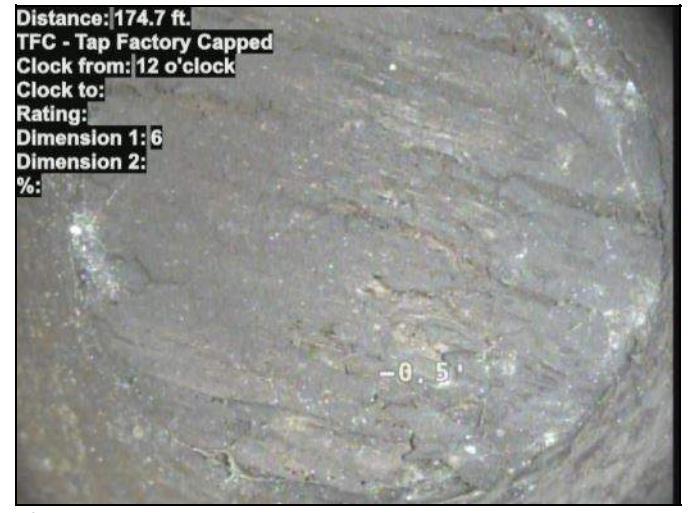
Photo: SMH98B-SMH98A-12032020-TFC-174.7 ft.-095851.JPG At: 174.734 ft. TFC - Tap Factory Capped 12/.

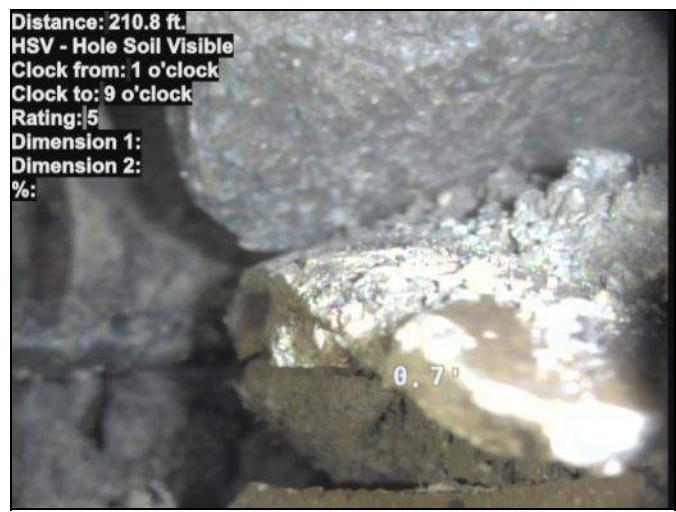
Photo:
 SMH98B-SMH98A-12032020-HSV-210.8 ft.-100124_1.JPG

At:
 210.761 ft.
 HSV - Hole Soil Visible

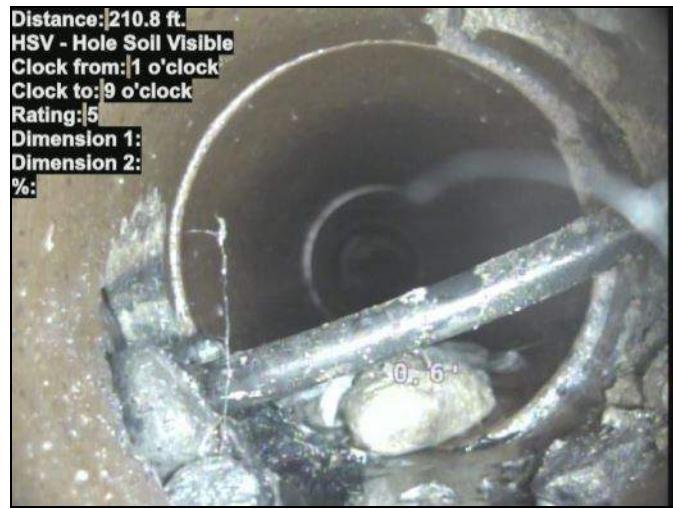
Photo:
 SMH98B-SMH98A-12032020-HSV-210.8 ft.-100124.JPG

At:
 210.761 ft.
 HSV - Hole Soil Visible

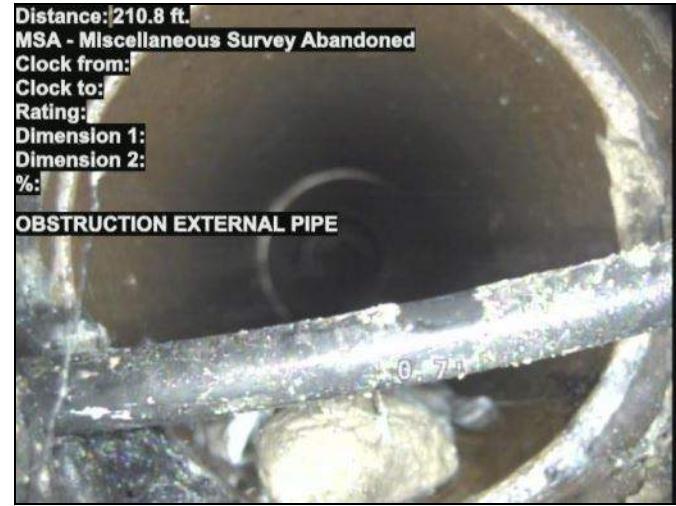
Photo:SMH98B-SMH98A-12032020-MSA-210.8 ft.-100213.JPGAt:210.761 ft.MSA - Miscellaneous Survey AbandonedJoint:NoOBSTRUCTION EXTERNAL PIPE

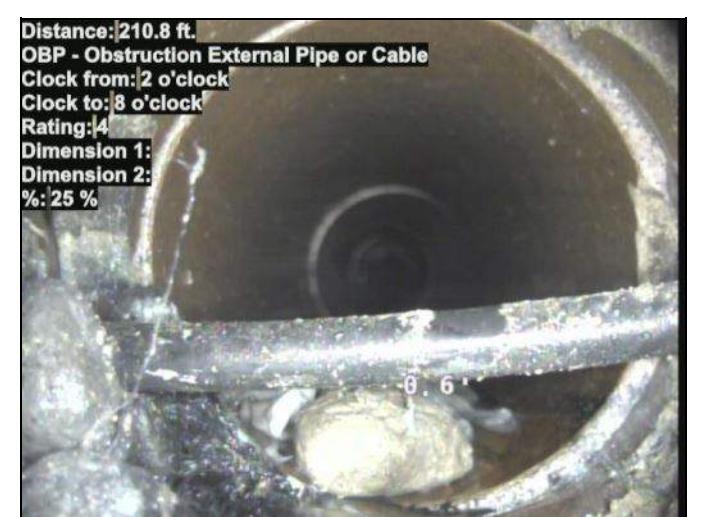
Photo: SMH98B-SMH98A-12032020-OBP-210.8 ft.-100038.JPG At: 210.761 ft. OBP - Obstruction External Pipe or Cable 2/8

Joint: No 25 %

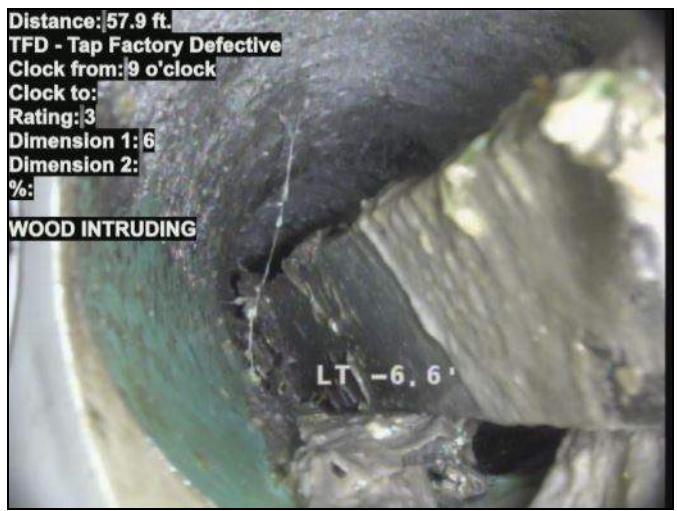
Photo:
 SMH79-SMH80-12032020-TFD-57.9 ft.-105256.JPG

At:
 57.944 ft. 9/. TFD - Tap Factory Defective

Joint:
 No
 WOOD INTRUDING

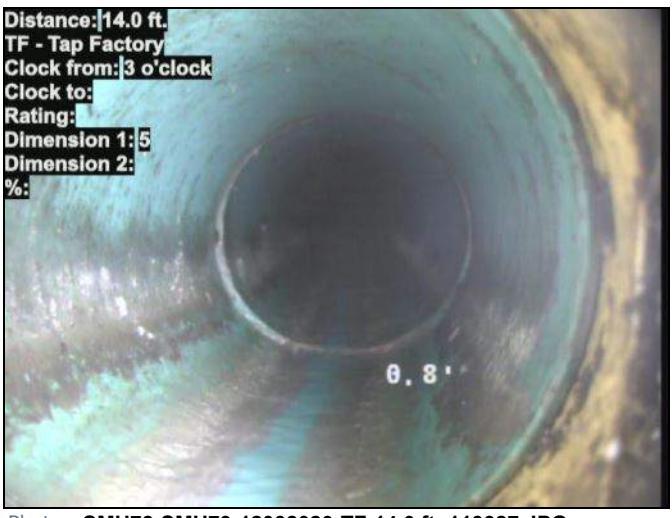
Photo: SMH78-SMH79-12032020-TF-14.0 ft.-113327.JPG At: 14.011 ft. 3/. TF - Tap Factory Joint: No

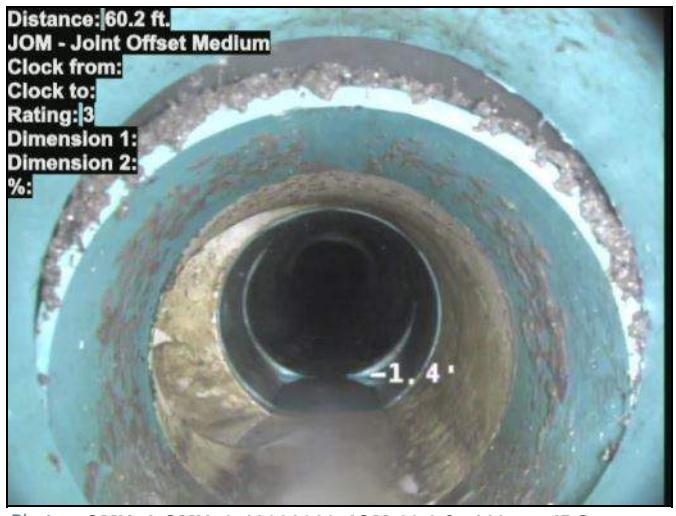
Photo: SMH78-SMH79-12032020-JOM-60.2 ft.-113755.JPG At: 60.246 ft. JOM - Joint Offset Medium Joint: No

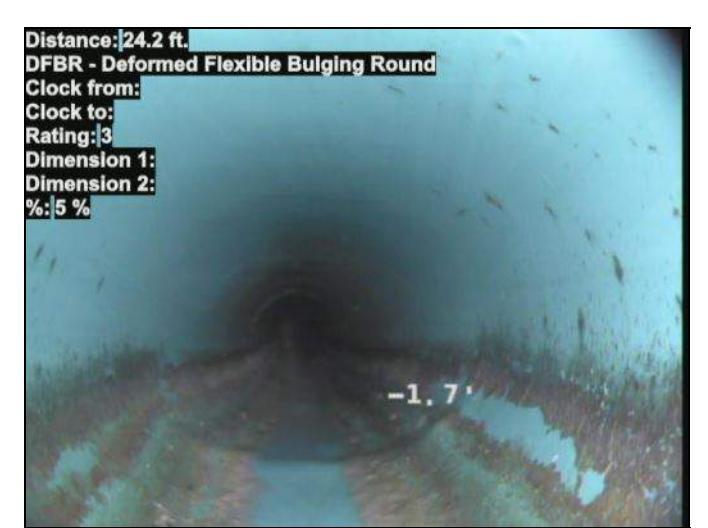
Photo: SMH78-SMH79-12032020-DFBR-24.2 ft.-113414.JPG At: 24.219 ft. **DFBR - Deformed Flexible Bulging Round** Joint: No 5%

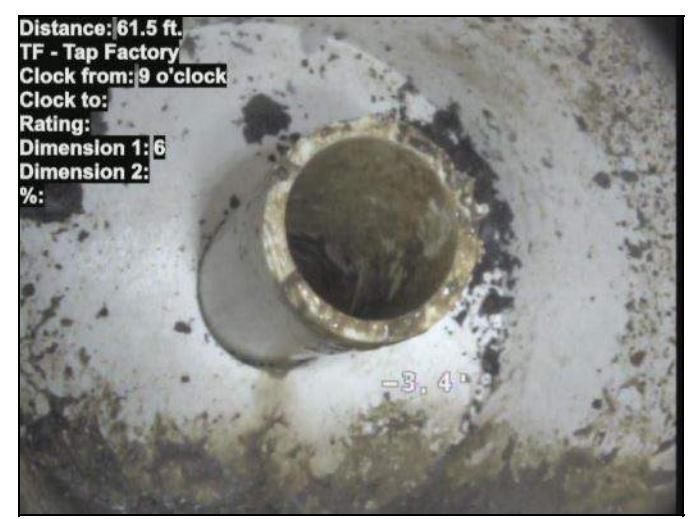
Photo: SMH78-SMH79-12032020-TF-61.5 ft.-113729.JPG At: 61.547 ft. 9/. TF - Tap Factory Joint: No

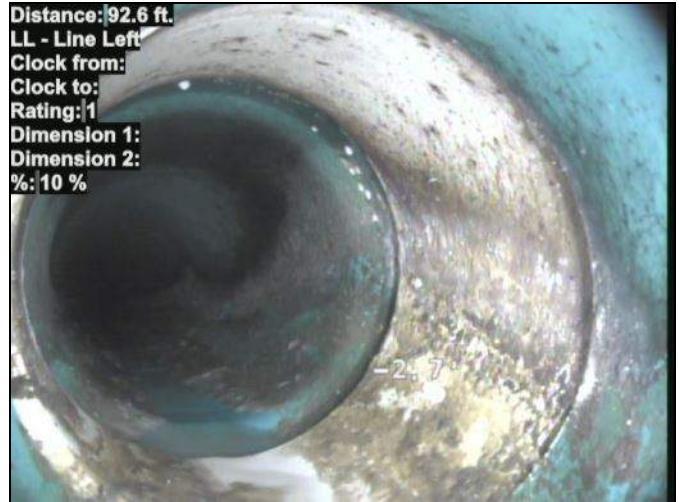
Photo:
 SMH78-SMH79-12032020-LL-92.6 ft.-114005.JPG

At:
 92.571 ft.
 LL - Line Left

Joint:
 No
 10 %
