Jericho-Brandon Study Area Town of Dudley, Massachusetts

Jericho-Brandon Infrastructure Planning Project

Prepared For: Town of Dudley 71 West Main Street Dudley, Massachusetts

June 2021

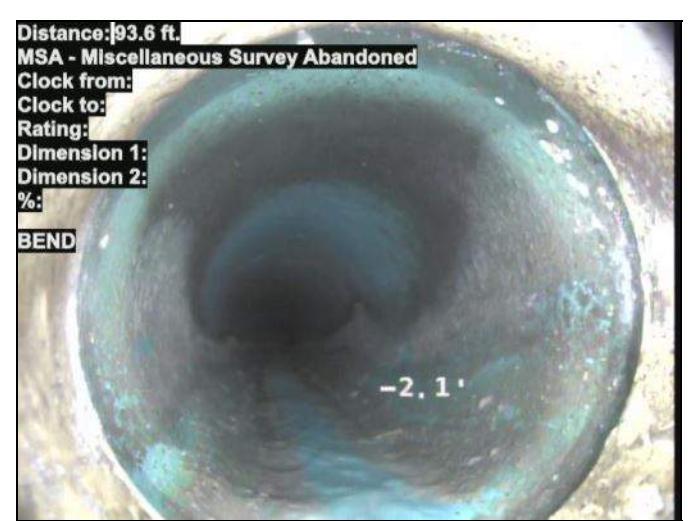
Photo:
 SMH78-SMH79-12032020-MSA-93.6 ft.-114029.JPG

At:
 93.572 ft.
 MSA - Miscellaneous Survey Abandoned

Joint:
 No
 BEND

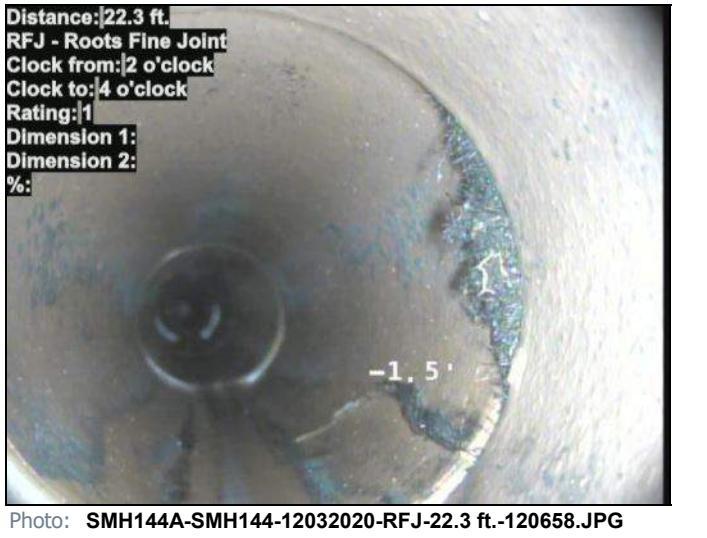
Photo: SMH144A-SMH144-12032020-RFJ-22.3 ft.-120658.JPC At: 22.317 ft. RFJ - Roots Fine Joint 2/4

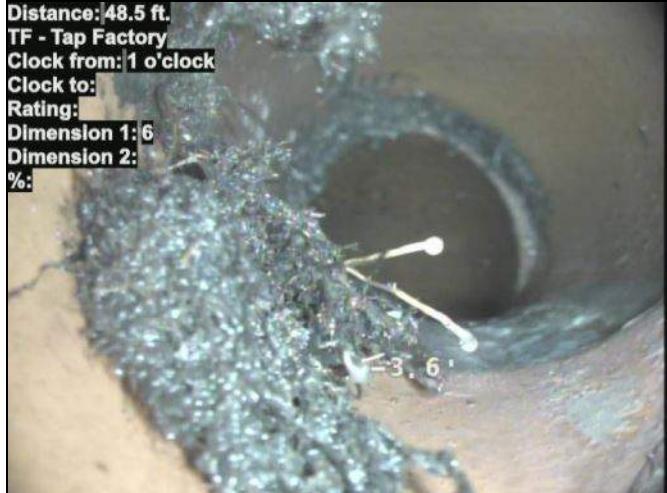
Photo:
 SMH144A-SMH144-12032020-TF-48.5 ft.-121239.JPG

At:
 48.537 ft. 1/. TF - Tap Factory

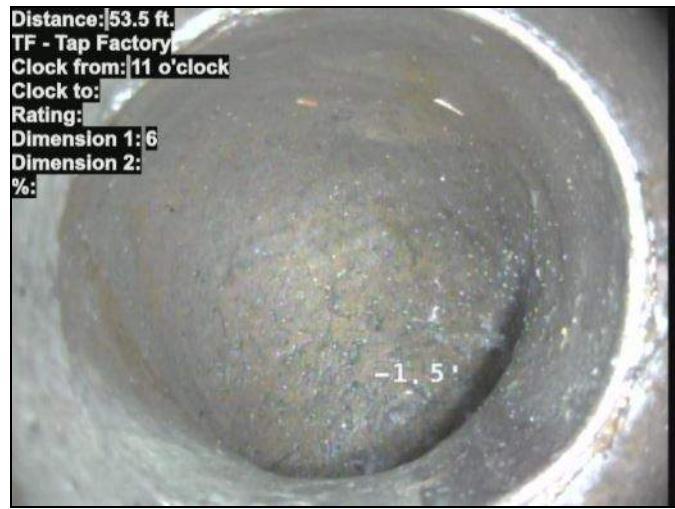
Photo: SMH144A-SMH144-12032020-TF-53.5 ft.-121302.JPG At: 53.541 ft. TF - Tap Factory 11/. Joint: No

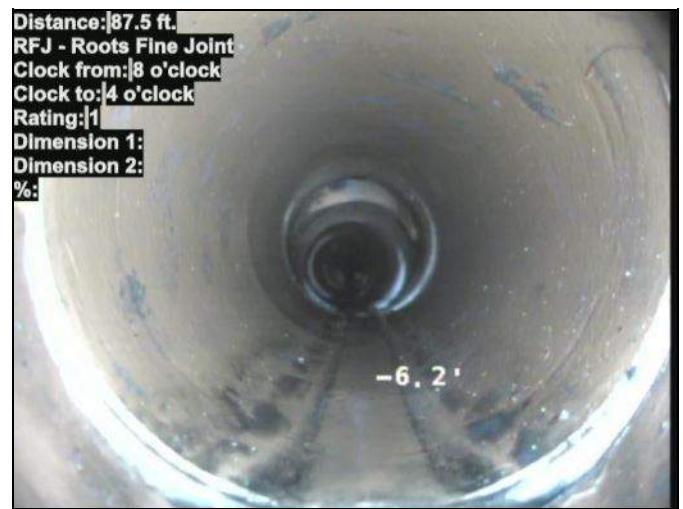
Photo: SMH144A-SMH144-12032020-RFJ-87.5 ft.-121555.JPG At: 87.467 ft. RFJ - Roots Fine Joint 8/4

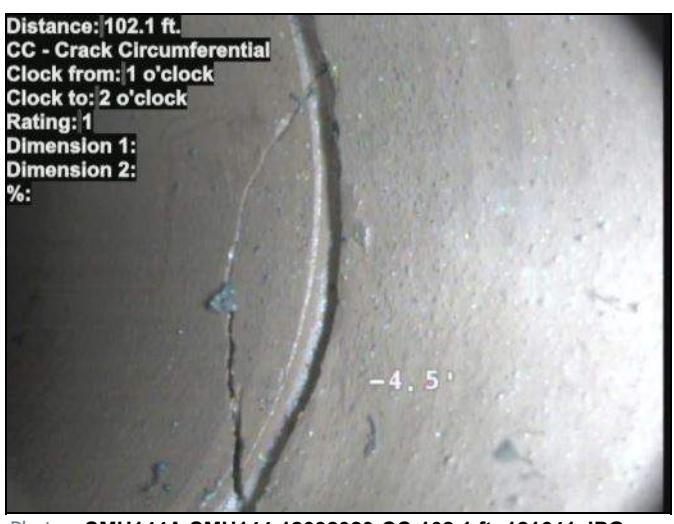
Photo:
 SMH144A-SMH144-12032020-CC-102.1 ft.-121641.JPG

At:
 102.078 ft.
 CC - Crack Circumferential

1/2
 Joint:
 Yes

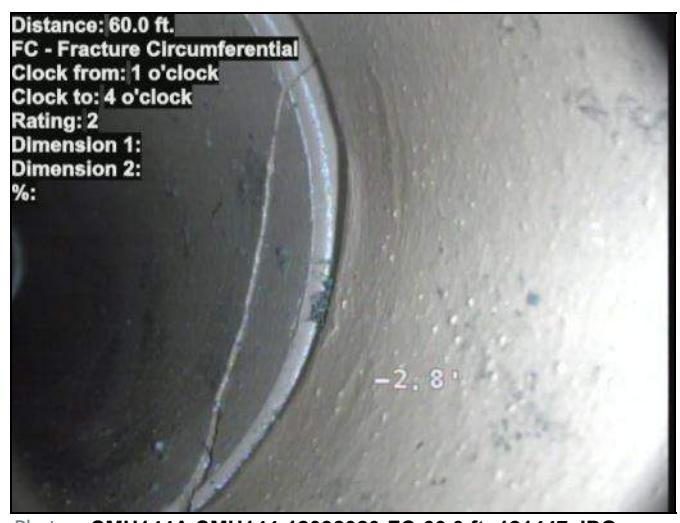
Photo:
 SMH144A-SMH144-12032020-FC-60.0 ft.-121447.JPG

At:
 60.046 ft.
 FC - Fracture Circumferential

1/4
 Joint:
 Yes

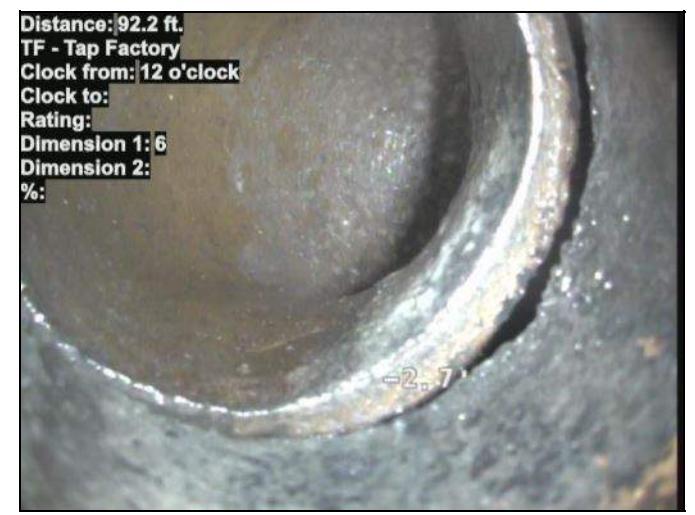
Photo: SMH144A-SMH144-12032020-TF-92.2 ft.-121607.JPG At: 92.171 ft. TF - Tap Factory 12/.

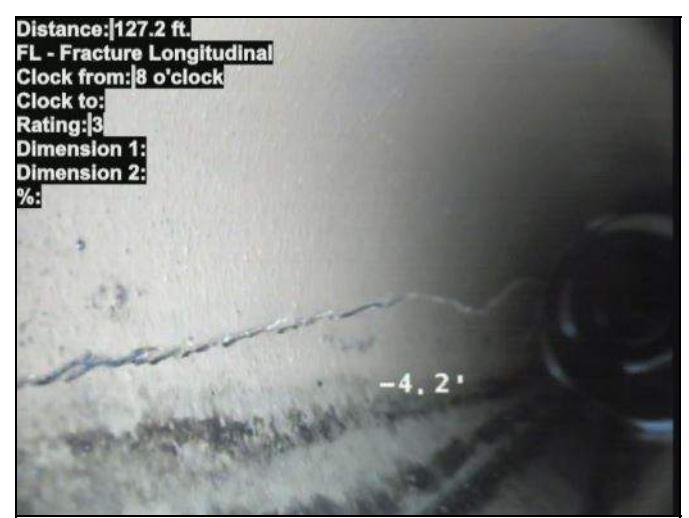
Photo: SMH144A-SMH144-12032020-FL-127.2 ft.-121734.JPG At: 127.197 ft. FL - Fracture Longitudinal 8/. Joint: No

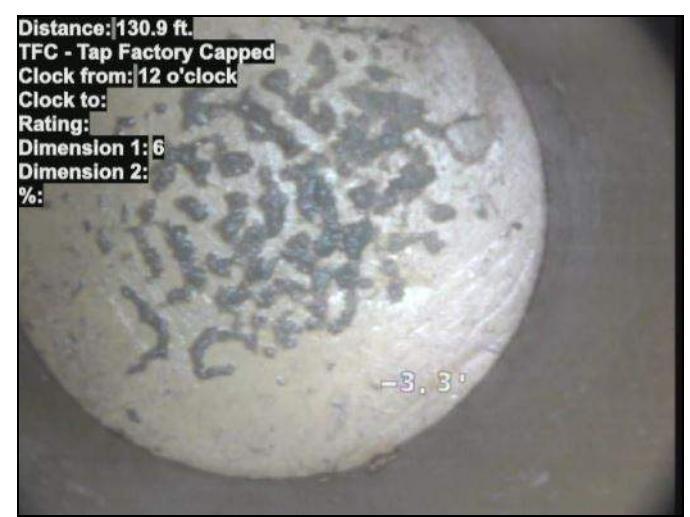
Photo:
 SMH144A-SMH144-12032020-TFC-130.9 ft.-121754.JPG

At:
 130.9 ft. 12/. TFC - Tap Factory Capped

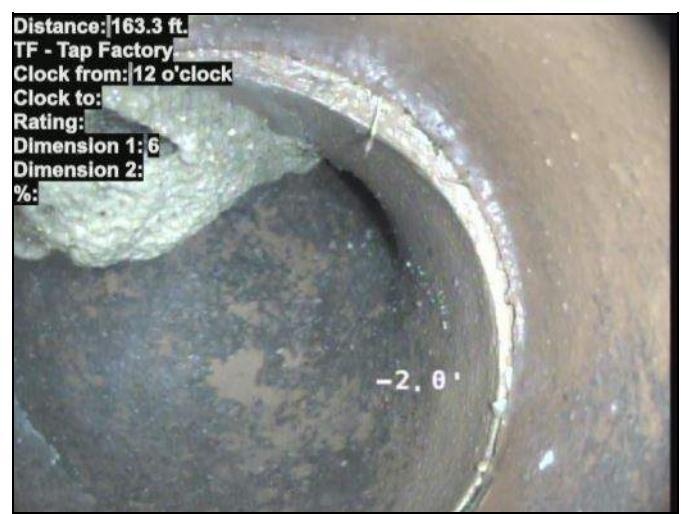
Photo: SMH144A-SMH144-12032020-TF-163.3 ft.-121935.JPG At: 163.325 ft. TF - Tap Factory 12/.

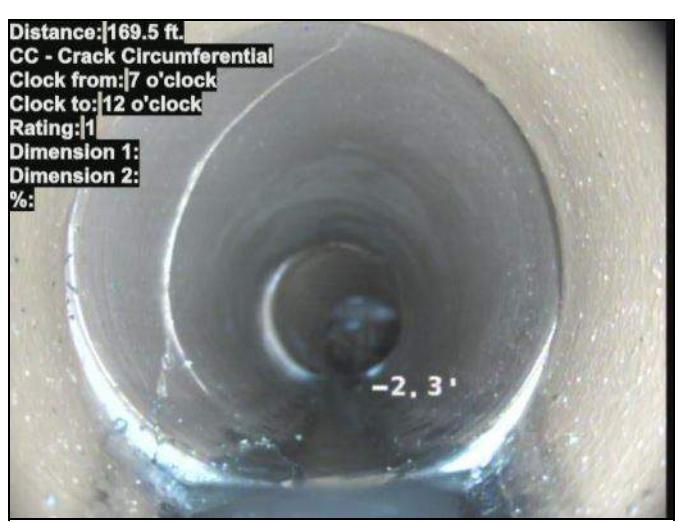
Photo:
 SMH144A-SMH144-12032020-CC-169.5 ft.-122014.JPG

At:
 169.53 ft.
 CC - Crack Circumferential

7/12
 Joint:
 No

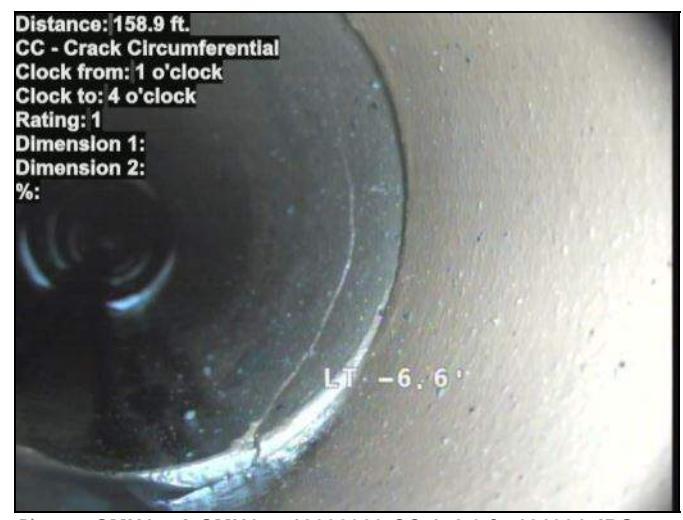
Photo:
 SMH144A-SMH144-12032020-CC-158.9 ft.-121901.JPG

At:
 158.922 ft.
 CC - Crack Circumferential

1/4
 Joint:
 Yes

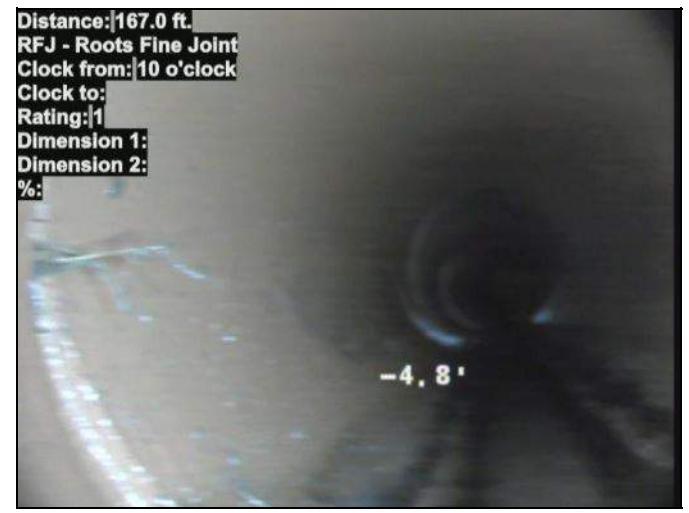
Photo: SMH144A-SMH144-12032020-RFJ-167.0 ft.-121957.JPG At: 167.028 ft. RFJ - Roots Fine Joint 10/.

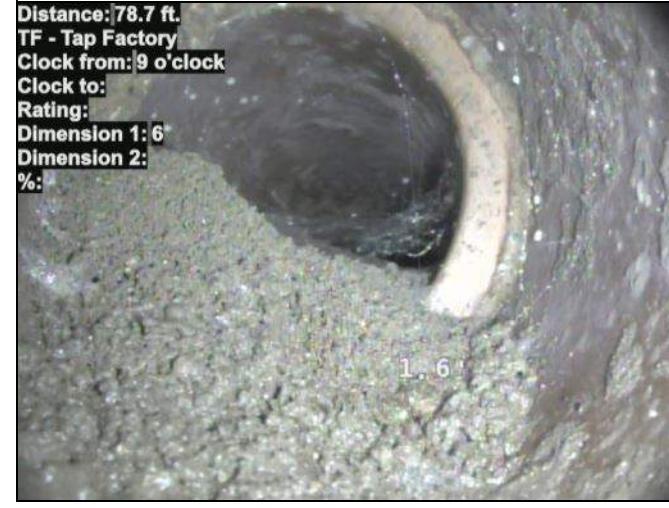
Photo: SMH235-SMH241-12032020-TF-78.7 ft.-125841.JPG 78.66 ft. 9/. TF - Tap Factory At: Joint: No

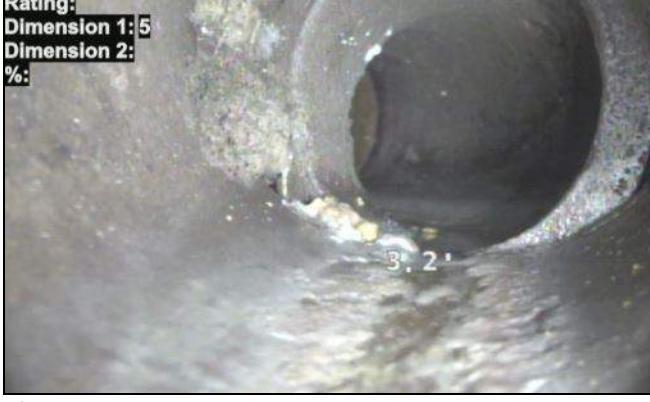
Photo: SMH235-SMH241-12032020-TF-61.8 ft.-125751.JPG 61.847 ft. 3/. TF - Tap Factory At: Joint: No

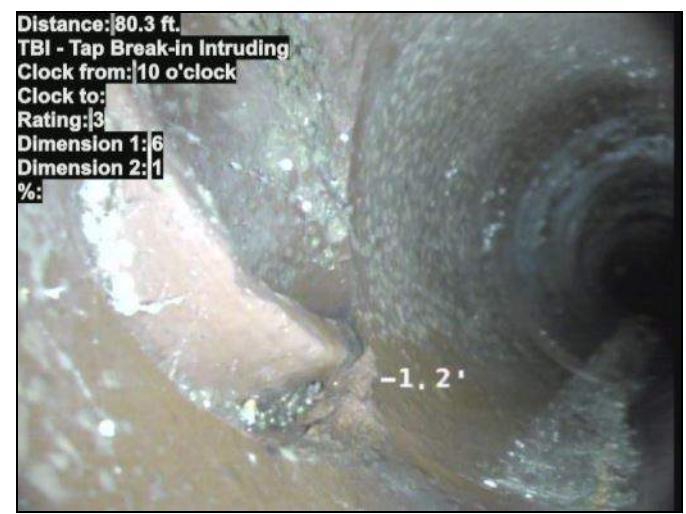
Photo:
 SMH235-SMH241-12032020-TBI-80.3 ft.-125903_1.JPG

At:
 80.261 ft.
 TBI - Tap Break-in Intruding 10/.

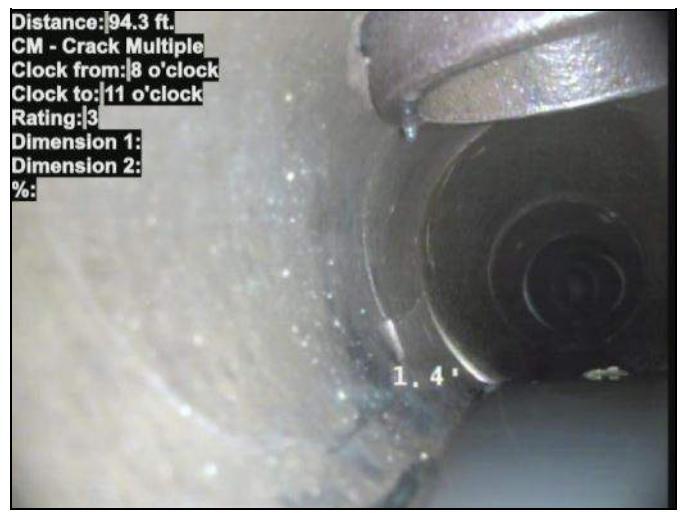
Photo: SMH235-SMH241-12032020-CM-94.3 ft.-125956.JPG At: 94.272 ft. CM - Crack Multiple 8/11

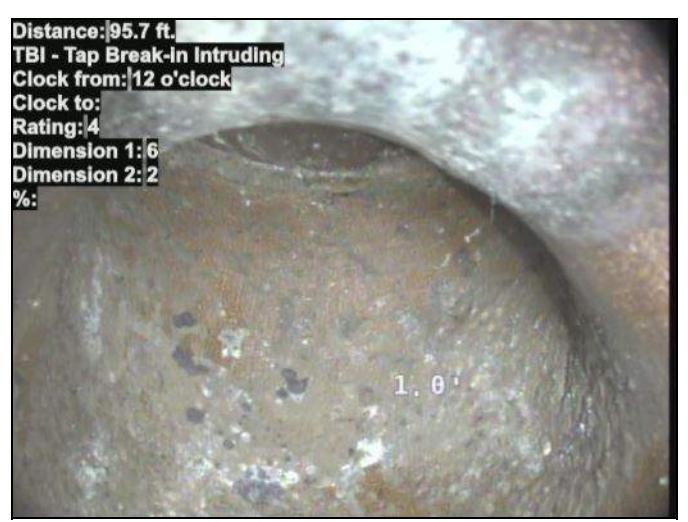
Photo:
 SMH235-SMH241-12032020-TBI-95.7 ft.-130017.JPG

At:
 95.673 ft.
 TBI - Tap Break-in Intruding

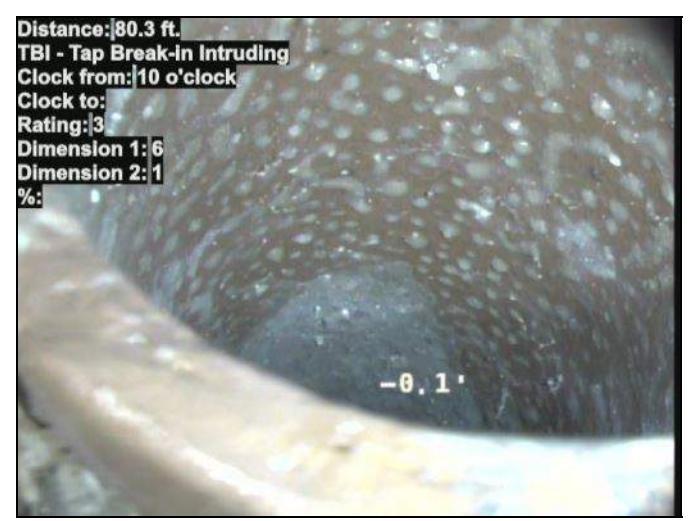
Photo: SMH235-SMH241-12032020-TBI-80.3 ft.-125903.JPG At: 80.261 ft. TBI - Tap Break-in Intruding 10/. Joint: No

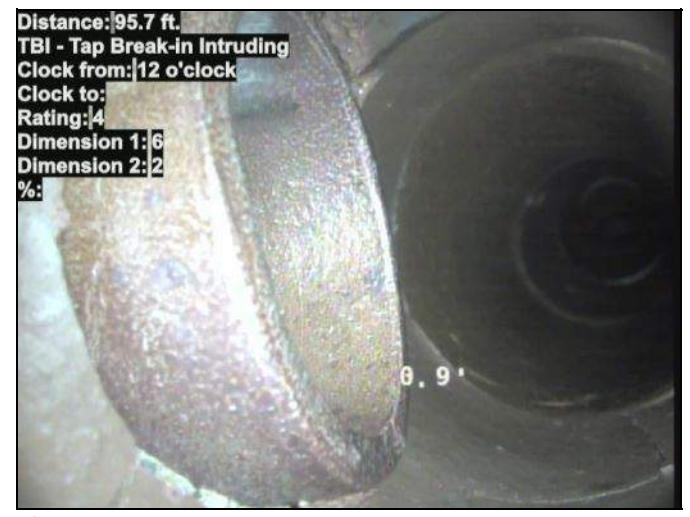
Photo: SMH235-SMH241-12032020-TBI-95.7 ft.-130017_1.JPG At: 95.673 ft. TBI - Tap Break-in Intruding 12/.

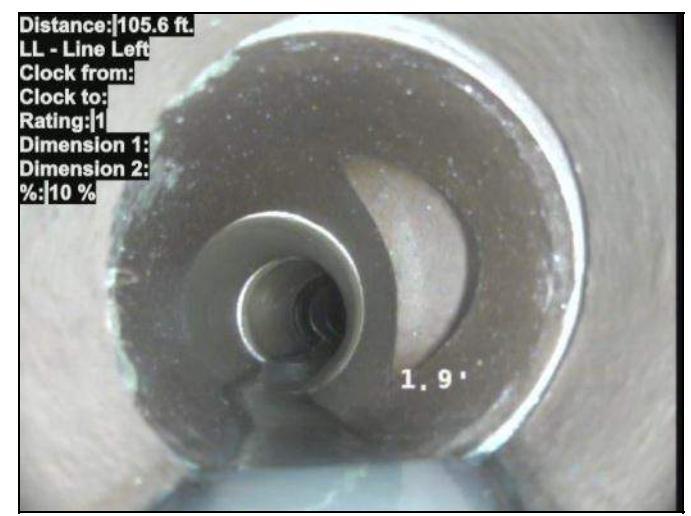
Photo:
 SMH235-SMH241-12032020-LL-105.6 ft.-130102.JPG

At:
 105.581 ft.
 LL - Line Left

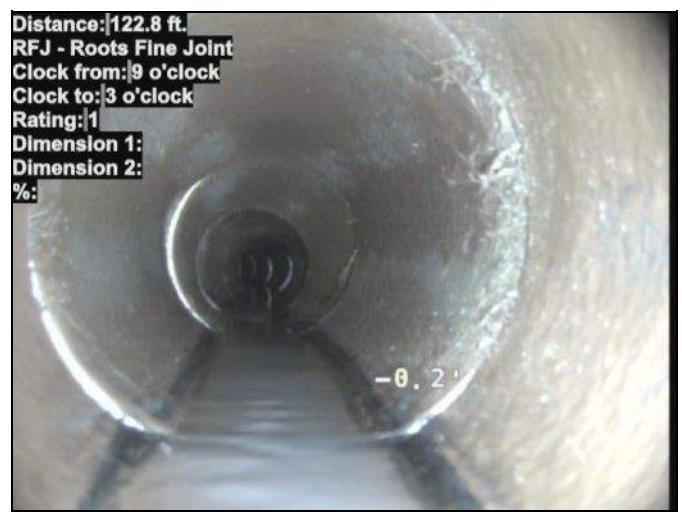
Photo: SMH235-SMH241-12032020-RFJ-122.8 ft.-130239.JPG At: 122.794 ft. RFJ - Roots Fine Joint 9/3

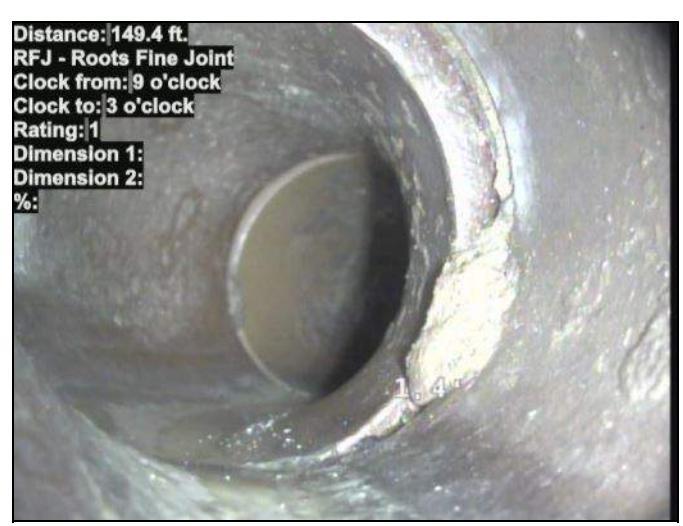
Photo: SMH235-SMH241-12032020-RFJ-149.4 ft.-130417.JPG At: 149.414 ft. RFJ - Roots Fine Joint 9/3 Joint: Yes

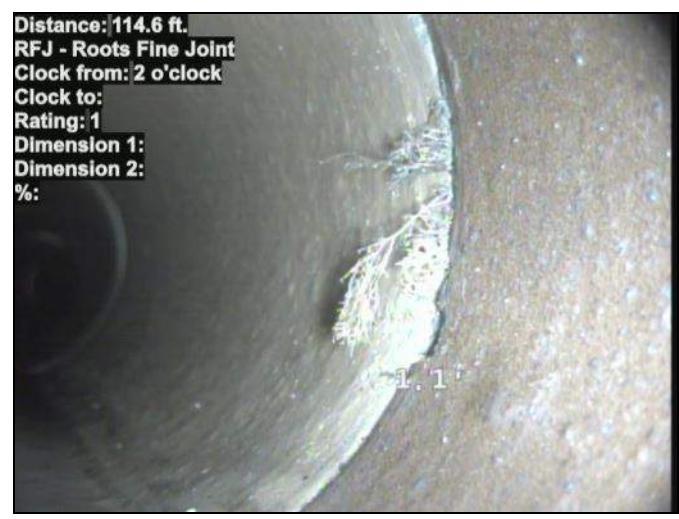
Photo: SMH235-SMH241-12032020-RFJ-114.6 ft.-130205.JPG At: 114.588 ft. RFJ - Roots Fine Joint 2/. Joint: Yes

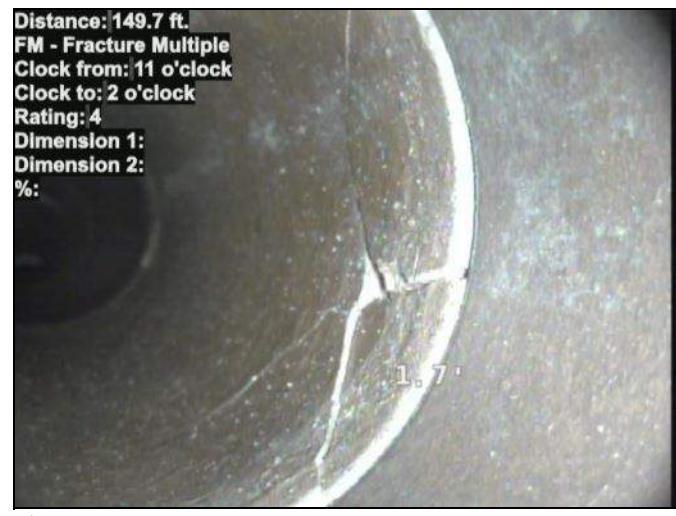
Photo: SMH235-SMH241-12032020-FM-149.7 ft.-130659.JPG At: 149.715 ft. FM - Fracture Multiple 11/2 Joint: No

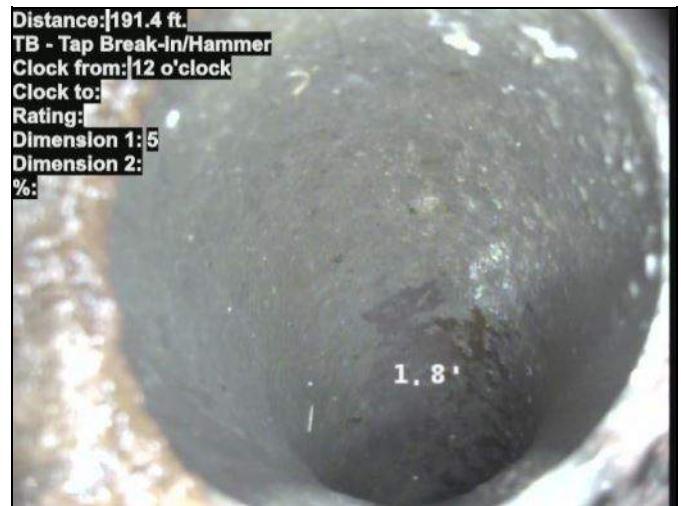
Photo: SMH235-SMH241-12032020-TB-191.4 ft.-130901.JPG At: 191.447 ft. TB - Tap Break-in/Hammer 12/.

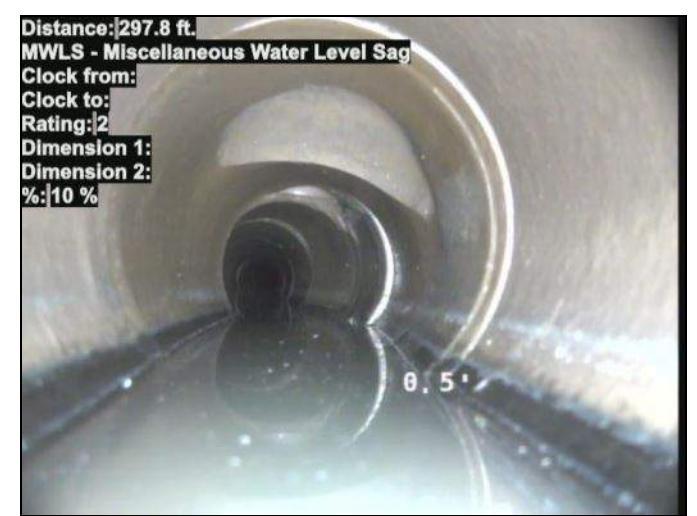
Photo:
 SMH235-SMH241-12032020-MWLS-297.8 ft.-131348.JPG

At:
 297.828 ft.
 MWLS - Miscellaneous Water Level Sag

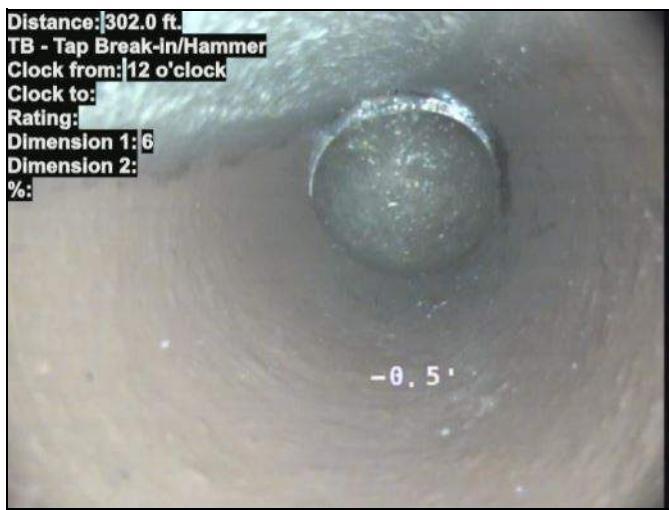
Photo: SMH235-SMH241-12032020-TB-302.0 ft.-131436.JPG At: 302.031 ft. TB - Tap Break-in/Hammer 12/.

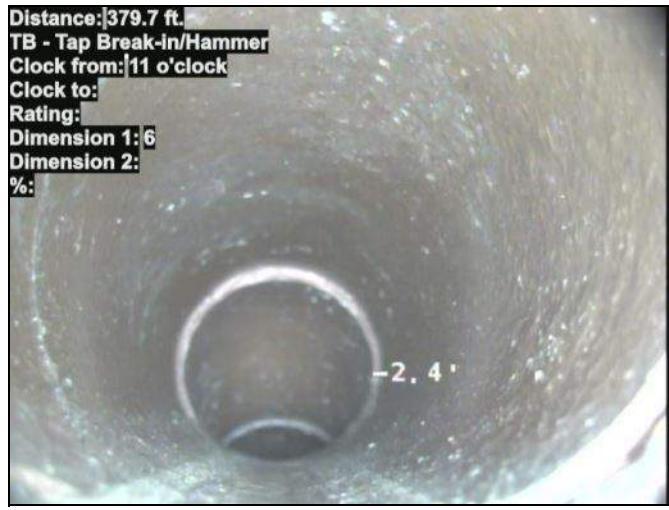
Photo: SMH235-SMH241-12032020-TB-379.7 ft.-131827.JPG At: 379.691 ft. TB - Tap Break-in/Hammer 11/. Joint: No

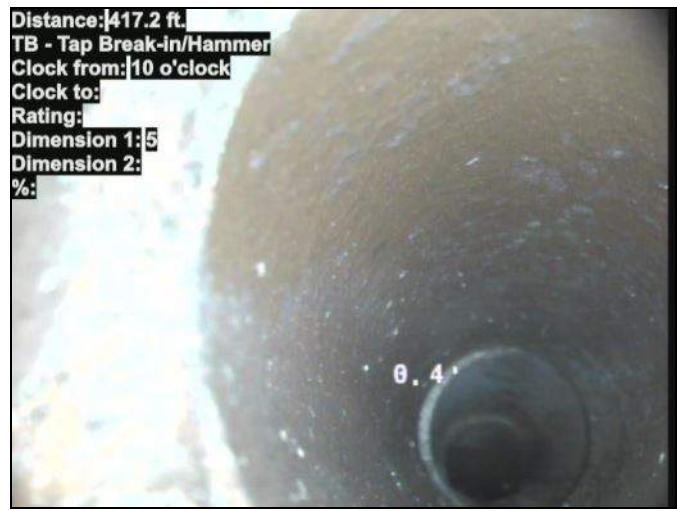
Photo: SMH235-SMH241-12032020-TB-417.2 ft.-131950.JPG At: 417.219 ft. TB - Tap Break-in/Hammer 10/. Joint: No

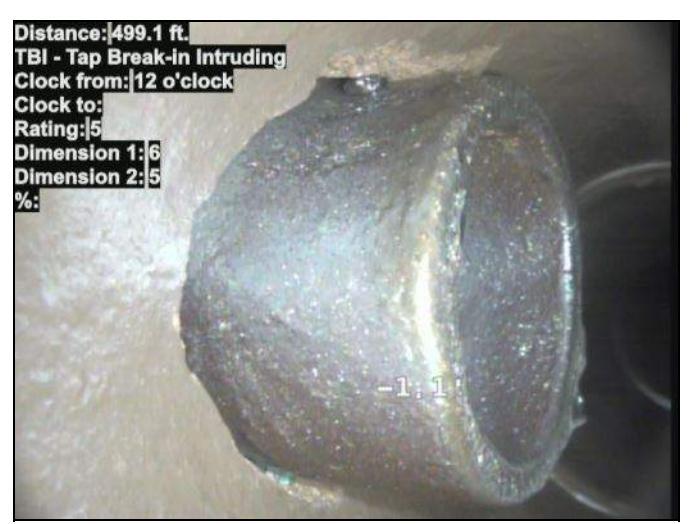
Photo: SMH235-SMH241-12032020-TBI-499.1 ft.-132336_1.JPG 499.082 ft. TBI - Tap Break-in Intruding At: 12/. Joint: No

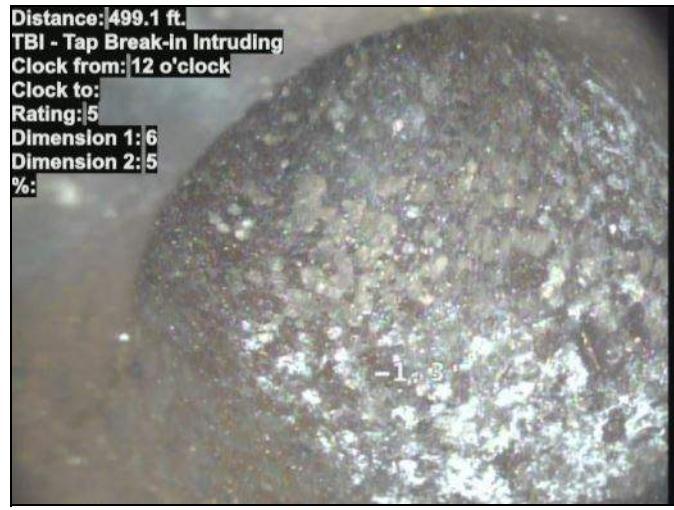
SMH235-SMH241-12032020-TBI-499.1 ft.-132336.JPG Photo: 499.082 ft. TBI - Tap Break-in Intruding At: 12/. No

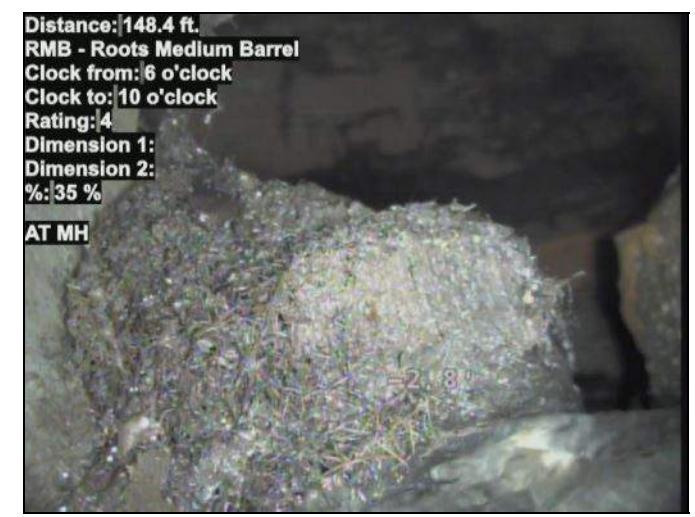
Photo: SMH-176-SMH-175-12042020-RMB-148.4 ft.-124840.JPG At: 148.414 ft. RMB - Roots Medium Barrel 6/10 Joint: No 35 % AT MH

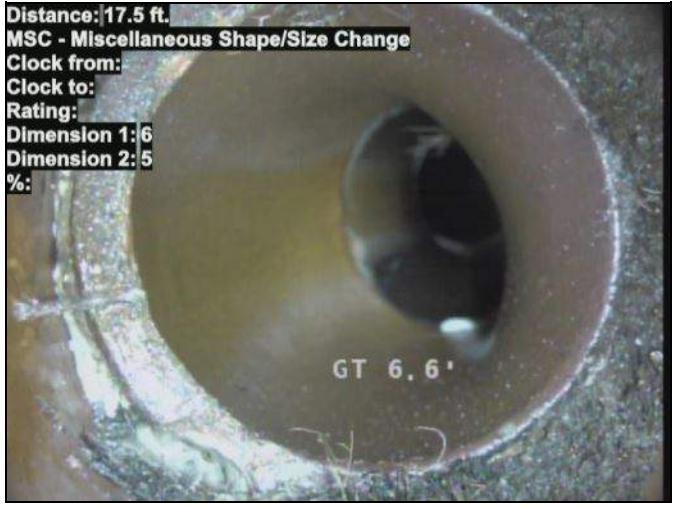
Photo: SMH178-SMH175-12042020-MSC-17.5 ft.-132928.JPG 17.513 ft. MSC - Miscellaneous Shape/Size Change At: Joint: No

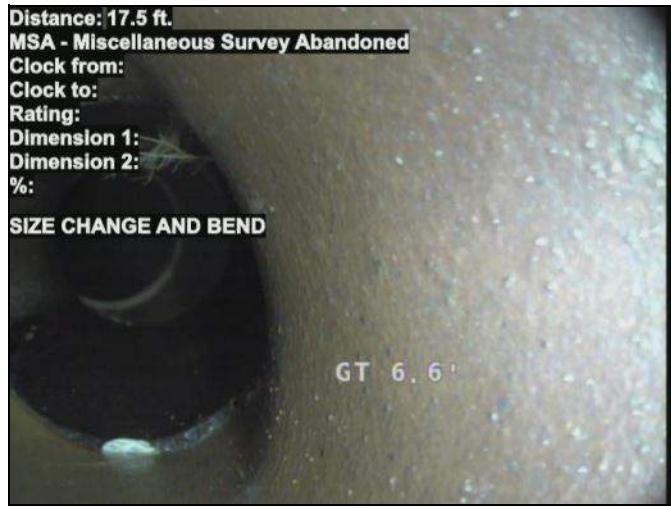
Photo: SMH178-SMH175-12042020-MSA-17.5 ft.-133022.JPG 17.513 ft. MSA - Miscellaneous Survey Abandoned At: Joint: No SIZE CHANGE AND BEND

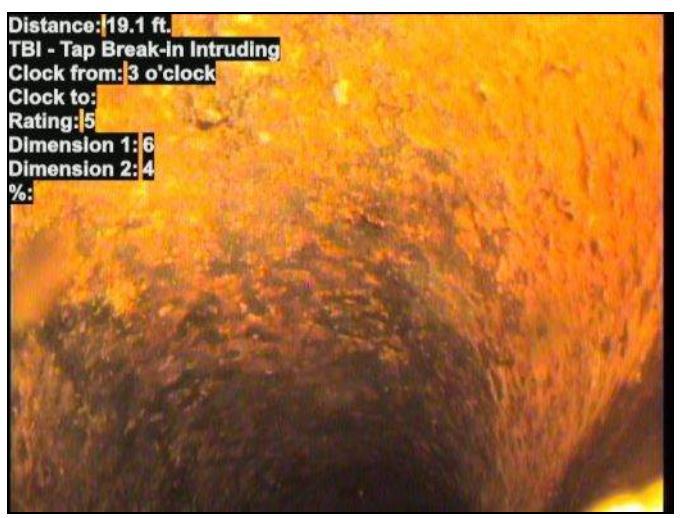
Photo:
 MH181-MH182-20210621-082405-082633.JPG

At:
 19.115 ft. 3/. TBI - Tap Break-in Intruding

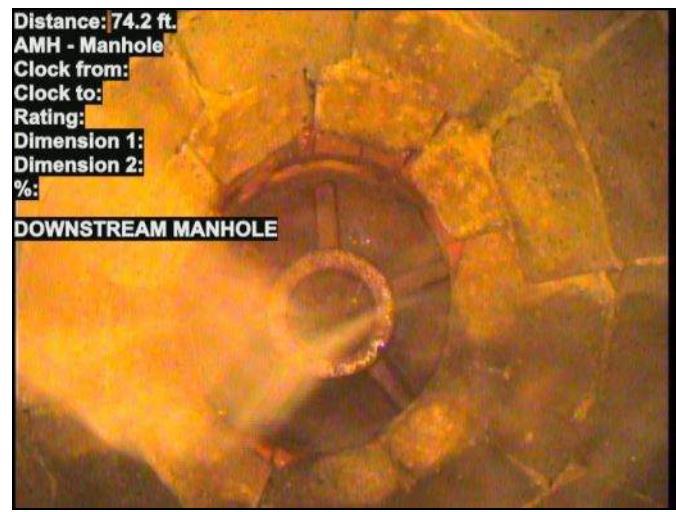
Photo:
 MH181-MH182-20210621-082405-082849.JPG

At:
 74.157 ft.
 AMH - Manhole

Joint:
 No
 DOWNSTREAM MANHOLE

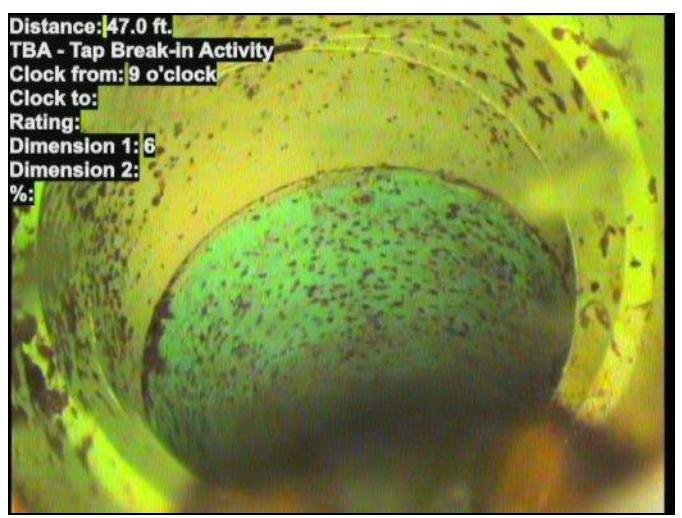
Photo:
 MH182-MH183-20210621-083201-083504.JPG

At:
 47.036 ft. 9/. TBA - Tap Break-in Activity

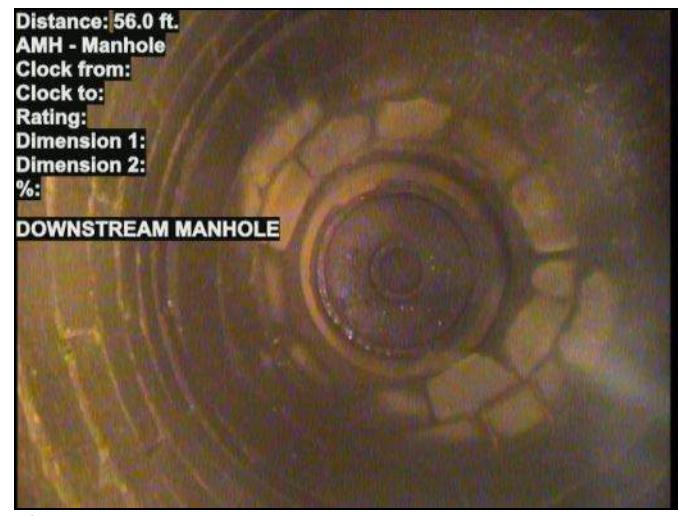
Photo:
 MH182-MH183-20210621-083201-083553.JPG

At:
 56.043 ft.
 AMH - Manhole

Joint:
 No
 DOWNSTREAM MANHOLE

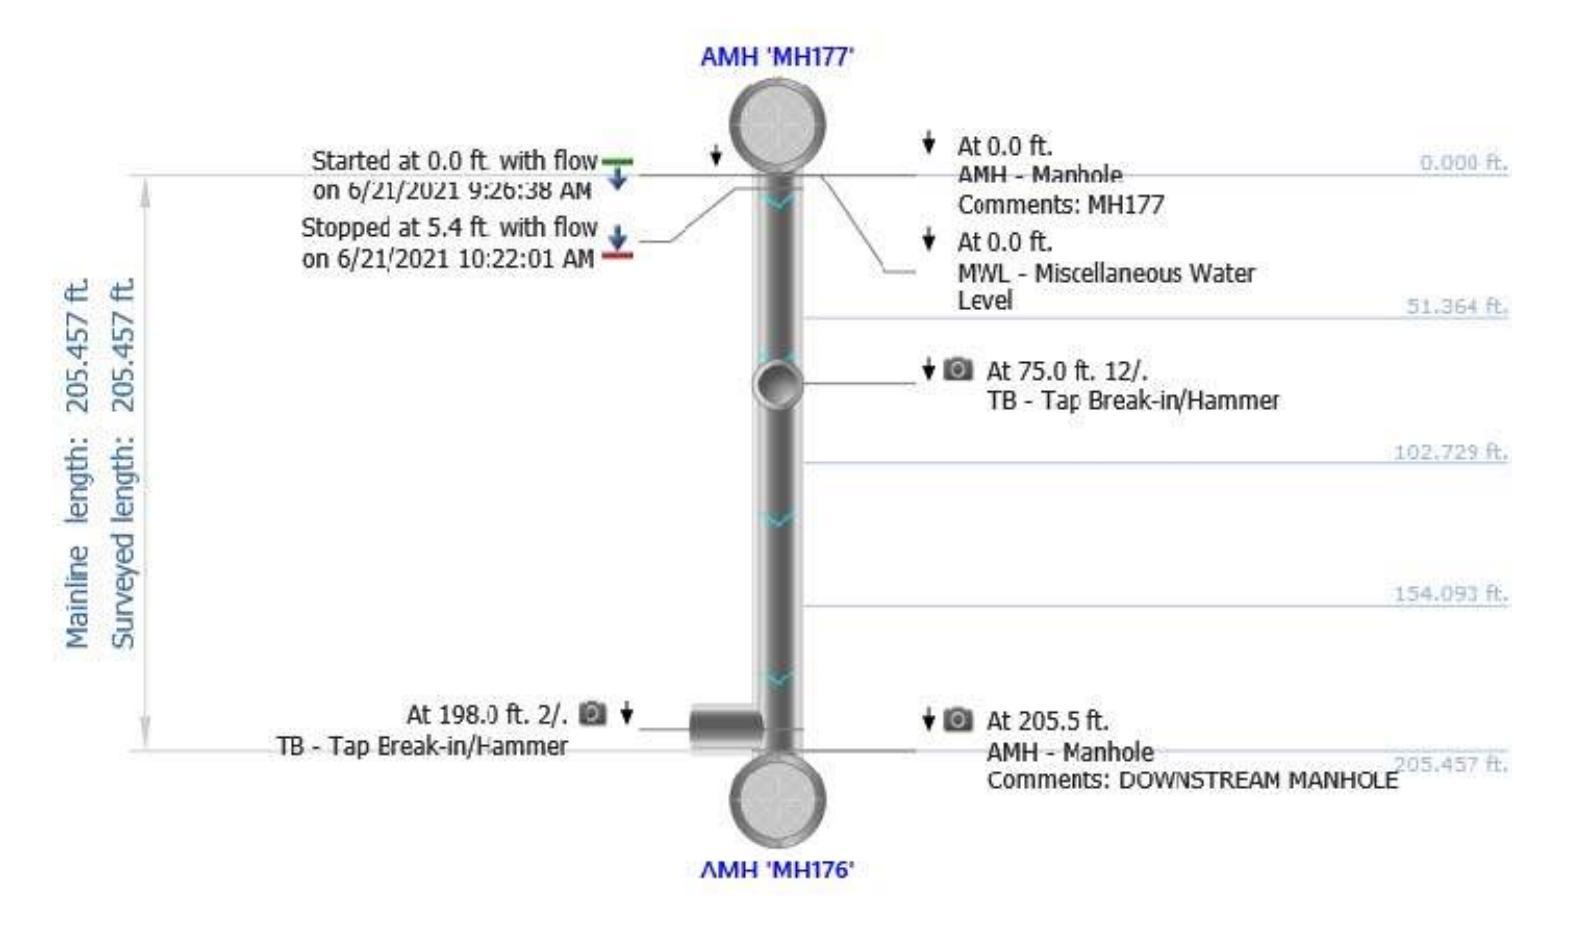
#### Distance: 75.0 ft. Distance: 198.0 ft. TB - Tap Break-in/Hammer Clock from: 2 o'clock Clock to: TB - Tap Break-in/Hammer Clock from: 12 o'clock Clock to: Rating: Rating: Dimension 1:6 Dimension 2 Dimension 2: %: Photo: MH177-MH176-20210621-092638-093127.JPG Photo: MH177-MH176-20210621-092638-094731.JPG At: 74.957 ft. TB - Tap Break-in/Hammer At: 197.952 ft. TB - Tap Break-in/Hammer 12/. 2/. Joint: No Joint: No

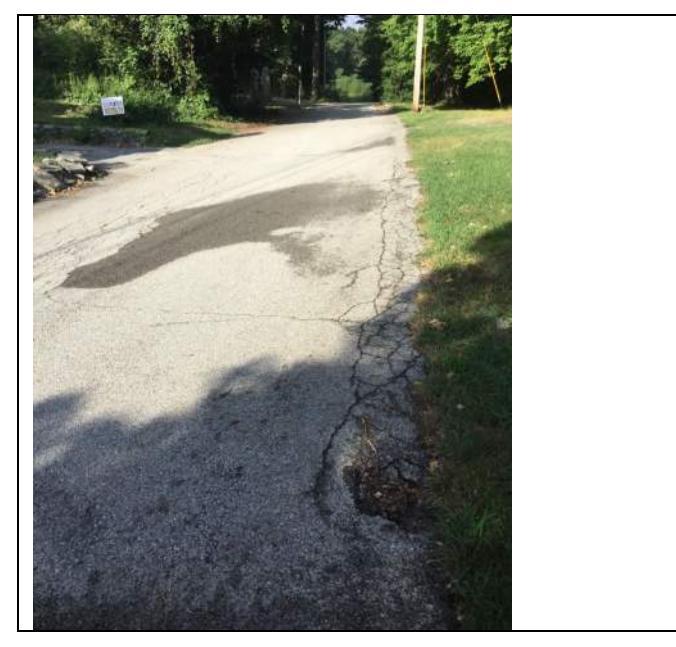
Public Improvement Data Street Name: Ardlock Place (please use a separate form for each street) Zoning or Land Use: Industry 43 <u>Infrastructure age</u> Water line: 1900 +/-Sewer line: 1959 Road surface: Unknown Lighting: N/A Sidewalk & curbs: N/A Other Relevant Data: N/A

Describe the condition	of each applicable component using the category definitions found on pages 11-14.
<u>Component</u>	Condition
Road Surface	Fair – The road surface has significant cracking and minor settlement.
Water Lines	Poor - Water main likely in poor structural condition due to age.
Sewer Lines	Fair – Water lines starting to age and need regular maintenance and repair.
Existing Sidewalk	N/A
Curbing	Fair – Bituminous curb has segments with of significant cracks and minimal revel height. Curbing is not continuous.
Drainage	N/A
Parking Lot:	N/A
Lighting:	N/A
Trees/Landscaping:	N/A
Park/Playground:	N/A
Other:	N/A

**Overall Rating:** (Excellent / Good / Fair / Poor) briefly state why. Fair – Surface features suffer from some damage. Sewer main and water main are in need of increasing maintenance due to age of infrastructure.

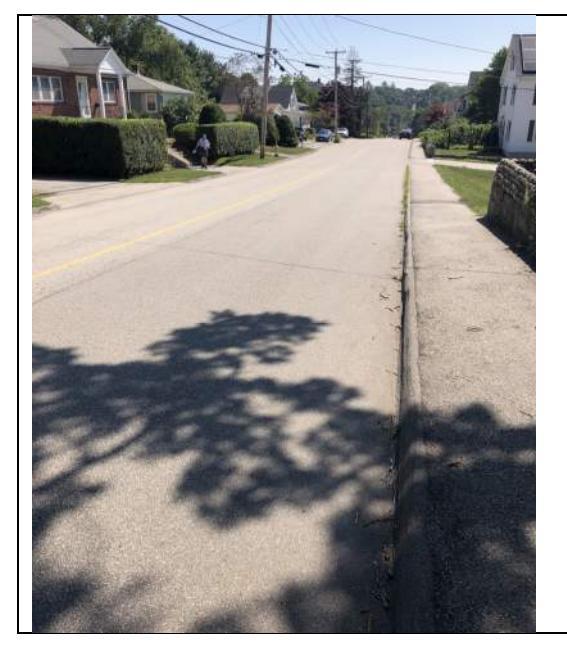
Public Improvement Data Street Name: Brandon Road (please use a separate form for each street) Zoning or Land Use: Business/General Residential Infrastructure age Water line: 1900 +/-Sewer line: 1930 Road surface: Unknown Lighting: Unknown Sidewalk & curbs: Unknown Other Relevant Data: N/A

Describe the condition of each applicable component using the category definitions found on pages 11-14. Component Condition Road Surface Good – The road surface has minor cracking. Water Lines Poor - Water main likely in poor structural condition due to age. Sewer Lines Poor – Sewer main is likely to be in poor structural condition due to age. Existing Sidewalk Good – Minor cracking and patches crossing sidewalk. Sidewalk ramps are present but not ADA compliant expect next to the library. Curbing Good – Minor deficiencies in bituminous curb face. N/A Drainage Parking Lot: N/A Lighting: Eight overhead street lights on telephone poles are present. Trees/Landscaping: N/A Park/Playground: N/A Other: N/A

**Overall Rating:** (Excellent / Good / Fair / Poor) briefly state why. Fair – The surface features are generally in good condition but underground utilities are in need of repairs and the lack of drainage infrastructure is problematic.

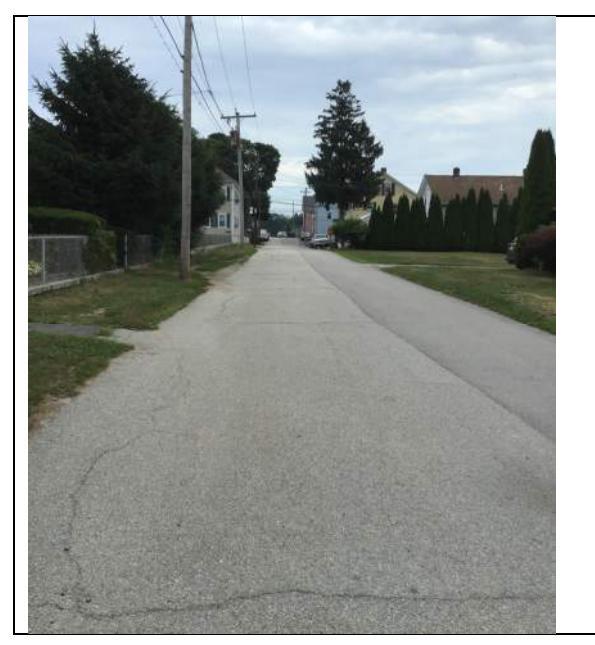
Public Improvement Data Street Name: Chestnut Street (please use a separate form for each street) Zoning or Land Use: Business/General Residential Infrastructure age Water line: 1900 +/-Sewer line: Unknown Road surface: Unknown Lighting: Unknown Sidewalk & curbs: N/A Other Relevant Data: N/A

Describe the condition of each applicable component using the category definitions found on pages 11-14.						
<u>Component</u>	<u>Condition</u>					
Road Surface	Good– The road surface has minor cracking and a trench patch from gas installation.					
Water Lines	Poor - Water main likely in poor structural condition due to age.					
Sewer Lines	Fair – Sewer Lines starting to age and may need regular maintenance and repair.					
Existing Sidewalk	N/A					
Curbing	N/A					
Drainage	Poor – Structures that are present have sediment build up, are of deteriorating condition and lack curbing—signs of previous erosion and flooding along street.					
Parking Lot:	N/A					
Lighting:	Three overhead street lights on telephone poles are present.					
Trees/Landscaping:	N/A					
Park/Playground:	N/A					
Other:	N/A

**Overall Rating:** (Excellent / Good / Fair / Poor) briefly state why. Fair – The surface features are generally in good condition but underground utilities are in need of repairs.

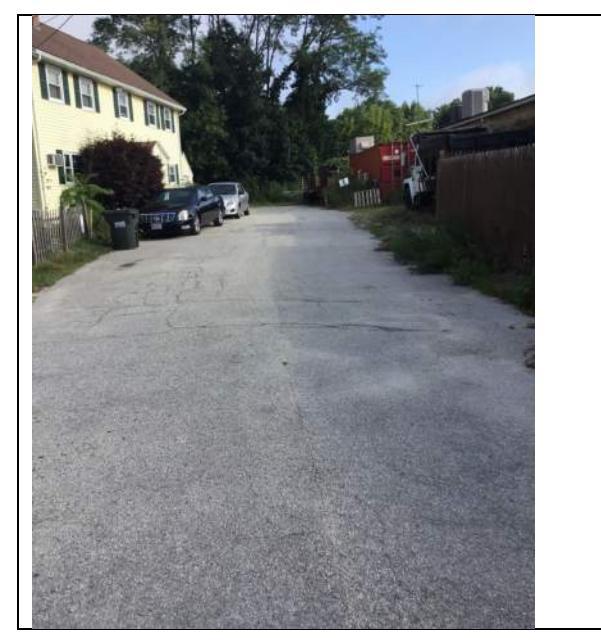
Public Improvement Data Street Name: Curfew Lane (please use a separate form for each street) Zoning or Land Use: Industry 43 <u>Infrastructure age</u> Water line: 1900 +/-Sewer line: 1959 Road surface: Unknown Lighting: N/A Sidewalk & curbs: N/A Other Relevant Data: N/A

Describe the condition	of each applicable component using the category definitions found on pages 11-14.				
<u>Component</u>	Condition				
Road Surface	Fair – The road surface has significant cracking and settlement.				
Water Lines	Poor - Water main likely in poor structural condition due to age.				
Sewer Lines	Fair – Sewer Lines starting to age and may need regular maintenance and repair.				
Existing Sidewalk	N/A				
Curbing	N/A				
Drainage	N/A				
Parking Lot:	N/A				
Lighting:	N/A				
Trees/Landscaping:	N/A				
Park/Playground:	N/A				
Other:	N/A				
Overall Rating: (Excellent / Good / Fair / Poor) briefly state why. Fair – Surface features suffer from some damage. Sewer main

and water main are in need of increasing maintenance due to age of infrastructure.

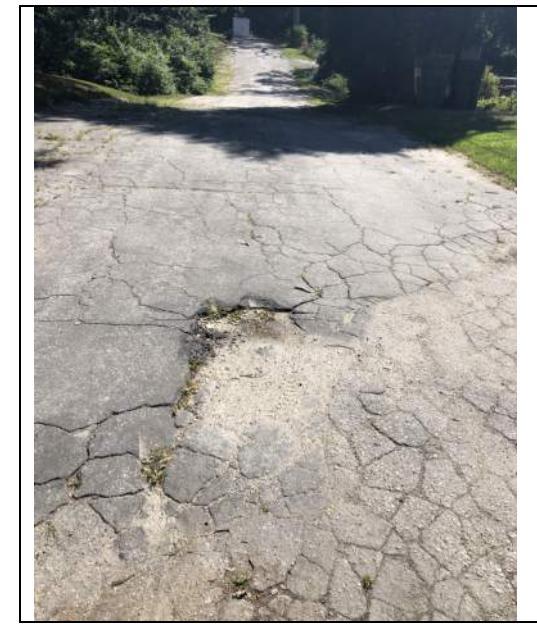
Public Improvement Data Street Name: Donna Lane (please use a separate form for each street) Zoning or Land Use: General Residential Infrastructure age Water line: N/A Sewer line: N/A Road surface: Unknown Lighting: N/A Sidewalk & curbs: N/A Other Relevant Data: N/A

<u>Component</u>	Condition				
Road Surface	Poor – The road surface is craked, uneven with numerous areas of exposed subbase. Appears to require full reconstruction.				
Water Lines	N/A				
Sewer Lines	N/A				
Existing Sidewalk	N/A				
Curbing	N/A				
Drainage	N/A				
Parking Lot:	N/A				
Lighting:	N/A				
Trees/Landscaping:	N/A				
Park/Playground:	N/A				
Other:	N/A				
Overall Rating: (Excellent / Good / Fair / Poor) briefly state why. Poor – Surface features suffer from significant damage.					
Public Improvement Data Street Name: Ellis Ave (please use a separate form for each street) Zoning or Land Use: General Residential Infrastructure age Water line: 1947 Sewer line: 1958 Road surface: Unknown Lighting: Unknown Sidewalk & curbs: Unknown Other Relevant Data: N/A

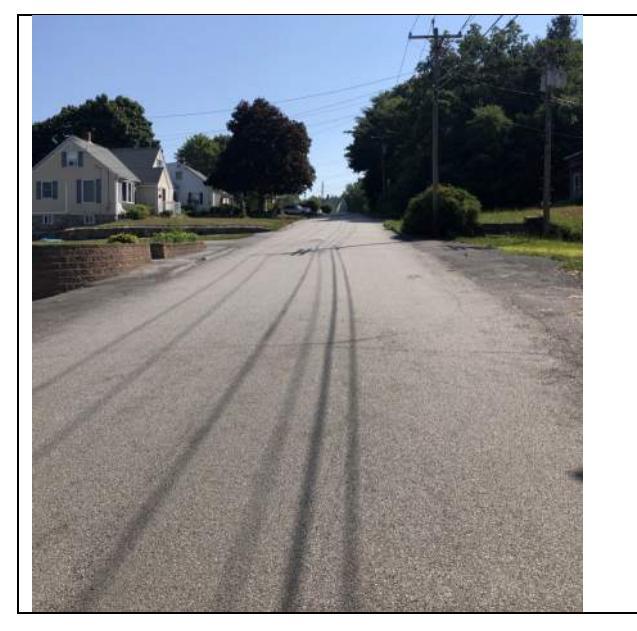
Describe the condition	of each applicable component using the category definitions found on pages 11-14.
<u>Component</u>	Condition
Road Surface	Excellent – Roadway Surface is of recent construction.
Water Lines	Fair – Water lines starting to age and need regular maintenance and repair.
Sewer Lines	Fair – Sewer Lines starting to age and may need regular maintenance and repair.
Existing Sidewalk	N/A
Curbing	Good – Minor deficiencies in bituminous curb face.
Drainage	N/A
Parking Lot:	N/A
Lighting:	Two overhead street lights on telephone poles are present.
Trees/Landscaping:	N/A
Park/Playground:	N/A
Other:	N/A
Overall Rating: (Excellent / Good / Fair / Poor) briefly state why. Good – The surface features are generally in good condition but

aging underground utilities may be in need of repairs.

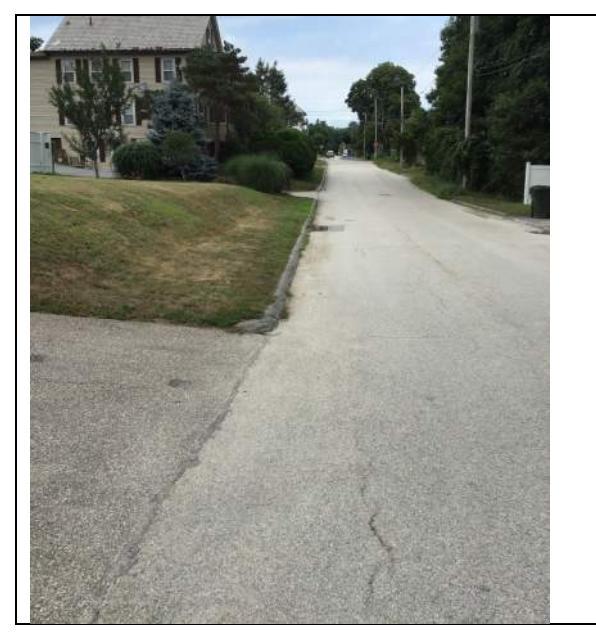
Public Improvement Data Street Name: Fairview Avenue (please use a separate form for each street) Zoning or Land Use: General Residential Infrastructure age Water line: 1900 +/-Sewer line: 1957 Road surface: Unknown Lighting: Unknown Sidewalk & curbs: Unknown Other Relevant Data: N/A

Describe the condition of each applicable component using the category definitions found on pages 11-14. Component Condition Road Surface Fair – Road surface has minor cracking, settlement around structures and potholing. Water Lines Poor - Water main likely in poor structural condition due to age. Sewer Lines Fair – Transite sewer lines starting to age and need regular maintenance and repair. Existing Sidewalk N/A Good – Minor cracking and deficiencies in bituminous curb face. Curbing Drainage Fair – Catch Basins have minor debris and minor deficiencies at frames. The DPW has indicated continued drainage problems. Parking Lot: N/A Lighting: Five overhead street lights on telephone poles are present. Trees/Landscaping: N/A Park/Playground: N/A Other: N/A

**Overall Rating:** (Excellent / Good / Fair / Poor) briefly state why. Fair – Surface features suffer from some damage. Sewer main and water main are in need of increasing maintenance due to age of infrastructure. Drainage infrastructure needs replacement.

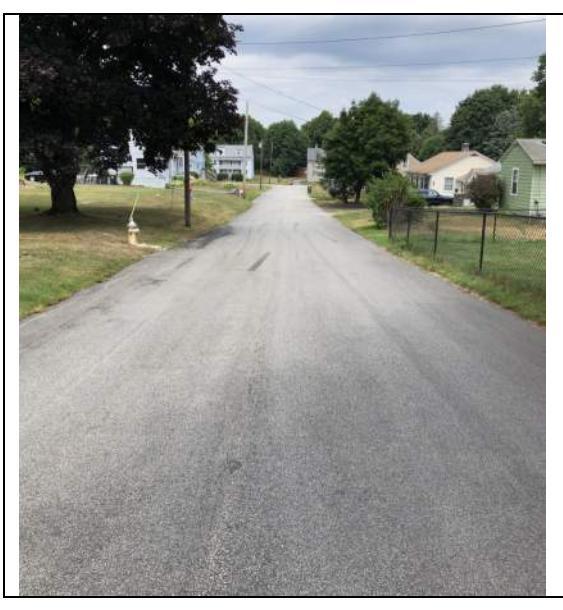
Public Improvement Data Street Name: Fifth Avenue (please use a separate form for each street) Zoning or Land Use: General Residential Infrastructure age Water line: 1948 Sewer line: Unknown Road surface: Unknown Lighting: Unknown Sidewalk & curbs: N/A Other Relevant Data: N/A

Describe the condition	of each applicable component using the category definitions found on pages 11-14.
<u>Component</u>	Condition
Road Surface	Excellent – Roadway surface is of recent construction.
Water Lines	Fair – Water lines starting to age and need regular maintenance and repair.
o	
Sewer Lines	Poor – Sewer main is likely to be in poor structural condition due to age.
Existing Sidewalk	Ν/Δ
Curbing	N/A
Drainage	N/A
Parking Lot:	N/A
Lighting:	One overhead street light on telephone note is present
Lighting.	One overhead street light on telephone pole is present.
Trees/Landscaping:	N/A
1 0	
Park/Playground:	N/A
Other:	N/A
Overall Definer (Everyland / Devid / Devid briefly state when Dein The surface for time and the line of the line o	
underground utilities are in need of repairs.
