Jericho-Brandon Study Area Town of Dudley, Massachusetts

Jericho-Brandon Infrastructure Planning Project

Prepared For: Town of Dudley 71 West Main Street Dudley, Massachusetts

June 2021

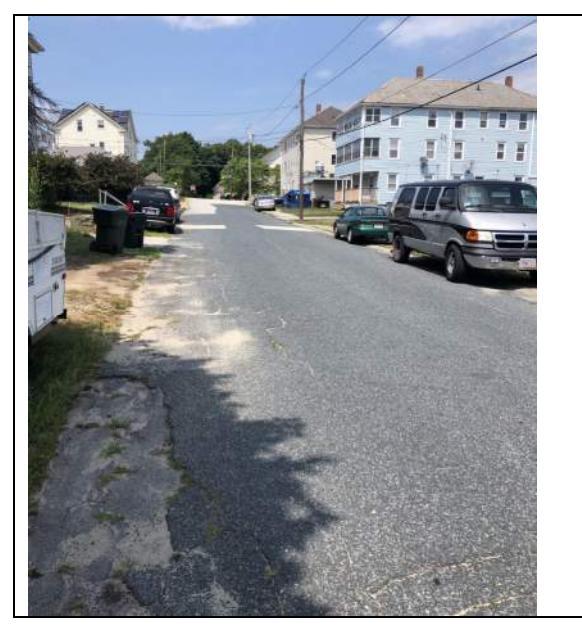
Describe the condition of each applicable component using the category definitions found on pages 11-14.	
<u>Component</u>	Condition
Road Surface	Fair – The road surface has significant cracking, settlement, patching, and deterioration along edges.
Water Lines	Poor - Water main likely in poor structural condition due to age.
Sewer Lines	Poor – Sewer main is likely to be in poor structural condition and a possible source of groundwater/stormwater inflow due to age.
Existing Sidewalk	Fair – Sidewalk has cracking and settlement. Sidewalk abruptly ends and cars are parked on sidewalk.
Curbing	Poor – Curbing has deteriorated to a point where it is barely still present.
Drainage	N/A
Parking Lot:	N/A
Lighting:	One overhead street light on telephone pole is present.
Trees/Landscaping:	N/A
Park/Playground:	N/A
Other:	N/A
Averall Pating: (Eventent / Cood / Eair / Boor) briefly state why Boor Surface features suffer from significant demons Course

Overall Rating: (Excellent / Good / Fair / Poor) briefly state why. Poor – Surface features suffer from significant damage. Sewer main and water main are in need of replacement due to age of infrastructure.

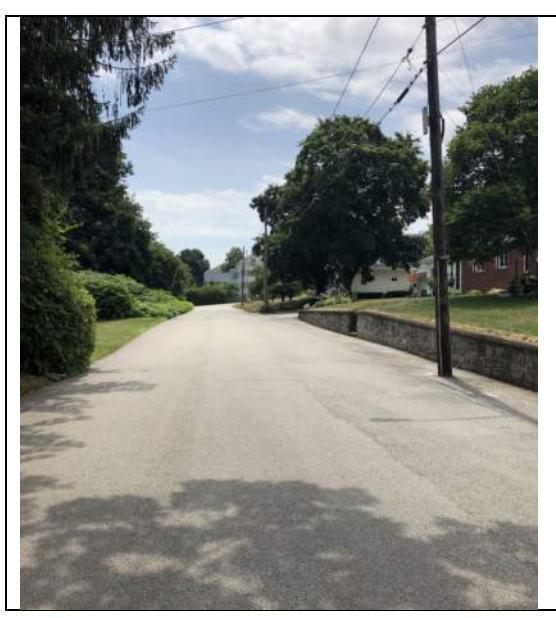
Public Improvement Data Street Name: Fourth Avenue (please use a separate form for each street) Zoning or Land Use: General Residential Infrastructure age Water line: 1949 Sewer line: Unknown Road surface: Unknown Lighting: Unknown Sidewalk & curbs: N/A Other Relevant Data: N/A

Describe the condition	of each applicable component using the category definitions found on pages 11-14.
<u>Component</u>	Condition
Road Surface	Excellent – Roadway surface is of recent construction.
Water Lines	Fair – Water lines starting to age and need regular maintenance and repair.
Sewer Lines	Poor – Sewer main is likely to be in poor structural condition due to age.
Existing Sidewalk	N/A
Curbing	Good – Short section of bituminous berm with minor cracking.
Drainage	N/A
Parking Lot:	N/A
Lighting:	Two overhead street lights on telephone poles are present.
Trees/Landscaping:	N/A
Park/Playground:	N/A
Other:	N/A
Overall Rating: (Excellent / Good / Fair / Poor) briefly state why. Fair – The surface features are generally in good condition but

underground utilities are in need of repairs.

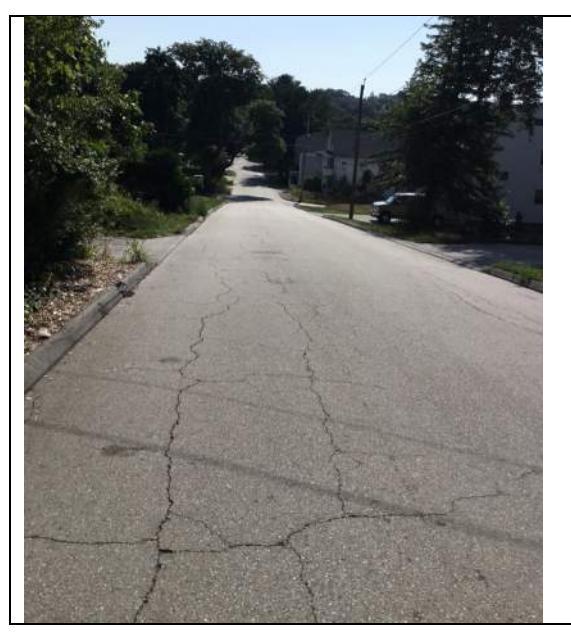
Describe the condition of each applicable component using the category definitions found on pages 11-14. Component Condition **Road Surface** Good – The road surface has some cracking. Water Lines Poor - Water main likely in poor structural condition due to age. Sewer Lines Poor - Sewer main is likely to be in poor structural condition and a possible source of groundwater/stormwater inflow due to age. **Existing Sidewalk** N/A Curbing Good - Minor deficiencies in bituminous curb face and minor cracking. Drainage N/A Parking Lot: N/A Lighting: Three overhead street lights on telephone poles are present. Trees/Landscaping: N/A Park/Playground: N/A Other: N/A

**Overall Rating:** (Excellent / Good / Fair / Poor) briefly state why. Fair – The surface features are generally in good condition but underground utilities are in need of repairs and the lack of drainage infrastructure is problematic.

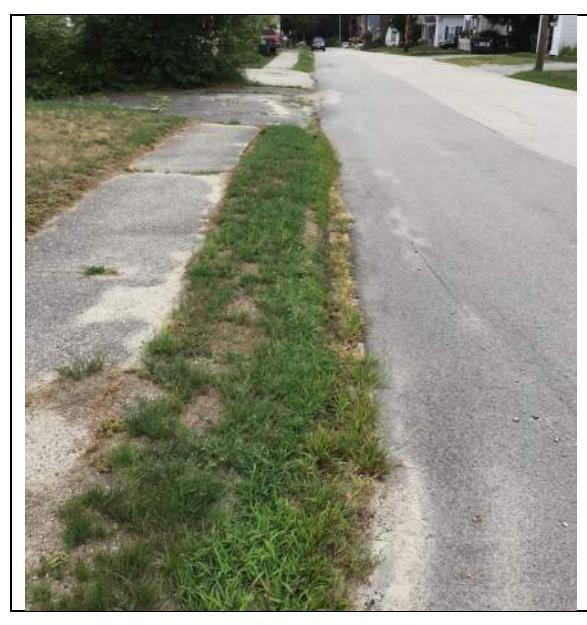
Describe the condition of each applicable component using the category definitions found on pages 11-14.	
<u>Component</u>	Condition
Road Surface	Good– The road surface has minor cracking and a trench patch from gas installation.
Water Lines	Poor - Water main likely in poor structural condition due to age.
Sewer Lines	Poor – Sewer main is likely to be in poor structural condition and a possible source of groundwater/stormwater inflow.
Existing Sidewalk	Fair – Bituminous sidewalks have minor cracking with grass growth, some uneven pavement caused by tree roots and some settling. Ramps are only sometimes present and not ADA compliant.
Curbing	Fair – Bituminous curb has segments with significant deficiencies in curb face, cracks with grass growth, settlement and/or of significant deterioration.
Drainage	N/A
Parking Lot:	N/A
Lighting:	Five overhead street lights on telephone poles are present.
Trees/Landscaping:	N/A

**Overall Rating:** (Excellent / Good / Fair / Poor) briefly state why. Fair – Surface features suffer from some damage. Sewer main and water main are in need of replacement due to age of infrastructure.

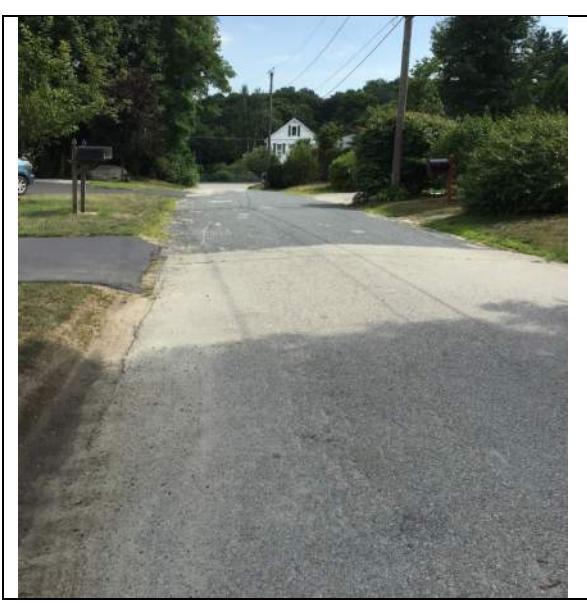
Public Improvement Data Street Name: Hill Court (please use a separate form for each street) Zoning or Land Use: General Residential Infrastructure age Water line: 1948 Sewer line: 2000 Road surface: Unknown Lighting: Unknown Sidewalk & curbs: N/A Other Relevant Data: N/A

Describe the condition	of each applicable component using the category definitions found on pages 11-14.
<u>Component</u>	Condition
Road Surface	Good– The road surface has minor cracking and patch around manhole.
Water Lines	Fair – Water lines starting to age and need regular maintenance and repair.
Sewer Lines	Fair – PVC Sewer Lines is a known area of infiltration.
Existing Sidewalk	N/A
Curbing	N/A
Drainage	Good – Catch basin is in good condition with minor deficiency is in cement under invert due to invert being installed in a higher location. Condition unkown in DMH and
Parking Lot:	outlet in private property. N/A
Lighting:	One overhead street light on telephone poles is present.
Trees/Landscaping:	N/A
Park/Playground:	N/A
Other:	N/A

**Overall Rating:** (Excellent / Good / Fair / Poor) briefly state why. Fair – The surface features are generally in good condition but underground utilities are in need of increasing maintenance.

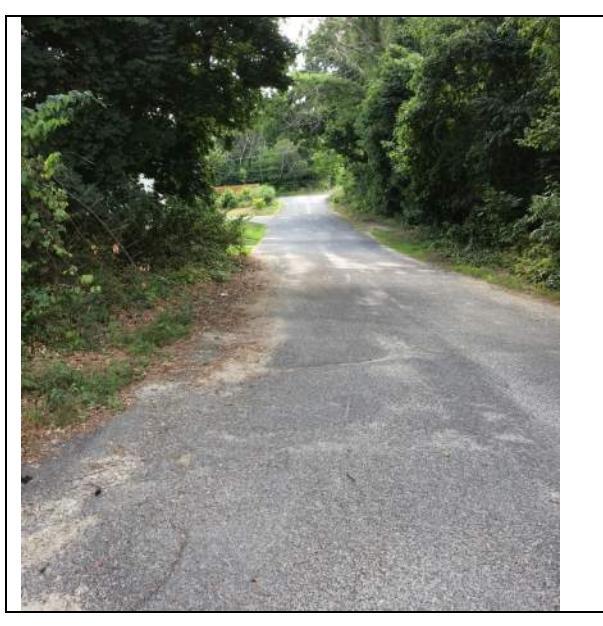
Public Improvement Data Street Name: James Street (please use a separate form for each street) Zoning or Land Use: General Residential Infrastructure age Water line: 1900 +/-Sewer line: 1954 Road surface: Unknown Lighting: Unknown Sidewalk & curbs: Unknown Other Relevant Data: N/A

Describe the condition	of each applicable component using the category definitions found on pages 11-14.
<u>Component</u>	Condition
Road Surface	Fair – The road surface has cracking and minor settlement. Some areas of cracking starting to degrade and will likely become potholes over the winter.
Water Lines	Poor - Water main likely in poor structural condition due to age.
Sewer Lines	Fair – Sewer Lines starting to age and may need regular maintenance and repair.
Existing Sidewalk	N/A
Curbing	Fair – Short segment of bituminous curbing with minor deficiencies in curb face.
Drainage	Poor – Catchbasins showing deficiencies and have sediment buildup with standing water.
Parking Lot:	N/A
Lighting:	Three overhead street lights on telephone poles are present.
Trees/Landscaping:	N/A
Park/Playground:	N/A
Other:	N/A
Overall Rating: (Excellent / Good / Fair / Poor) briefly state why. Fair – Surface features suffer from some damage. Sewer main and water main are in need of increasing maintenance due to age of infrastructure. Drainage infrastructure is in need or repair.

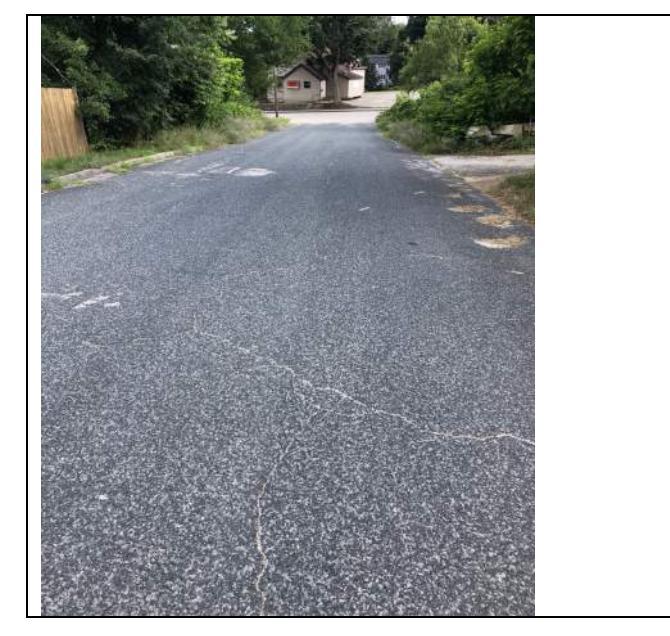
Public Improvement Data Street Name: Love Court (please use a separate form for each street) Zoning or Land Use: General Residential Infrastructure age Water line: N/A Sewer line: N/A Road surface: Unknown Lighting: N/A Sidewalk & curbs: Unknown Other Relevant Data: N/A

Describe the condition	of each applicable component using the category definitions found on pages 11-14.
<u>Component</u>	Condition
Road Surface	Good – The road surface has minor cracking and settlement.
Water Lines	N/A
Sewer Lines	N/A
Existing Sidewalk	N/A
Curbing	Good – Minor cracking with vegetation and minor deficiencies in bituminous curb face.
Drainage	N/A
Parking Lot:	N/A
Lighting:	N/A
Trees/Landscaping:	N/A
Park/Playground:	N/A
Other:	N/A
Overall Rating: (Excellent / Good / Fair / Poor) briefly state why. Good – The surface features are generally in good and no underground utilities are present.

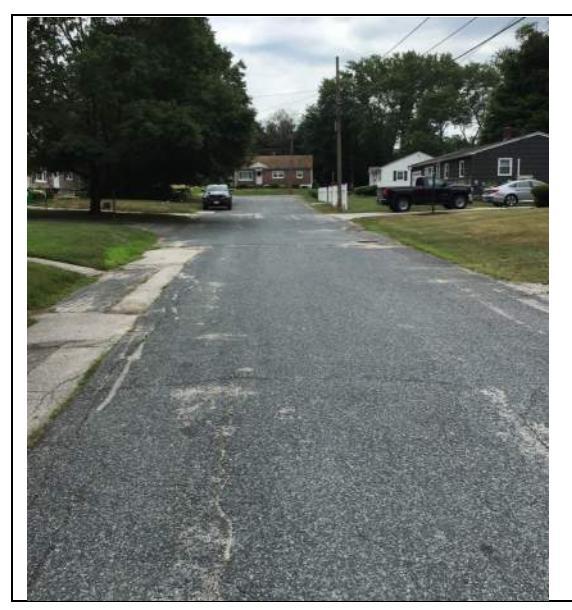
Public Improvement Data Street Name: Marshall Terrace (please use a separate form for each street) Zoning or Land Use: General Residential <u>Infrastructure age</u> Water line: 1959 Sewer line: 1964 Road surface: Unknown Lighting: Unknown Sidewalk & curbs: N/A Other Relevant Data: N/a

Describe the condition	of each applicable component using the category definitions found on pages 11-14.
<u>Component</u>	Condition
Road Surface	Fair – The road surface has significant cracking, settlement and patching.
Water Lines	Fair – Water lines starting to age and need regular maintenance and repair.
Sewer Lines	Fair – Sewer Lines starting to age and may need regular maintenance and repair.
Existing Sidewalk	N/A
Curbing	N/A
Drainage	Poor – Structures that are present have sediment build up and are of deteriorating condition. Signs of previous flooding and confirmed drainage issues by DPW.
Parking Lot:	N/A
Lighting:	Four overhead street lights on telephone poles are present.
Trees/Landscaping:	N/A
Park/Playground:	N/A
Other:	N/A
Overall Rating: (Excellent / Good / Fair / Poor) briefly state why. Fair – Surface features suffer from some damage. Sewer main

and water main are in need of increasing maintenance due to age of infrastructure. Drainage infrastructure requires replacement.

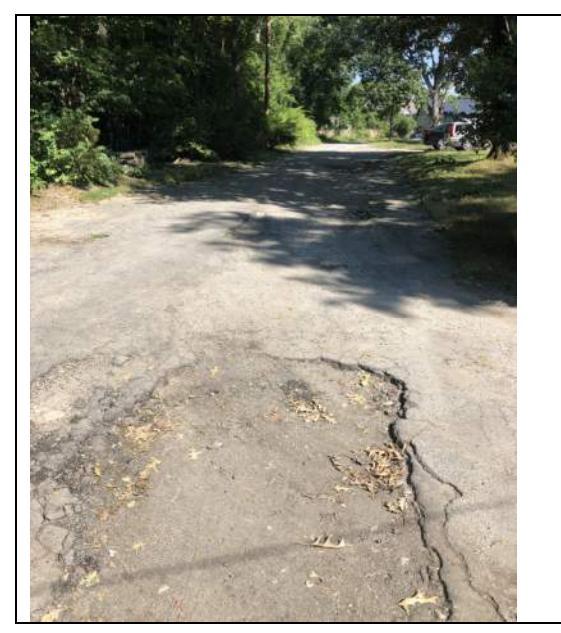
Public Improvement Data Street Name: Menzone Drive (please use a separate form for each street) Zoning or Land Use: General Residential Infrastructure age Water line: N/A Sewer line: N/A Road surface: Unknown Lighting: Unknown Sidewalk & curbs: N/A Other Relevant Data: N/A

Describe the condition of each applicable component using the category definitions found on pages 11-14. Component Condition Road Surface Poor – The road surface is cracked, uneven with areas of settlement. Appears to require full reconstruction. Water Lines N/A Sewer Lines N/A Existing Sidewalk N/A Curbing N/A Drainage N/A Parking Lot: N/A Lighting: Two overhead street lights on telephone poles are present. Trees/Landscaping: N/A Park/Playground: N/A Other: N/A

Overall Rating: (Excellent / Good / Fair / Poor) briefly state why. Poor – Street requires reconstruction based on evaluation of current surface conditions.

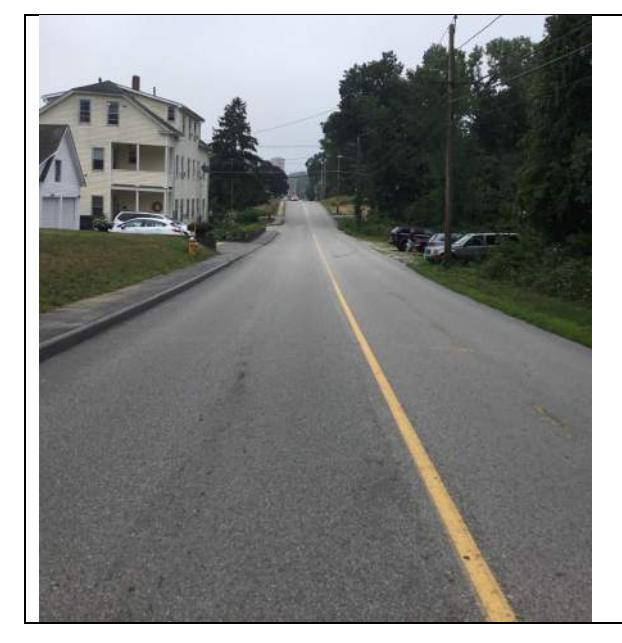
Describe the condition of each applicable component using the category definitions found on pages 11-14. Component Condition Good – The majority of roadway surface is of recent construction. Some road surface Road Surface has minor cracking and a trench patch from gas installation. Water Lines Excellent – Water line is of recent construction. Sewer Lines Fair – Sewer Lines starting to age and may need regular maintenance and repair. Existing Sidewalk Good – Some bituminous sidewalk is of recent construction. Some has Minor cracking and patches. Some ramps are present but not ADA compliant. Curbing Good – Minor deficiencies in bituminous curb face. Drainage Fair – Structures that are present have sediment build up, and are showing signs of deterioration. Parking Lot: N/A Lighting: Seven overhead street lights on telephone poles are present. Trees/Landscaping: N/A Park/Playground: N/A Other: N/A

**Overall Rating:** (Excellent / Good / Fair / Poor) briefly state why. Good – The surface features are generally in good condition. The water main is of recent construction but other aging underground utilities may require repairs.

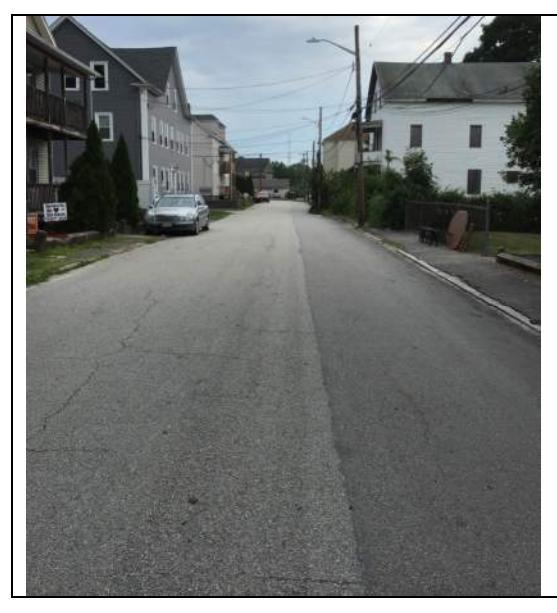
Describe the condition	of each applicable component using the category definitions found on pages 11-14.
<u>Component</u>	Condition
Road Surface	Good– The road surface has minor cracking and a trench patch from gas installation.
Water Lines	Poor - Water main likely in poor structural condition due to age.
Sewer Lines	Poor – Sewer main is likely to be in poor structural condition and a possible source of groundwater/stormwater inflow due to age.
Existing Sidewalk	Fair – Bituminous sidewalks have minor cracking with grass growth and some uneven pavement/. Ramps are not present.
Curbing	Fair – Granit curbing has minor chipping and areas of settlement / minimal revel height.
Drainage	N/A
Parking Lot:	N/A
Lighting:	Two overhead street lights on telephone poles are present.
Trees/Landscaping:	N/A
Park/Playground:	N/A
Other:	N/A
Overall Rating: (Excellent / Good / Fair / Poor) briefly state why. Fair – Surface features suffer from some damage. Sewer main and water main require replacement due to age of infrastructure.

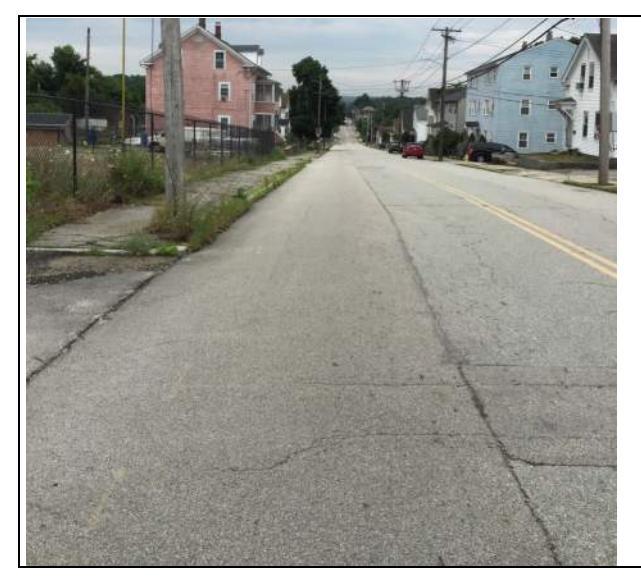
Public Improvement Data Street Name: Oxford Avenue (please use a separate form for each street) Zoning or Land Use: Light Industry 43 Infrastructure age Water line: 1900 +/-Sewer line: 1900 Road surface: Unknown Lighting: Unknown Sidewalk & curbs: Unknown Other Relevant Data: N/A

Describe the condition of each applicable component using the category definitions found on pages 11-14. Component Condition Road Surface Good – The road surface has minor cracking. Water Lines Poor - Water main likely in poor structural condition due to age and severely undersized. Sewer Lines Fair – Based on the sewer main section that was inspected via CCTV, the sewer is in fair condition with some structural and operation and maintenance defects. **Existing Sidewalk** Poor – The cement concrete sidewalks display cracking and patching. Bituminous sidewalks have significant cracking with grass growth, uneven pavement and settling. Ramps are only sometimes present and not ADA compliant. Fair – Granite curbing shows chipping and settlement. Curbing Drainage Good – Catchbasin at bottom of hill before the bridge have no visible deficiencies. Parking Lot: N/A Lighting: Five overhead street lights on telephone poles are present. Trees/Landscaping: N/A Park/Playground: N/A N/A Other:

**Overall Rating:** (Excellent / Good / Fair / Poor) briefly state why. Poor – Surface features suffer from significant damage. Water main requires replacement due to age of infrastructure and capacity.

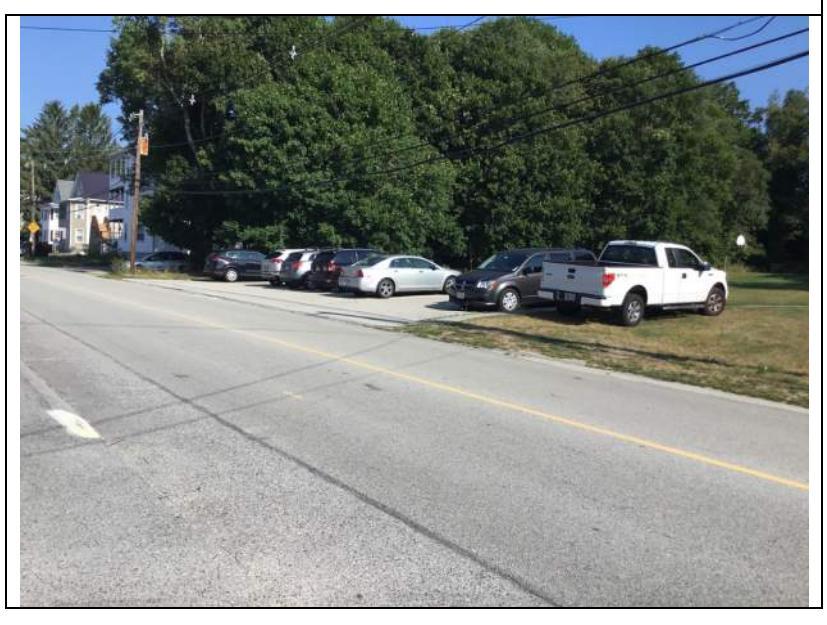
Describe the condition of each applicable component using the category definitions found on pages 11-14.		
<u>Component</u>	Condition	
Road Surface	Excellent – Roadway surface is of recent construction.	
Water Lines	Excellent – Water Lines are of recent construction.	
Sewer Lines	Poor – Sewer main is likely to be in poor structural condition and a possible source of groundwater/stormwater inflow due to age.	
Existing Sidewalk	Good – Bituminous sidewalks are of recent construction. Ramps are present but not ADA compliant.	
Curbing	Excellent – Bituminous curb is of recent construction with minor deficiencies in curb face.	
Drainage	Fair – Structures that are present have sediment build up, and are showing signs of deterioration. CMP is rusted, many grates are broken and mortar/ bricks, specifically around frame have seen deterioration.	
Parking Lot:	Good – The parking lot has some cracking with early signs of vegetation growth.

Lighting:	Four overhead street lights on telephone poles are present.	
Trees/Landscaping:	N/A	
Park/Playground:	Good – Basketball court has minor cracking and some signs of pooling water but park is in overall good condition.	
Other:	N/A

**Overall Rating:** (Excellent / Good / Fair / Poor) briefly state why. Good – The surface features are generally in good condition. The water main is of recent construction but other aging underground utilities may require repairs.

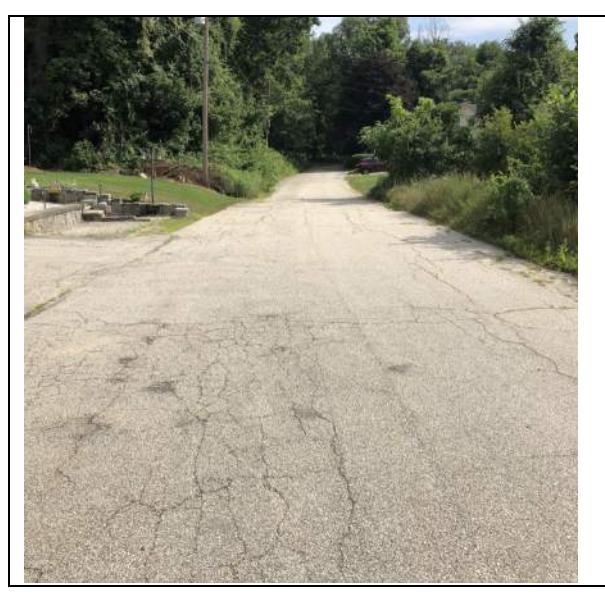
Describe the condition	of each applicable component using the category definitions found on pages 11-14.
<u>Component</u>	Condition
Road Surface	Fair – The road surface has significant cracking, settlement and patching. Signs of pooling water following a rain event.
Water Lines	Poor - Water main likely in poor structural condition due to age.
Sewer Lines	Fair – Sewer Lines starting to age and may need regular maintenance and repair.
Existing Sidewalk	N/A
Curbing	N/A
Drainage	Fair – Structures have sediment build up and vegetation grown over the grate. They are showing signs of deterioration, including rusted CMP.
Parking Lot:	N/A
Lighting:	One overhead street lights on telephone pole present.
Trees/Landscaping:	N/A
Park/Playground:	N/A
Other:	N/A
Overall Rating: (Excellent / Good / Fair / Poor) briefly state why. Fair – Surface features suffer from some damage. Sewer main.

water main and drainage are in need of increasing maintenance due to age of infrastructure.

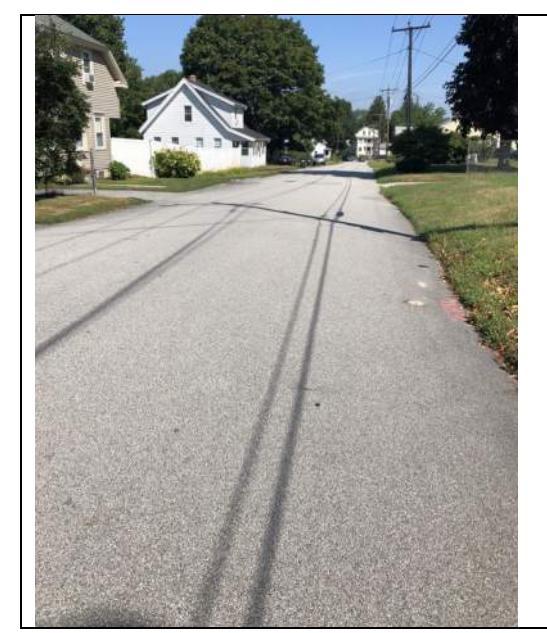
Public Improvement Data Street Name: Prospect Avenue (please use a separate form for each street) Zoning or Land Use: Business/General Residential Infrastructure age Water line: 1900 +/-Sewer line: 1958-1961 Road surface: Unknown Lighting: Unknown Sidewalk & curbs: N/A Other Relevant Data: N/A

Describe the condition of each applicable component using the category definitions found on pages 11-14. Component Condition Road Surface Excellent – Roadway surface is of recent construction. Water Lines Poor - Water main likely in poor structural condition due to age. Sewer Lines Fair – Sewer Lines starting to age and may need regular maintenance and repair. N/A Existing Sidewalk N/A Curbing Drainage N/A – Some sediment build up along street from flooding/pooling. Parking Lot: N/A Lighting: One overhead street lights on telephone pole present. Trees/Landscaping: N/A Park/Playground: N/A Other: N/A

**Overall Rating:** (Excellent / Good / Fair / Poor) briefly state why. Fair – The surface features are generally in good condition but underground utilities may require repairs.

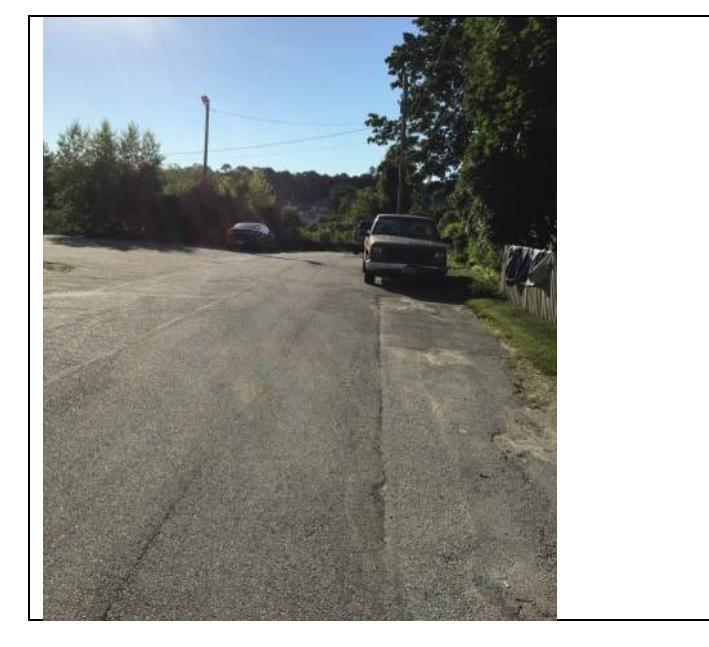
Public Improvement Data Street Name: Saenger Street (please use a separate form for each street) Zoning or Land Use: Light Industry 43 Infrastructure age Water line: 1900 +/-Sewer line: 1900 Road surface: Unknown Lighting: Unknown Sidewalk & curbs: N/A Other Relevant Data: N/A

Describe the condition	Describe the condition of each applicable component using the category definitions found on pages 11-14.	
<u>Component</u>	Condition	
Road Surface	Fair – The road surface has significant cracking, settlement and patching. Signs of pooling water following a rain event.	
Water Lines	Poor - Water main likely in poor structural condition due to age.	
Sewer Lines	Poor – Sewer main is likely to be in poor structural condition due to age. Sewer is connected to the main trunkline with only a T connection.	
Existing Sidewalk	N/A	
Curbing	N/A	
Drainage	N/A	
Parking Lot:	N/A	
Lighting:	One overhead street light on telephone pole present.	
Trees/Landscaping:	N/A	
Park/Playground:	N/A	
Other:	N/A

**Overall Rating:** (Excellent / Good / Fair / Poor) briefly state why. Fair – Surface features suffer from some damage. Sewer main and water main are in need of replacement due to age of infrastructure.

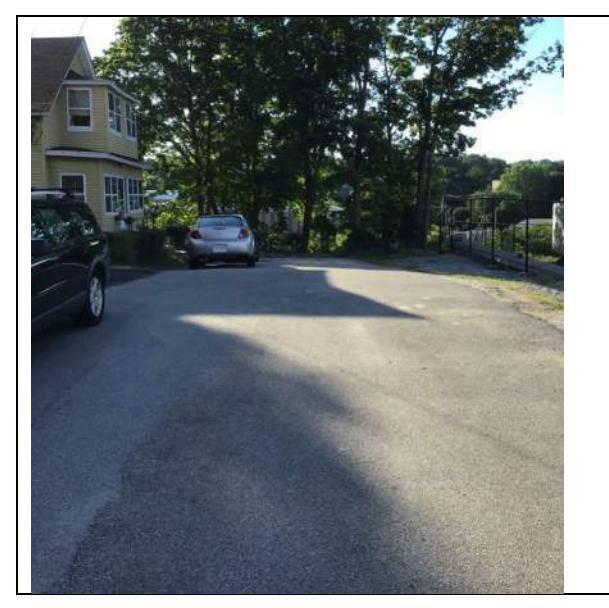
Public Improvement Data Street Name: School Court (please use a separate form for each street) Zoning or Land Use: Light Industry 43 <u>Infrastructure age</u> Water line: N/A Sewer line: Unknown Road surface: Unknown Lighting: Unknown Sidewalk & curbs: N/A Other Relevant Data: N/A

Describe the condition	of each applicable component using the category definitions found on pages 11-14.
<u>Component</u>	Condition
Road Surface	Good– The road surface has minor cracking and a trench patch from gas installation.
Water Lines	N/A
Sewer Lines	Poor – Sewer main is likely to be in poor structural condition due to age. Sewer is connected to the main trunkline with only a T connection.
Existing Sidewalk	N/A
Curbing	N/A
Drainage	N/A
Parking Lot:	N/A
Lighting:	One overhead street light on telephone pole present.
Trees/Landscaping:	N/A
Park/Playground:	N/A
Other:	N/A
Overall Rating: (Excellent / Good / Fair / Poor) briefly state why. Fair – Surface features suffer from some damage. Water main

are in need of replacement due to age of infrastructure. Erosion present.

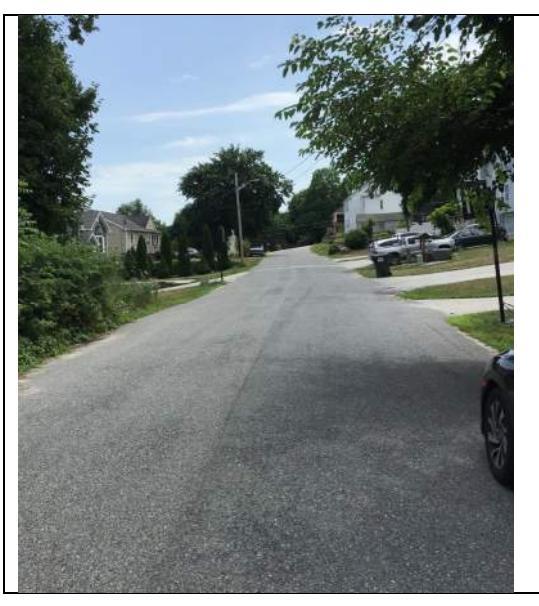
Public Improvement Data Street Name: Second Avenue (please use a separate form for each street) Zoning or Land Use: General Residential Infrastructure age Water line: 1900 +/-Sewer line: 1942 Road surface: Unknown Lighting: Unknown Sidewalk & curbs: N/A Other Relevant Data: N/A

Describe the condition	of each applicable component using the category definitions found on pages 11-14.
<u>Component</u>	Condition
Road Surface	Good – Roadway surface is of recent construction and has a trench patch that is settling and some signs of erosion/ settlement near hydrant valves.
Water Lines	Poor - Water main likely in poor structural condition due to age.
Sewer Lines	Poor – Sewer main is likely to be in poor structural condition due to age.
Existing Sidewalk	N/A
Curbing	Good – Minor deficiencies in bituminous curb face. Curb only in front of one property.
Drainage	Good – Infiltration catch basins are of recent construction.
Parking Lot:	N/A
Lighting:	Two overhead street lights on telephone poles are present.
Trees/Landscaping:	N/A
Park/Playground:	N/A
Other:	N/A
Overall Rating: (Excellent / Good / Fair / Poor) briefly state why. Good – The surface features are generally in good condition but

aging underground utilities require repairs.

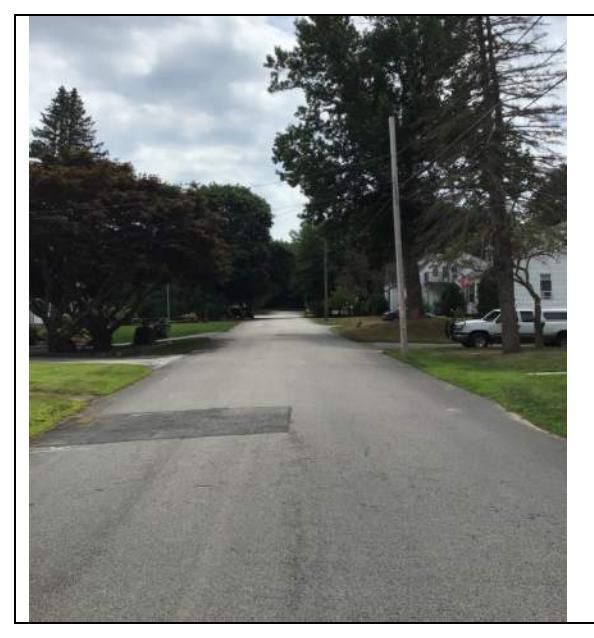
Public Improvement Data Street Name: Sixth Avenue (please use a separate form for each street) Zoning or Land Use: General Residential Infrastructure age Water line: 1900 +/-Sewer line: 1936 Road surface: Unknown Lighting: Unknown Sidewalk & curbs: N/A Other Relevant Data: N/A

<u>Component</u>	Condition
Road Surface	Excellent – Roadway surface is of recent construction.
Water Lines	Poor - Water main likely in poor structural condition due to age.
Sewer Lines	Poor – Sewer main is likely to be in poor structural condition due to age.
Existing Sidewalk	N/A
Curbing	N/A
Drainage	N/A
Parking Lot:	N/A
Lighting:	Two overhead street lights on telephone poles are present.
Trees/Landscaping:	N/A
Park/Playground:	N/A
Other:	N/A

**Overall Rating:** (Excellent / Good / Fair / Poor) briefly state why. Fair – The surface features are generally in good condition but underground utilities may require repairs.

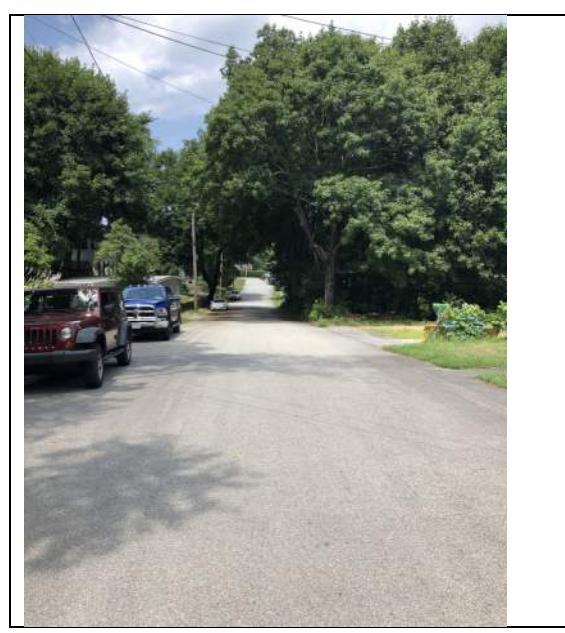
Public Improvement Data Street Name: Third Avenue (please use a separate form for each street) Zoning or Land Use: General Residential Infrastructure age Water line: 1900 +/-Sewer line: 1942 Road surface: Unknown Lighting: Unknown Sidewalk & curbs: N/A Other Relevant Data: N/A

Describe the condition of each applicable component using the category definitions found on pages 11-14. Component Condition Road Surface Excellent – Roadway surface is of recent construction. Water Lines Poor - Water main likely in poor structural condition due to age. Sewer Lines Poor – Sewer main is likely to be in poor structural condition due to age. N/A Existing Sidewalk N/A Curbing Drainage Fair – Structures have sediment build up and water prevents inspection. Outlet into private property with signs of flooding. Parking Lot: N/A Lighting: N/A Trees/Landscaping: N/A Park/Playground: N/A Other: N/A

**Overall Rating:** (Excellent / Good / Fair / Poor) briefly state why. Fair – The surface features are generally in good condition but underground utilities may require repairs.

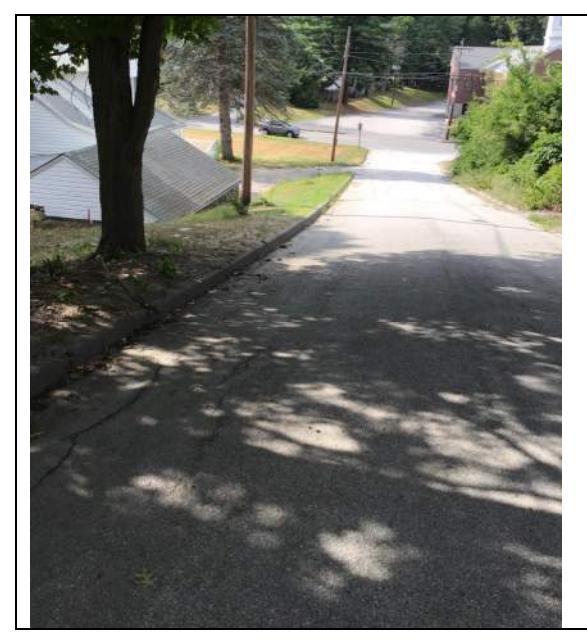
Describe the condition of each applicable component using the category definitions found on pages 11-14.	
<u>Component</u>	Condition
Road Surface	Fair – The road surface has some cracking that vegetation has started to grow through and erosion along edges.
Water Lines	Fair – Water lines starting to age and need regular maintenance and repair.
Sewer Lines	N/A
Existing Sidewalk	N/A
Curbing	Good – Minor deficiencies in bituminous curb face.
Drainage	N/A
Parking Lot:	N/A
Lighting:	One overhead street light on telephone pole is present.
Trees/Landscaping:	N/A
Park/Playground:	N/A
Other:	N/A

**Overall Rating:** (Excellent / Good / Fair / Poor) briefly state why. Fair – Surface features suffer from some damage. Water main may require increasing maintenance due to age of infrastructure.

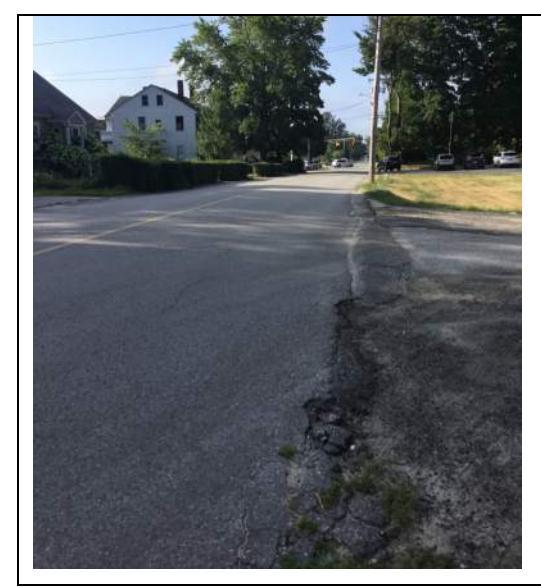
Describe the condition	of each applicable component using the category definitions found on pages 11-14.
<u>Component</u>	Condition
Road Surface	Good – The road surface has minor cracking and deterioration started along ages due to erosion/ pooling water.
Water Lines	Excellent – Water line is of recent construction.
Sewer Lines	Poor – Sewer main is likely to be in poor structural condition and a possible source of groundwater/stormwater inflow due to age. Connects to the main trunk line via private property.
Existing Sidewalk	Poor – Bituminous sidewalk has no berm, major cracking and settlement. Sidewalk is acting as a collection area for stormwater.
Curbing	N/A
Drainage	N/A
Parking Lot:	N/A
Lighting:	Three overhead street lights on telephone poles are present.
Trees/Landscaping:	N/A
Park/Playground:	N/A
Other:	N/A
Overall Pating: (Everyllent / Cood / Fair / Paer) briefly state why. Fair - Overfees factures outfar from some demonstrations

**Overall Rating:** (Excellent / Good / Fair / Poor) briefly state why. Fair – Surface features suffer from some damage. Water main is of recent construction Sewer main is need of replacement due to age of infrastructure and location.

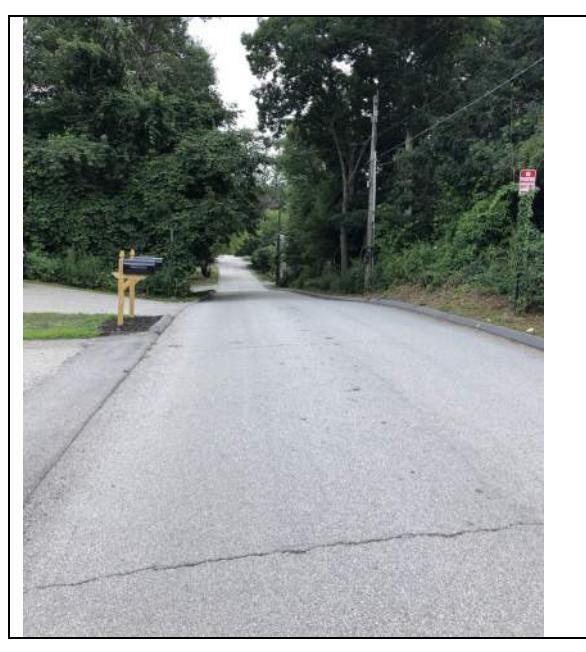
Public Improvement Data Street Name: Warsaw Avenue (please use a separate form for each street) Zoning or Land Use: General Residential Infrastructure age Water line: 1900 +/-Sewer line: Unknown Road surface: Unknown Lighting: Unknown Sidewalk & curbs: Unknown Other Relevant Data: N/A

Describe the condition of each applicable component using the category definitions found on pages 11-14.	
<u>Component</u>	Condition
Road Surface	Good – The road surface has minor cracking.
Water Lines	Poor - Water main likely in poor structural condition due to age.
Sewer Lines	Good– Some sewer lines are of newer construction some sewer lines starting to age and may need regular maintenance and repair.
Existing Sidewalk	N/A
Curbing	Good – Minor deficiencies in bituminous curb face.
Drainage	N/A
Parking Lot:	N/A
Lighting:	One overhead street light on telephone pole present.
Trees/Landscaping:	N/A
Park/Playground:	N/A
Other:	N/A

**Overall Rating:** (Excellent / Good / Fair / Poor) briefly state why. Good – The surface features are generally in good condition but aging underground utilities may require repairs.

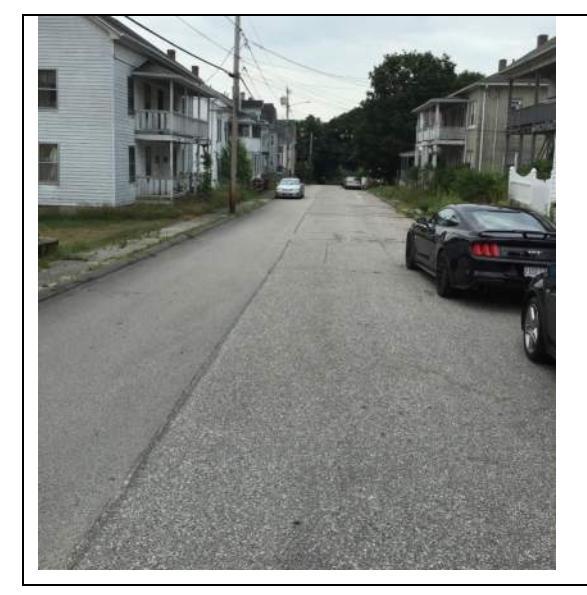
Describe the condition	of each applicable component using the category definitions found on pages 11-14.
<u>Component</u>	Condition
Road Surface	Fair – Some of the road surface has significant cracking and minor settlement.
Water Lines	Poor - Water main likely in poor structural condition due to age.
Sewer Lines	Poor – Sewer main is likely to be in poor structural condition and a possible source of groundwater/stormwater inflow due to age.
Existing Sidewalk	Poor – Bituminous sidewalk has major cracking, settlement and walking hazards that make it not walkable in some areas. Ramps are only sometimes present and not ADA
Curbing	Fair – Bituminous curb has segments with of significant cracks and setteling.
Drainage	Fair – Structures have sediment build up, and are showing signs of deterioration. CMP is rusted, a grate is broken and there is ponding around the structure.
Parking Lot:	N/A
Lighting:	Three overhead street lights on telephone poles are present.

**Overall Rating:** (Excellent / Good / Fair / Poor) briefly state why. Poor – Surface features suffer from significant damage. Sewer main, water main and drainage require replacement due to age of infrastructure.

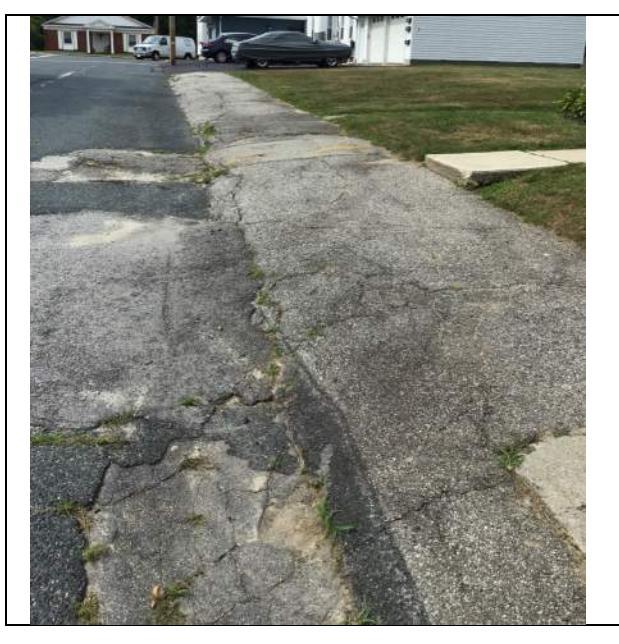
Describe the condition of each applicable component using the category definitions found on pages 11-14.	
<u>Component</u>	Condition
Road Surface	Poor – The road surface is cracked, uneven with areas of settlement. Appears to require full reconstruction.
Water Lines	Poor - Water main likely in poor structural condition due to age.
Sewer Lines	Fair – Sewer Lines starting to age and may need regular maintenance and repair. Connects to main trunk line via private property.
Existing Sidewalk	Poor – Bituminous sidewalk has now berm, major cracking and settlement.
Curbing	N/A
Drainage	Poor – Structures that are present have sediment build up, are of deteriorating condition and lack curbing—signs of previous erosion and flooding along street.
Parking Lot:	N/A
Lighting:	Two overhead street lights on telephone poles are present.
Trees/Landscaping:	N/A
Park/Playground:	N/A
Other:	N/A

**Overall Rating:** (Excellent / Good / Fair / Poor) briefly state why. Poor – Streets and curbs may require reconstruction based on evaluation of current surface conditions. Sewer main and water main require increasing maintenance due to age of infrastructure.

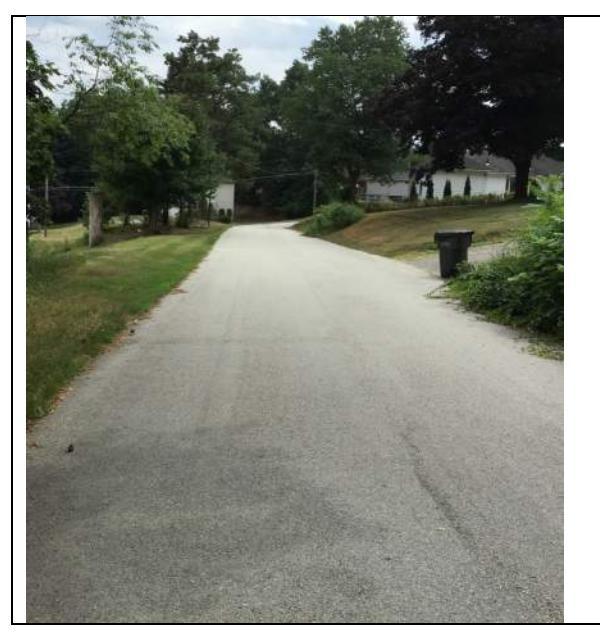
Public Improvement Data Street Name: Wooddell Road (please use a separate form for each street) Zoning or Land Use: General Residential Infrastructure age Water line: 1969 Sewer line: N/A Road surface: Unknown Lighting: N/A Sidewalk & curbs: N/A Other Relevant Data: N/A

<u>Component</u>	Condition	
Road Surface	Excellent – Roadway surface is of recent construction.	
Water Lines	Fair – Water lines starting to age and need regular maintenance and repair.	
Sewer Lines	N/A	
Existing Sidewalk	N/A	
Curbing	Good – Minor deficiencies in bituminous curb face.	
Drainage	N/A	
Parking Lot:	N/A	
Lighting:	N/A	
Trees/Landscaping:	N/A	
Park/Playground:	N/A	
Other:	N/A

**Overall Rating:** (Excellent / Good / Fair / Poor) briefly state why. Fair – The surface features are generally in good condition but underground utilities may require repairs.
